**Building Information - Tipp City Exempted Village (45617) - Broadway Elementary**

Program Type	Classroom Facilities Assistance Program (CFAP) - Regular
Setting	Small City
Assessment Name	Broadway Elementary with EEA & 2015 Costs
Assessment Date (on-site; non-EEA)	2015-03-31
Kitchen Type	Full Kitchen
Cost Set:	2015
Building Name	Broadway Elementary
Building IRN	3707
Building Address	223 West Broadway
Building City	Tipp City
Building Zipcode	45371
Building Phone	937-667-6216
Acreage	5.50
Current Grades:	2-3
Teaching Stations	33
Number of Floors	2
Student Capacity	451
Current Enrollment	375
Enrollment Date	2015-02-04
Enrollment Date is the date in which the current enrollment was taken.	
Number of Classrooms	29
Historical Register	<b>NO</b>
Building's Principal	Mr. Galen Gingerich
Building Type	Elementary

Broadway Elementary, which is not on the National Register of Historic Buildings, and originally constructed in 1951, is a two-story, 72,039 square foot brick school building located in a small town residential setting. One addition has been added to the building since its 1951 Original Construction. The 1967 Addition consists of 24,119 square feet of the overall square footage a

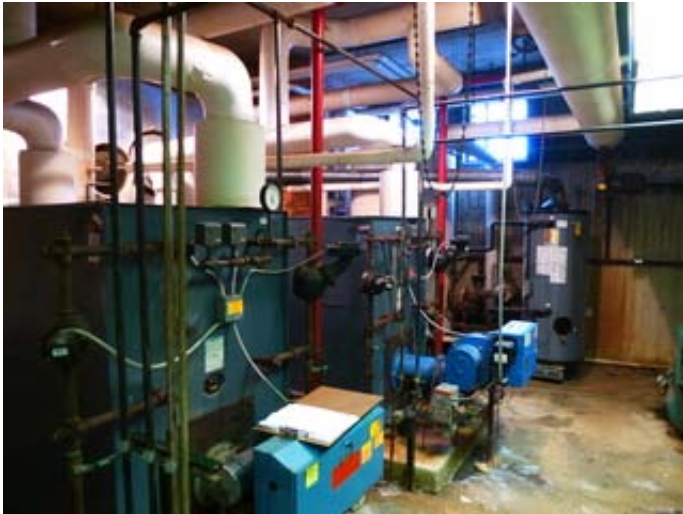
**Description:** The existing system for the overall facility is a gas fired steam boiler, installed in 1951 and 1995, and is in fair condition. The boiler plant, which services Broadway Elementary School, is located in a separate Maintenance Building behind the school, and tunnels related to this system are located beneath the shared parking lot between Broadway Elementary School and the Tipp City (TC) Enrichment Program Building. The Maintenance Building structure was not assessed during the Physical Assessment. 2-pipe vs. 4-pipe designations are not applicable in this facility, as no central air conditioning is provided. The two gas-fired steam boilers, manufactured by Weil McLain, were installed in 1995 and are in fair condition, and one gas fired boiler (used only as backup), manufactured by Kewanee, was installed in 1951 and is in poor condition. Steam is distributed to terminal units consisting of unit ventilators, cabinet heaters, unit heaters and fin tubes. The terminal equipment was installed in 1951 and 1967 and is in fair condition. The system does comply with the 15 CFM per person fresh air requirements of the Ohio Building Code mechanical code and Ohio School Design Manual. The pneumatic type system temperature controls were installed in 1951 and 1967 and are in fair condition. The system does feature individual temperature controls in all spaces required by the OSDM. The overall system does not feature any central energy recovery systems. The facility is equipped with a moderate quantity of louvered interior doors to facilitate Corridor utilization as return air plenums. (Louvered doors are replaced in Item J - General Finishes and Item O - Handicapped Access, if applicable.) The existing system is not ducted, and floor to structural deck heights will not accommodate the installation of properly sized ductwork for a future Ohio School Design Manual approved system. The overall heating system is evaluated as being in safe but inefficient working order, and long term life expectancy of the existing system is not anticipated. The structure is not equipped with central air conditioning. The site does not contain underground fuel tanks.

**Rating:** 3 Needs Replacement

Existing Steam Boilers

**Recommendations:** Provide new overall heating, ventilating, and air conditioning system to achieve compliance with Ohio Building Code and Ohio School Design Manual standards. Convert to a ducted system to facilitate efficient exchange of conditioned air. Provide new DDC type temperature controls to meet Ohio Building Code and Ohio School Design Manual standards. Provide architectural soffits to accommodate the installation of ductwork. Refer to Item T - Hazardous Material, for information regarding the abatement of boiler system hazardous materials in the Maintenance Building.

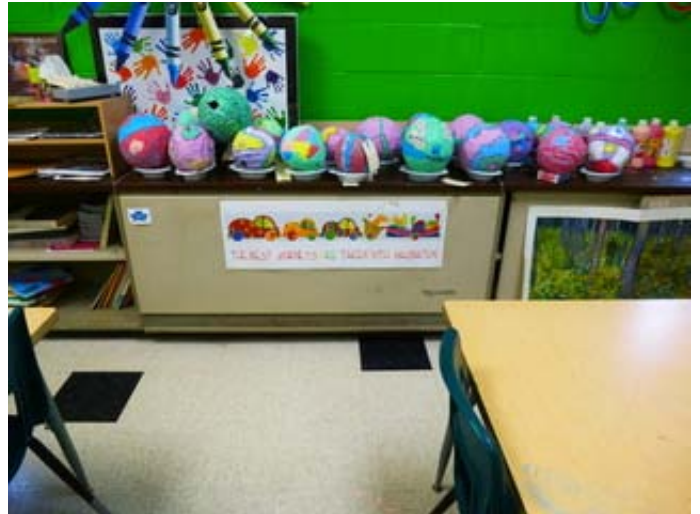
Typical Unit Ventilator

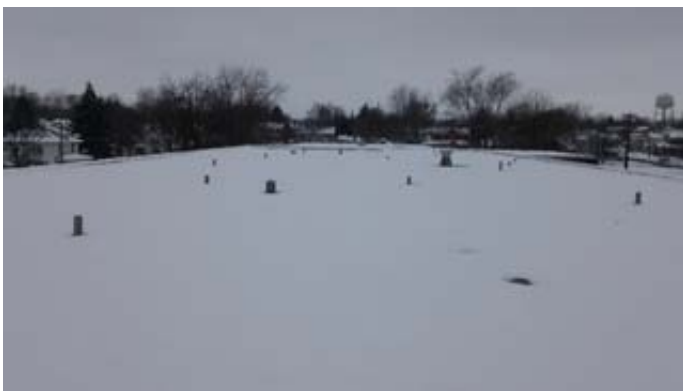
**Description:** The roofing system of the overall facility is a built-up asphalt roof membrane, was replaced from 1992-1993, and is in poor condition. There are District reports of current leaking. Signs of past leaking were observed during the physical assessment. Access to the roof was gained by an access door in poor condition. Fall safety protection cages are not required, and are not provided. There were no observations of standing water on the roof. Metal cap flashings with built-up asphalt roof membrane adhered up and over the metal cap flashings are in poor condition. Roof storm drainage is addressed through a system of roof drains, which are improperly located, and in good condition. The roof is not equipped with overflow roof drains, though they are needed on this building. All roof penetrations are in poor condition and should be replaced.

**Rating:** 3 Needs Replacement

1951 Original Construction Roof

**Recommendations:** The roofing system over the overall facility requires replacement to meet Ohio School Design Manual guidelines for age of system and due to condition. Remove all existing roof insulation. Provide a minimum of 4" new polyiso rigid roof insulation over the overall facility. The flashings and copings for the overall facility require replacement due to condition. Due to existing conditions, additional roof drains are required as well as emergency overflow drains. Replace the existing roof access door. Costs associated with this replacement will be included in the scope for exterior door replacement in Item S - Exterior Doors. Provide new roof access ladders. Remove all existing roof membrane, insulation, metal copings, and metal soffit systems at the small one-story appendage to the 1951 Original Construction. Replace with a new roofing system, minimum 4" new polyiso roof insulation, metal soffit, and metal copings. Remove all existing roof membrane, insulation, metal copings, and metal soffit systems at the roof overhang at the rear entry of the 1967 Addition. Replace with a new roofing system, minimum 4" new polyiso roof insulation, metal soffit, and metal copings. Due to the deteriorating concrete overhang, provide wood blocking to secure new metal copings and transitions.

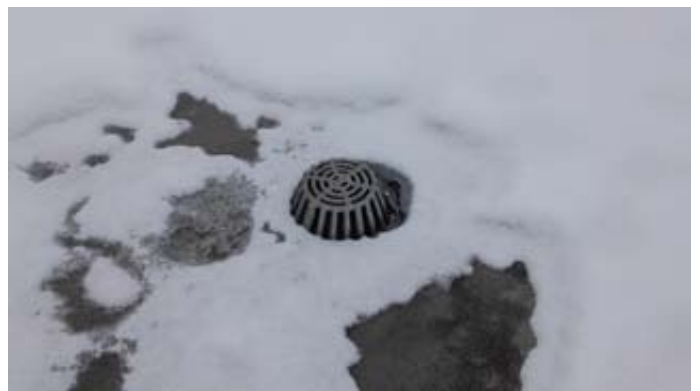
Typical Roof Drain

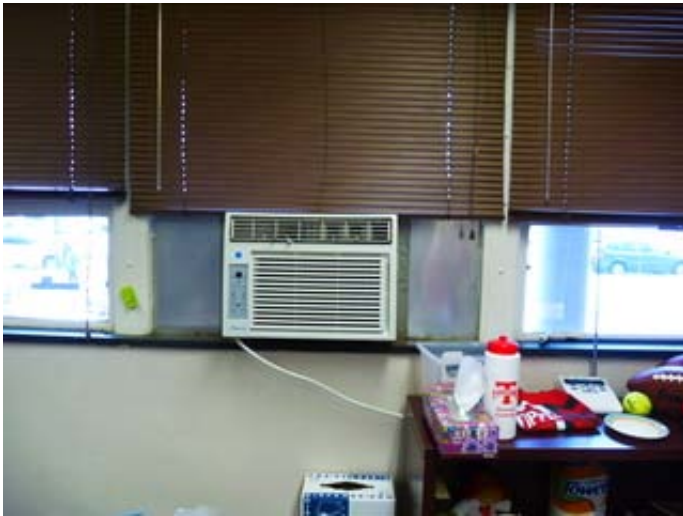
**Description:** The overall facility is not equipped with a central air conditioning system. Window units are provided in the Office, Library, and Clinic locations. A mobile air conditioning unit is provided in the Technology Room. The ventilation system in the overall facility consists of unit ventilators, installed in 1951 and 1967 and in fair condition, providing fresh air to Classrooms, and air handlers, installed in 1951 and 1967 and in fair condition, providing fresh air to other miscellaneous spaces such as Gymnasiums, the Student Dining area, and Media Center spaces. Relief air venting is provided by ceiling plenums exhausted by roof ventilation fans. The ventilation system does not meet the Ohio Building Code 15 CFM per occupant fresh air requirement. The overall system is not compliant with Ohio Building Code and Ohio School Design Manual requirements. Dust collection systems are not required in this facility. The Art program is equipped with a kiln, and existing kiln ventilation is adequate, and in good condition. General building exhaust systems for Restrooms Storage Rooms, Art Rooms, and Custodial Closets are adequately placed, and in fair condition.

Typical Window A/C Unit

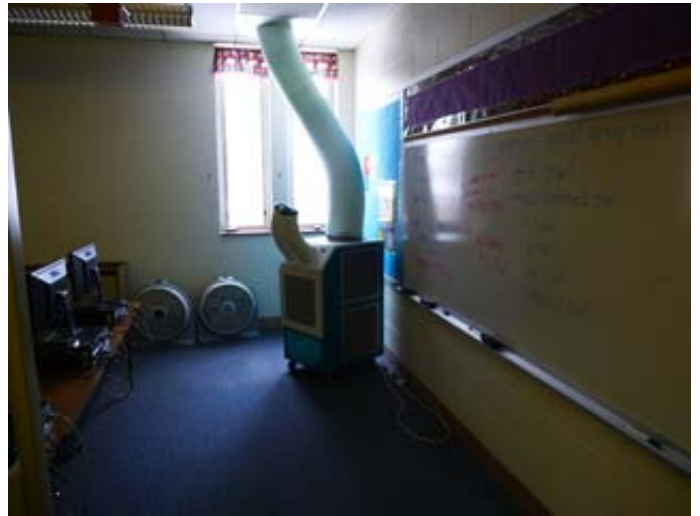
Portable A/C Unit

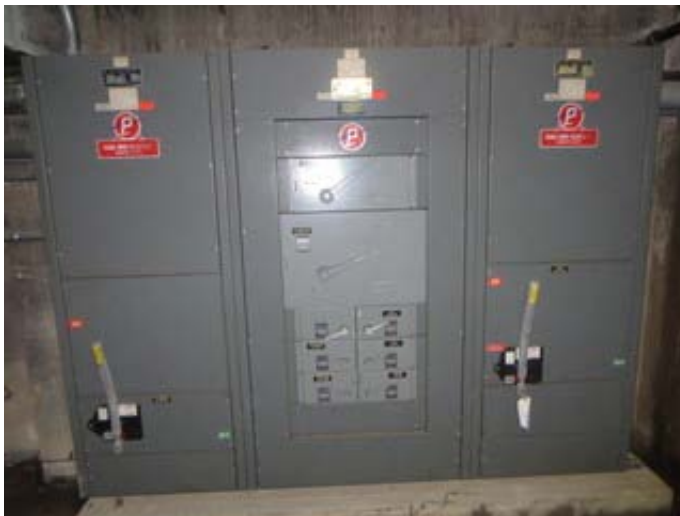
**Description:** The electrical system provided to the 1951 Original Construction is a 120/208V, 800A, 3 phase and 4 wire system replaced in 1986, and is in good condition, located in the Mechanical Systems Building adjacent to the school. This electric service also serves the electrical distribution in the Tippecanoe Central (TC) Enrichment Program Building. The electrical system provided to the 1967 Addition is a 120/208V, 400A, 3 phase and 4 wire system replaced in 2001, and is in good condition. The system in the 1967 Addition is a separate metered electrical service. Power is provided to the school by two district owned, pad-mounted transformers located outside the building and in good condition. The panel system, installed in the 1951 Original Construction, is in poor condition, and cannot be expanded to add additional capacity. The panel system, installed in the 1967 Addition, is in poor condition, and cannot be expanded to add additional capacity. The Classrooms are not equipped with adequate electrical outlets. The typical Classroom contains 5 general purpose outlets, 3 dedicated outlets for each Classroom computer, and 0 dedicated outlets for each Classroom television. Some Classrooms are equipped with as many as 5 general purpose outlets, while others are equipped with as few as 3 general purpose outlets. There are not any spaces that have no electrical outlets. The Corridors are equipped with adequate electrical outlets for servicing. Adequate GFI protected exterior outlets are not provided around the perimeter of the building. The facility is not equipped with an emergency generator. Adequate lightning protection safeguards are not provided. Stage lighting power system including control panel, breakers, and dimmers is not provided and does not meet OSDM requirements. The overall electrical system does not meet Ohio School Design Manual requirements in supporting the current needs of the school, and will be inadequate to meet the facility's future needs.

**Rating:** 3 Needs Replacement

Main Electric Distribution

**Recommendations:** The entire electrical system requires replacement to meet Ohio School Design Manual guidelines for overall capacity, due to condition and age, and lack of OSDM-required features.

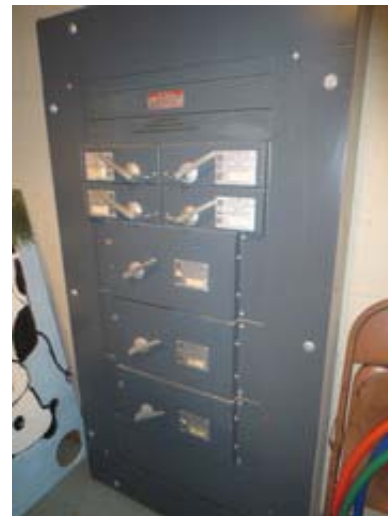
Addition Electrical Distribution

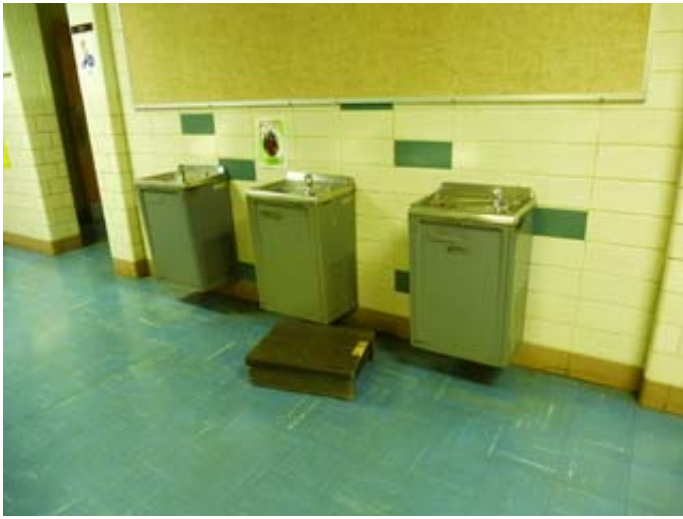
**Description:** The service entrance is not equipped with a reduced pressure back flow preventer. A water treatment system is not provided. The domestic water supply piping in the overall facility is galvanized, was installed in 1951 and 1967, is original to each addition, and is in fair condition. The waste piping in the overall facility is cast iron, was installed in 1951 and 1967, is original to each addition, and is in fair condition. The facility is equipped with (10 qty) 5 gallon electric water heaters, in fair condition that serve Classroom sinks. The facility is also equipped with 1 gas water heater in good condition and 1 separate storage tank in fair condition, that serves the 1951 Original Construction. The school contains 4 Large Group Restrooms for boys, 4 Large Group Restrooms for girls, 1 Locker Room Restroom for boys, 1 Locker Room Restroom for girls, and 2 Restrooms for staff. Boys' Large Group Restrooms contain 0 ADA and 5 non-ADA wall mounted flush valve toilets and 8 non-ADA floor mounted flush valve toilets, 0 ADA and 11 non-ADA wall mounted flush valve urinals and 0 ADA and 11 non-ADA floor mounted flush valve urinals, as well as 0 ADA and 13 non-ADA wall mounted lavatories. Girls' Large Group Restrooms contain 0 ADA 9 non-ADA wall mounted flush valve toilets and 0 ADA and 11 non-ADA floor mounted flush valve toilets, as well as 0 ADA and 13 non-ADA wall mounted lavatories. Boys' Locker Room Restrooms contain 0 ADA and 1 non-ADA floor mounted flush valve toilets, 0 ADA and 4 non-ADA floor mounted flush valve urinals and 0 ADA and 2 non-ADA wall mounted lavatories. Girls' Locker Room Restrooms contain 0 ADA and 3 non-ADA floor mounted flush valve toilets, as well as 0 ADA and 2 non-ADA wall mounted lavatories. Staff Restrooms contain 0 ADA and 2 non-ADA floor mounted flush valve toilets, as well as 0 ADA and 2 non-ADA wall mounted lavatories. Condition of fixtures is fair. The facility is equipped with 6 non-ADA electric water coolers, in fair condition. The 27 Elementary Classrooms are equipped with 27 non-ADA sink mounted type drinking fountains, in fair condition. The Special Education Classroom is not equipped with the required Restroom facilities. The Kitchen is equipped with the required Restroom, and fixtures are in fair condition. The Heath Clinic is equipped with the required Restroom, and fixtures are in fair condition. Kindergarten / Pre-K Classrooms are equipped with Restroom facilities, and fixtures are in fair condition. Kitchen fixtures consist of 1 double compartment sink, 1 triple compartment sink, 1 dishwasher, and 1 disposal, which are in good condition. The Kitchen is equipped with an unsatisfactory floor mounted grease interceptor. The Kitchen is provided with the required 140 degree hot water supply via a 90 gallon, gas fired type water heater, which is in good condition. The school does not meet the OBC requirements for fixtures. Relative to LEED requirements, the school is not equipped with low flow type fixtures. Per OBC and OSDM requirements this facility should be equipped with 29 toilets, 6 urinals, 18 lavatories, 27 Classroom sink mounted drinking fountains, and 9 electric water coolers. Observations revealed that the school is currently equipped with 43 toilets, 26 urinals, 36 lavatories, 27 Classroom sink mounted drinking fountains, and 6 electric water coolers. ADA requirements are not met for fixtures and drinking fountains (see Item O). Custodial Closets are properly located and provided with required service sinks or floor drain sinks, which are in fair condition. Science Classroom / Lab utility sinks, gas connections, compressed air connections, and safety shower / eyewash are not provided, but are not required due to existing grade configuration. Due to existing grade configuration, no Biology or Chemistry Classroom acid waste systems are required. Adequate exterior wall hydrants are not provided.

**Rating:** 3 Needs Replacement

Typical Drinking Fountain

**Recommendations:** Due to age, condition, LEED, and OSFC requirements, provide a total of 43 toilets, 26 urinals, 36 lavatories, 27 Classroom sink mounted drinking fountains, and 9 electric water coolers. Fixture totals are coordinated between Item E - Plumbing and Fixtures and Item O - Handicapped Access. Within Item E - Plumbing and Fixtures, provide 31 new toilets / 24 new lavatories / 21 new urinals / 4 new electric water coolers / 27 new lavatory mounted type drinking fountains. See Item O - Handicapped Access, for the remainder of fixture replacements and additions related to ADA requirements. Provide new water heater, circulation pump, and piping to eliminate under the counter electric water heaters. Provide new mop sinks due to age and condition. Replace galvanized water supply piping in the overall facility with copper piping. Replace sanitary waste piping in the overall facility due to age. Provide new grease interceptor due to age and condition. Provide reduced pressure back flow preventer. Provide exterior wall hydrants.

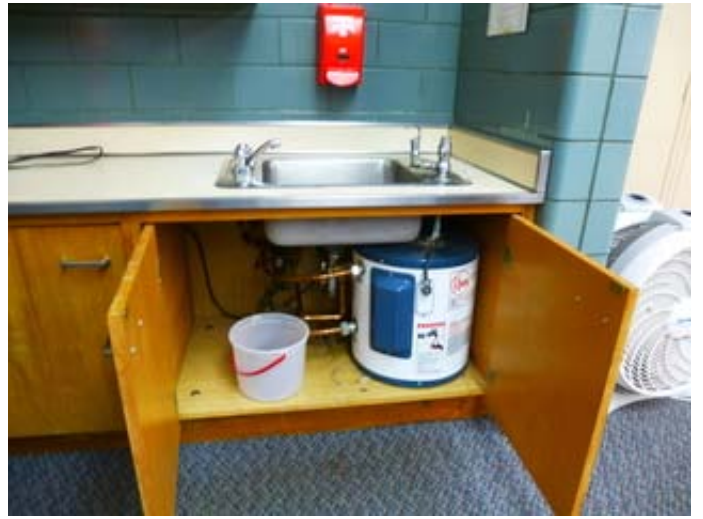
Under the Counter Water Heater

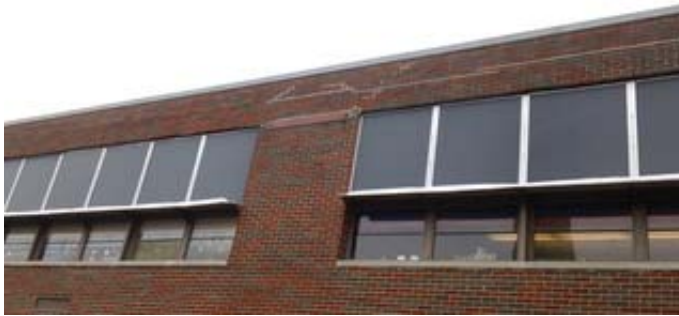
**Description:** The overall facility is equipped with aluminum windows with single glazed type window system, and are in poor condition. The window system features operable windows throughout the building, and operable windows are equipped with opening limiters in poor condition. No insect screens are present. Window system seals are in poor condition, with moderate air and water infiltration being experienced. Window system hardware is in poor condition. The window system features no blinds. This facility is not equipped with any curtain wall systems. This facility does not feature any glass block windows. The window system does feature painted steel sunshades in the rear of the building, which are in poor condition. The exterior doors in the overall facility are aluminum and steel with sidelights and transoms with single pane glazing, in poor condition. Exterior door vision panels are also single pane. The school does not contain skylights. The school does not contain clerestories. Interior glass is not OSDM-compliant due to not being safety glazing. Window security grilles are not provided for ground floor windows. There is not a Greenhouse associated with this school.

**Rating:** 3 Needs Replacement

1951 Original Construction Windows

**Recommendations:** Provide a new insulated window system with integral blinds to meet with Ohio School Design Manual requirements. Costs associated with the replacement of window transoms and sidelights at exterior doors of the overall facility are included within the replacement of the exterior storefront systems. Replace transoms over interior doors and all other non-compliant interior glazing with 1/4" tempered glass. Exterior door vision panel replacement is addressed in the replacement of exterior doors in Item S - Exterior Doors. Scrape/sand sunshades and repaint.

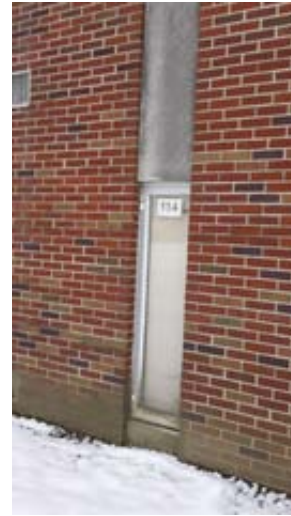
1967 Addition Windows

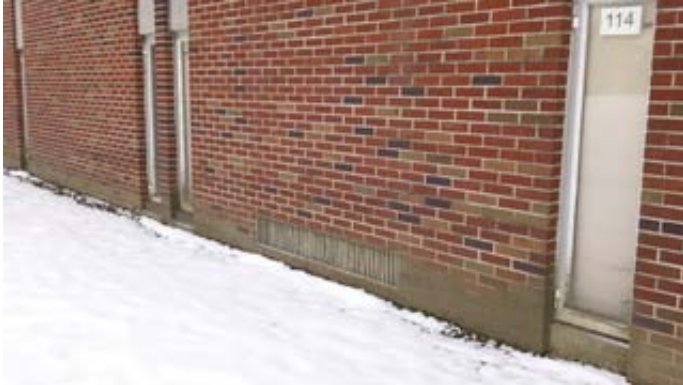
**Description:** The overall facility is equipped with concrete foundation walls on concrete spread footings, which displayed no locations of significant differential settlement, cracking, or leaking, and are in good condition. Areas of minor cracking and spalling were observed through the 1951 Original Construction. The District reports that there has been no past leaking. No grading or site drainage deficiencies were noted around the perimeter of the structure that are contributing or could contribute to foundation / wall structural deterioration.

**Rating:** 2 Needs Repair

Masonry Foundation

**Recommendations:** Repair areas of cracking and spalling where present in the 1951 Original Construction.

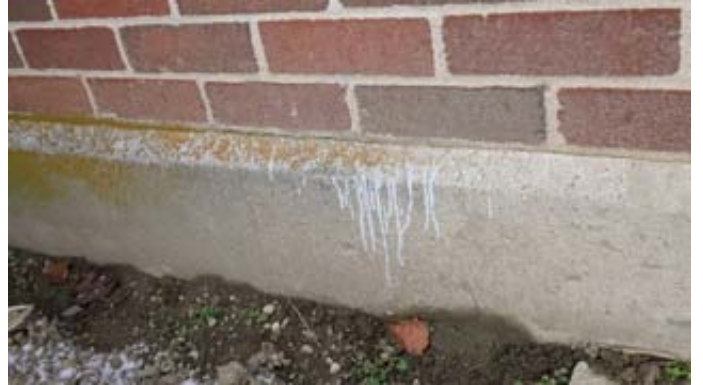
Concrete Foundation

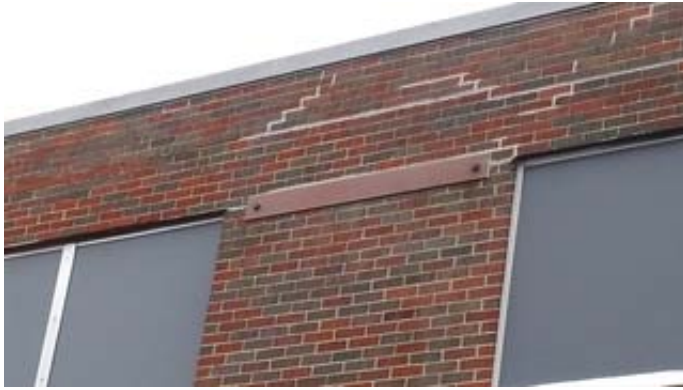
There is a structural issue along the north side exterior wall and south side exterior wall of the academic wing of the 1951 Original Construction. The walls are connected to each other via steel bracing to secure in place.

1951 Original Construction Classroom Wing Wall Bracing

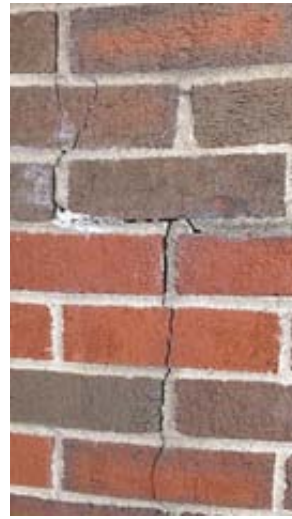
**Description:** The overall facility features a brick veneer on load bearing masonry wall system, which displayed locations of deterioration, and is in fair condition. The exterior masonry appears to have no control joints. Control joints are not provided at lintel locations, at doors and windows, building corners, and wall offsets. The school does not contain expansion joints. There is indication of exterior masonry cracking and separation, and it has been recommended that control joints be added throughout the facility to mediate this movement. Exterior walls in the overall facility are inadequately insulated. Brick veneer masonry walls are not cavity walls. Weep holes and vents are not provided or required. The exterior masonry has not been cleaned and sealed in recent years, and shows evidence of mortar deterioration. Architectural exterior accent materials consist of concrete panels and sills, which are in fair condition. The exterior walls contain openings and louvers for the unit ventilators within the building. With the addition of a new HVAC system, these unit ventilators will be removed. Therefore, the openings for these unit ventilators will need to be filled in with materials matching adjacent materials. The Facilities Director informed us that a portion of the 1951 Original Construction (Classroom wing) has been reinforced from front to back of the building above the second floor ceiling because the walls are moving away from the building. This will need structural engineering investigation and possible complete replacement. Interior wall construction consists of concrete masonry units, glazed block, or masonry framed partitions with plaster. Each construction type is in fair condition. Interior masonry walls appear to have no control joints. Interior soffits are of plaster type construction, and are in fair condition. The window sills are marble, glazed block, or painted steel, and are in good condition. The exterior lintels are precast steel members that are rusting and in fair condition. Chimneys are in good condition. Canopies over entrances are concrete type construction, and are in fair condition. Exterior soffits are of plaster type construction, and are in fair condition. The school is not equipped with a loading dock.

**Rating:** 3 Needs Replacement

Cracking due to Insufficient Control Joints

**Recommendations:** Provide tuckpointing in all areas of mortar deterioration as required through the overall facility. Provide masonry cleaning and sealing through the overall facility. Sawcut and caulk new appropriately spaced control joints in existing masonry through the overall facility. Prep and paint exposed steel lintels through the overall facility. Exterior wall insulation deficiencies are addressed in Item J - General Finishes. Provide brick, insulation and CMU back up infill at locations where unit ventilator louvers are being removed. Removal and reconstruction of the exterior walls that are currently being braced together is necessary. Overall extent of replacement should be determined by a structural engineer. Interior and exterior soffits need to be repainted. The associated cost of repainting exterior soffits can be found below. The associated cost of repainting interior soffits is included in Item J - General Finishes, under the full replacement of finishes and casework.

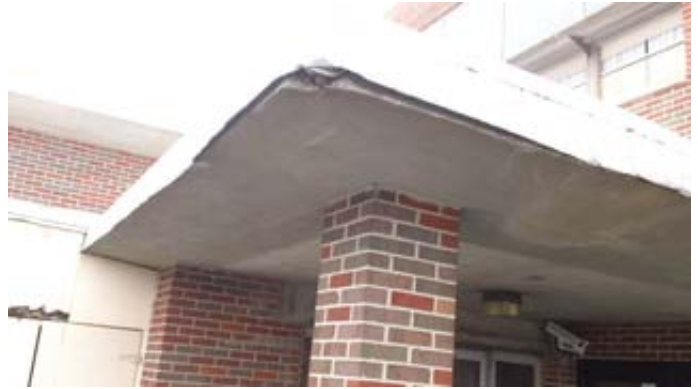
Concrete Overhang at North Entry

<b>Other:</b> Repair Concrete Overhang	\$3,000.00	lump sum		Required		\$3,000.00	Repair the concrete overhang at the North Entrance in the 1951 Original Construction.
<b>Other:</b> Replace Flashing and Counterflashing	\$30.00	ln.ft.		390 Required		\$11,700.00	Remove and replace all through wall flashing and counterflashing at roof/vertical wall transition points.
<b>Sum:</b>			\$1,400,999.60	\$946,600.00	\$454,399.60

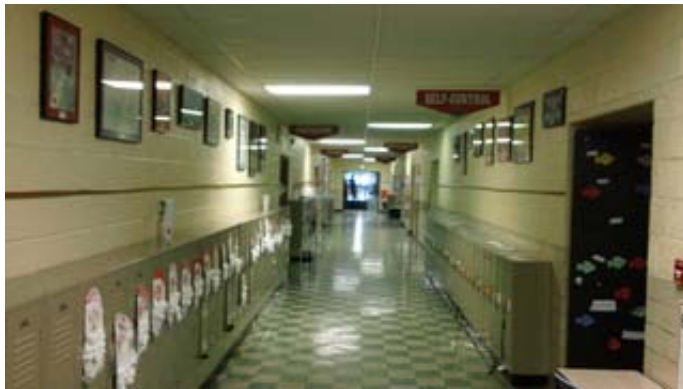
**Description:** The overall facility features conventionally partitioned Classrooms with carpet over VAT type flooring, acoustical lay in type ceilings, as well as CMU type wall finishes, and they are in poor condition. The overall facility has Corridors with VAT type flooring, acoustical lay in type ceilings, as well as CMU and glazed concrete masonry units type wall finishes, and they are in poor condition. The overall facility has Restrooms with quarry tile type flooring, acoustical lay in type ceilings, as well as glazed concrete masonry units type wall finishes, and they are in fair condition. Toilet partitions are metal, and are in poor condition. Classroom casework in the overall facility is wood type construction with plastic laminate tops, is inadequately provided, and in poor condition. Casework provided in a typical Classroom ranges from 12 to 34 feet. Classrooms are not provided adequate chalkboards, markerboards, and tackboards, which are in poor condition. Lockers located in the Corridors are adequately provided, and are in poor condition. The Art program is equipped with a kiln in fair condition. The facility is equipped with wood louvered and non-louvered interior doors. Interior Classroom doors of the 1951 Original Construction are primarily recessed, without proper ADA hardware or clearances, and in poor condition. Interior Classroom doors of the 1967 Addition are primarily flush mounted, without proper ADA hardware or clearances, and in poor condition. The facility features two Gymnasium spaces. The Gymnasium located in the 1951 Original Construction has rubberized "Tartan" type flooring, hard plaster type ceilings, as well as CMU type wall finishes, and they are in poor condition. There are no bleachers, but fixed concrete stands are provided, which feature wooden seats in poor condition. Gymnasium basketball backboards are fixed type, and are in fair condition. The Auxiliary Gymnasium located in the 1967 Addition has rubberized "Tartan" type flooring, hard plaster type ceilings, as well as CMU type wall finishes, and they are in poor condition. Gymnasium basketball backboards are both fixed and manually operated type, and are in fair condition. The Media Center, located in the 1951 Original Construction, has carpet type flooring, acoustical lay in type ceilings, as well as CMU type wall finishes, and they are in poor condition. The Student Dining area, located in the 1967 Addition, has VAT type flooring, hard plaster type ceilings, as well as masonry and plaster type wall finishes, and they are in poor condition. OSDM-required fixed equipment for the Stage areas is inadequately provided, and in fair condition. Existing Gymnasium, Auxiliary Gymnasium, Student Dining, Media Center, and Music spaces (Stage areas of the 1951 Gymnasium and the 1967 Auxiliary Gymnasium) are not provided with appropriate sound attenuation acoustical surface treatments. The existing Kitchen is full service, is undersized based on current enrollment, and the existing Kitchen equipment, installed in 1951, is in fair condition. The Kitchen hood is in poor condition, and is not equipped with the required UL 300 compliant wet chemical fire suppression system. The required 6" overhang on all three exposed sides of the cooking equipment is not provided by the hood. Kitchen hood exhaust ductwork is not of proper construction, material, insulation, or installed as required by the OSDM and OBCMC. A walk-in cooler and freezer are located within the Kitchen spaces, and are in poor condition.

**Rating:** 3 Needs Replacement

Typical Corridor Finishes

**Recommendations:** Provide complete replacement of finishes and casework due to installation of systems outlined in Items (A / C / D / E / I / K / L / M / N / T / U / W). Funding for replacement of interior doors is provided in Item O - Handicapped Access, including doors here noted as being in poor condition. Replace toilet partitions as required throughout the overall facility, due to condition. Replace the Toilet Room accessories throughout the overall facility, due to condition. Replace all Kitchen equipment and the Kitchen hood due to age and condition. Replace the kiln for the Art program due to condition. Replace synthetic gymnasium flooring in both Gymnasiums. Refer to Item T - Hazardous Material, for further information regarding synthetic Gymnasium flooring. Replace basketball backboards due to condition. Fur out interior walls with metals studs and add insulation and abuse resistant GWB. Replace original wood seats in the 1951 Gymnasium with new seating. Provide sound attenuation acoustical surface treatments in the Primary Gymnasium, Auxiliary Gymnasium, Student Dining Area, Media Center, and Music spaces (Stage areas of the 1951 Gymnasium or the 1967 Auxiliary Gymnasium). In order to comply with OSDM required fixed Stage equipment, provide a projection screen for the 1951 Gymnasium Stage area and stair railings for the 1967 Auxiliary Gymnasium Stage area. Costs associated with the addition of Stage railings are provided in Item U - Life Safety. Replacement costs have also been provided in the table below in coordination with the abatement of materials in Item T - Hazardous Material.

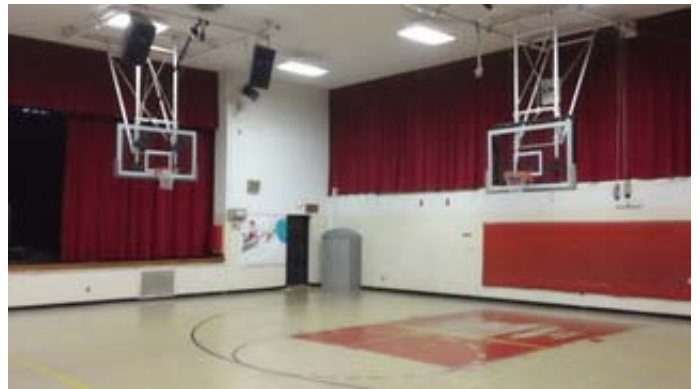
1951 Gymnasium Finishes

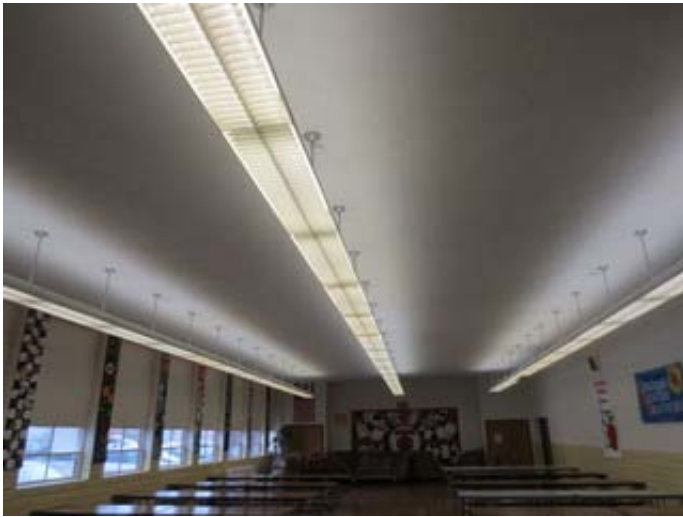
**Rating:** 3 Needs Replacement

Student Dining Lighting Fixtures

**Recommendations:** Provide complete replacement of the lighting system due to condition, lighting levels, utilization of T-12 fixtures, and the lack of multilevel switching.

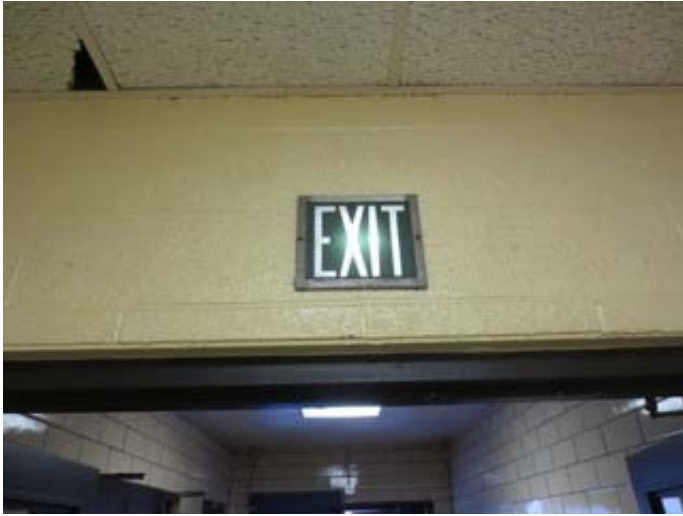
Incandescent Exit Sign

**Recommendations:** Provide complete replacement of new emergency / egress lighting system to meet Ohio School Design Manual and Ohio Building Code guidelines.

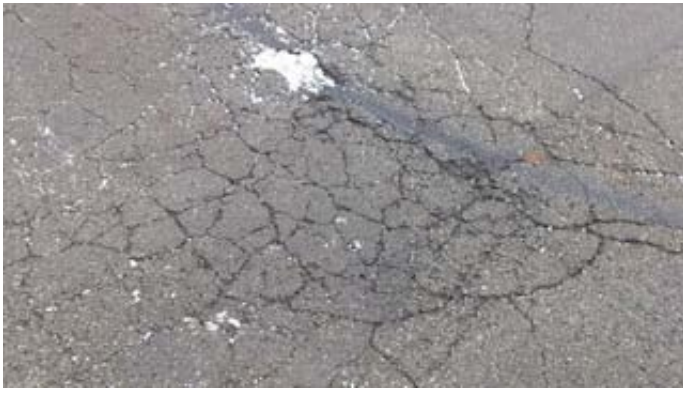
Cracking Asphalt

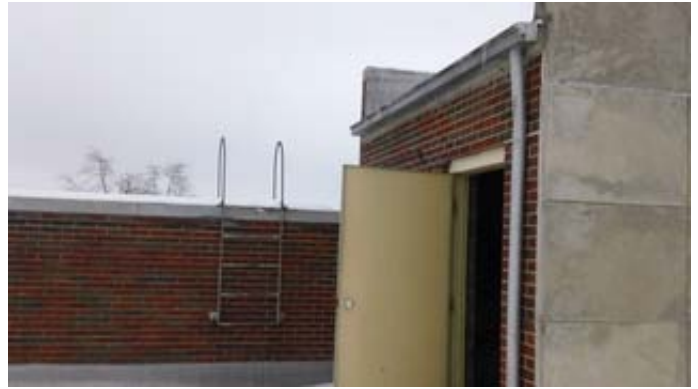
Roof Access Door

**Recommendations:** Replace all exterior doors, vision glass, and transom glass to comply with Ohio Building Code, ADA, and Ohio School Design Manual guidelines. Refer to Item F - Windows, for further information regarding costs associated with transom glass. Due to the replacement of exterior doors, costs associated with vision panel replacement will be included in the funding for new door systems. Replace existing roof access doors.
