Building Information - Tipp City Exempted Village (45617) - Nevin Coppock Elementary

Program Type	Classroom Facilities Assistance Program (CFAP) - Regular
Setting	Small City
Assessment Name	Nevin Coppock Elementary with EEA & 2015 Costs
Assessment Date (on-site; non-EEA)	2015-03-31
Kitchen Type	Full Kitchen
Cost Set:	2015
Building Name	Nevin Coppock Elementary
Building IRN	26591
Building Address	525 North Hyatt
Building City	Tipp City
Building Zipcode	45371
Building Phone	937-667-2275
Acreage	43.00
Current Grades:	K-1
Teaching Stations	24
Number of Floors	1
Student Capacity	334
Current Enrollment	357
Enrollment Date	2015-02-04
Enrollment Date is the date in which the current enrollment was taken.	
Number of Classrooms	24
Historical Register	NO
Building's Principal	Rick Brownlee
Building Type	Elementary

Building Construction Information - Tipp City Exempted Village (45617) - Nevin Coppock Elementary (26591)

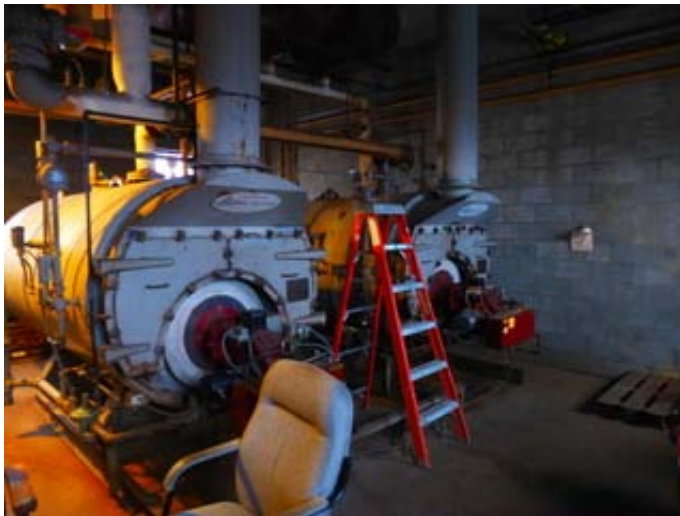
Description: The existing system for the overall facility is a gas fired boiler with heating water circulating pumps located in a separate building to the west of the school (which also serves Tippecanoe Middle School), installed in 1959, and is in fair condition. 2-pipe vs. 4-pipe designations are not applicable in this facility, as no central air conditioning is provided. The two boilers, manufactured by Atlas, were installed in 1959 and are in poor condition. Heating water is distributed to terminal units consisting of unit ventilators, cabinet heaters, unit heaters and air handlers. The terminal equipment was installed in 1959 and is in fair condition. The system does not comply with the 15 CFM per person fresh air requirements of the Ohio Building Code mechanical code and Ohio School Design Manual. The pneumatic type system temperature controls were installed in 1959 and are in fair condition. The system does feature individual temperature controls in all spaces required by the OSDM. The overall system does not feature any central energy recovery systems. The facility is equipped with both louvered and non-louvered interior doors. A moderate quantity of louvered interior doors are used to facilitate Corridor utilization as return air plenums. Interior door replacement is discussed in Item O - Handicapped Access. The existing system is not ducted, and floor to structural deck heights will not accommodate the installation of properly sized ductwork for a future Ohio School Design Manual approved system. The overall heating system is evaluated as being in safe but inefficient working order, and long term life expectancy of the existing system is not anticipated. The structure is not equipped with central air conditioning. The site does not contain underground fuel tanks.

Rating: 3 Needs Replacement

Existing Boiler Plant

Recommendations: Provide new overall heating, ventilating, and air conditioning system to achieve compliance with Ohio Building Code and Ohio School Design Manual standards. Convert to a ducted system to facilitate efficient exchange of conditioned air. Provide architectural soffits to accommodate the installation of ductwork.

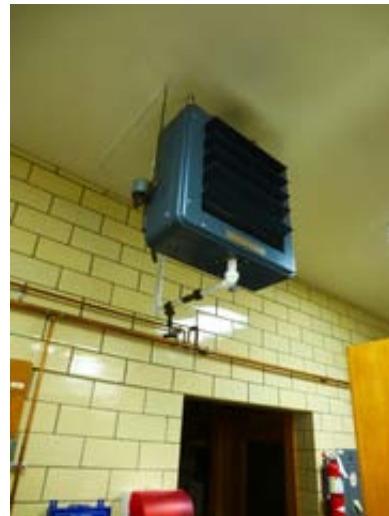
Existing Unit Heater

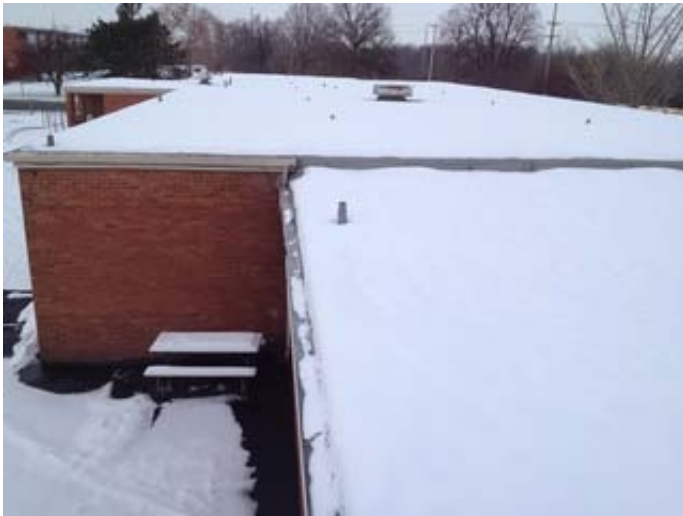
Description: The roof over the overall facility is a built-up asphalt system that was installed in 2000 and is in poor condition. There are no District reports of current leaking. Moisture stains were documented on Corridor drop panel ceiling tiles, but these stains could also be attributed to past issues with plumbing or mechanical systems within the drop ceiling. Access to the low roof was gained by an access hatch in the Mechanical Room, and access to the Multipurpose Room roof was gained by an access ladder from the low roof. Both the access hatch and access ladder are in poor conditions. Fall safety protection cages are not provided and are not required. There were no observations of standing water on the roof. Metal cap flashings are in fair condition. Roof storm drainage is addressed through a system of gutters and downspouts, which are properly located, and in poor condition. The roof is not equipped with overflow roof drains, and they are not needed on this building. No problems requiring attention were encountered with any roof penetrations. There are not any covered walkways attached to this structure.

Rating: 3 Needs Replacement

Typical Roof Condition

Recommendations: The roof over the overall facility requires replacement to meet Ohio School Design Manual guidelines for age of system and due to condition. Remove all existing roof insulation. Provide a minimum of 4" new polyiso rigid roof insulation over the overall facility. The flashing and coping on the overall facility require replacement due to condition. Due to existing conditions gutters and downspouts require replacement. Replace the upper roof access ladder.

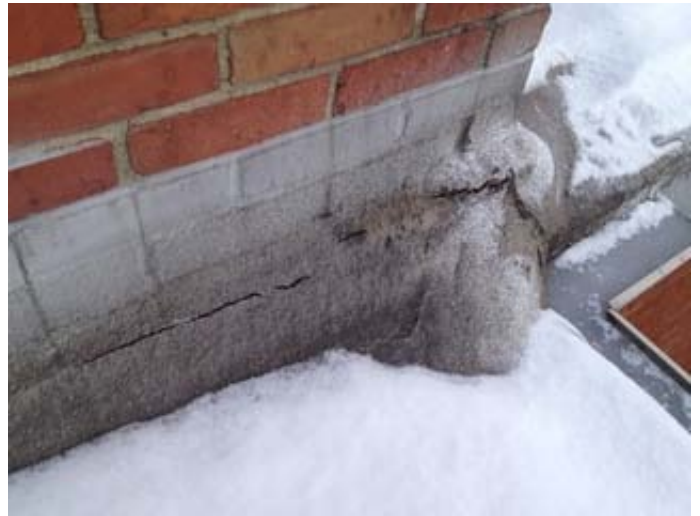
Roof Damage at a Corner Transition

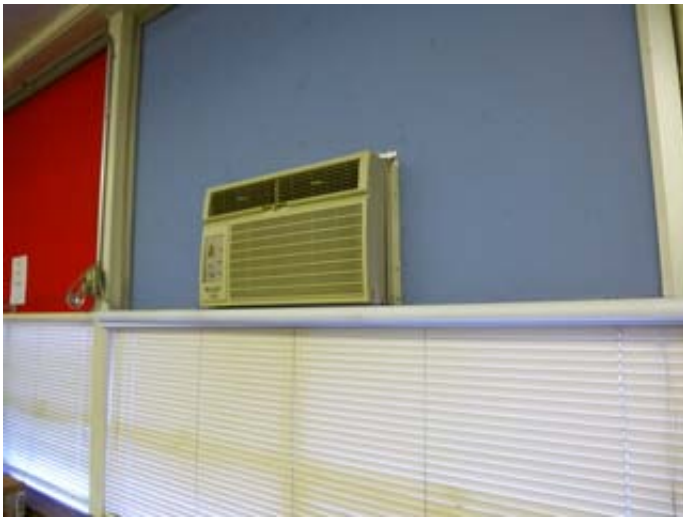
Description: The overall facility is not equipped with a central air conditioning system. Window units are provided in Office and Media Center. The ventilation system in the overall facility consists of unit ventilators, installed in 1959 and in fair condition, providing fresh air to Classrooms, and air handlers, installed in 1959 and in fair condition, providing fresh air to other miscellaneous spaces such as Gymnasiums. Relief air venting is provided by louvered interior doors. The ventilation system does not meet the Ohio Building Code 15 CFM per occupant fresh air requirement. The overall system is not compliant with Ohio Building Code and Ohio School Design Manual requirements. Dust collection systems are not required in this facility. The Art program is equipped with a kiln, and existing kiln ventilation is adequate, and in fair condition. General building exhaust systems for Restrooms, Storage Rooms, Art Rooms and Custodial Closets are adequately placed, and in fair condition.

Typical Window A/C Unit

Recommendations: (The above rating of "1 Satisfactory" has been provided because the following item costs are included Item A - Heating System, in the cost to completely replace the HVAC system. This section would receive a "3 Needs Replacement" if associated costs appeared in the table below.) Provide an air conditioning system to meet with Ohio Building Code and Ohio School Design Manual requirements. Pricing included in Item A. Replace general building exhaust systems located in Restrooms, Storage Rooms and Custodial Closets.

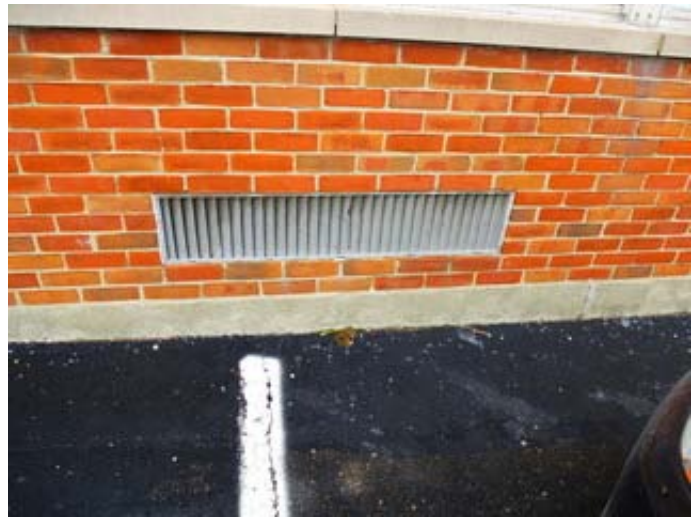
Unit Ventilator Outdoor Louver

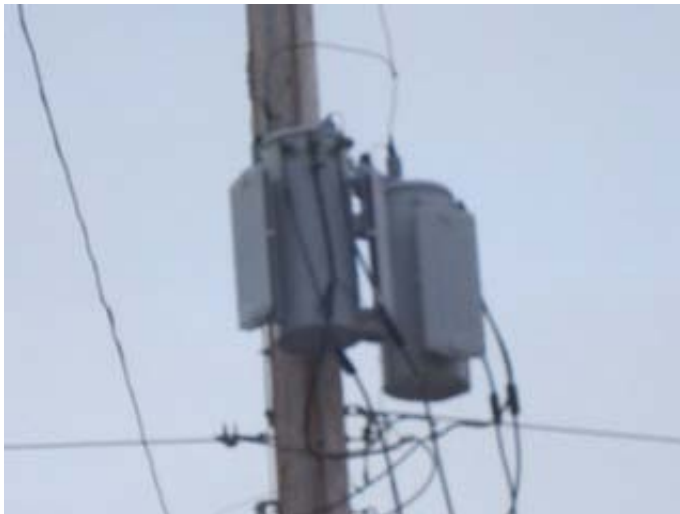
Description: The electrical system provided to the overall facility is a 120/240 volts, 800 amp, 1 phase and 3 wire system installed in 1998 and is in good condition. Power is provided to the school by a single utility owned pole-mounted transformer located outside on the property line and in good condition. The panel system, installed in 1959 is in poor condition, and cannot be expanded to add additional capacity. The Classrooms are not equipped with adequate electrical outlets. The typical Classroom contains 4 general purpose outlets, 2 dedicated outlets for each Classroom computer, and 0 dedicated outlets for each Classroom television. Some Classrooms are equipped with as many as 5 general purpose outlets, while others are equipped with as few as 2 general purpose outlets. There are not any spaces that have no electrical outlets. The Corridors are equipped with adequate electrical outlets for servicing. Adequate GFI protected exterior outlets are provided around the perimeter of the building. The facility is not equipped with an emergency generator. Adequate lightning protection safeguards are not provided. Stage lighting power system including control panel, breakers, and dimmers is inadequately provided, in poor condition and does not meet OSDM requirements. The overall electrical system meets does not meet Ohio School Design Manual requirements in supporting the current needs of the school, and will be inadequate to meet the facility's future needs.

Rating: 3 Needs Replacement

Utility Owned Transformer

Recommendations: The entire electrical system requires replacement to meet Ohio School Design Manual guidelines for overall capacity, Classroom capacity, due to condition and age, lack of OSDM-required features, and to accommodate the addition of an air conditioning system.

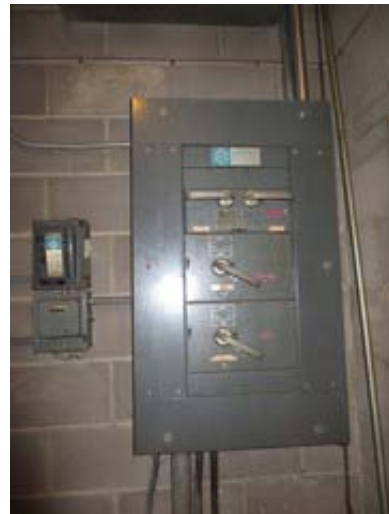
Original Electrical Distribution Equipment

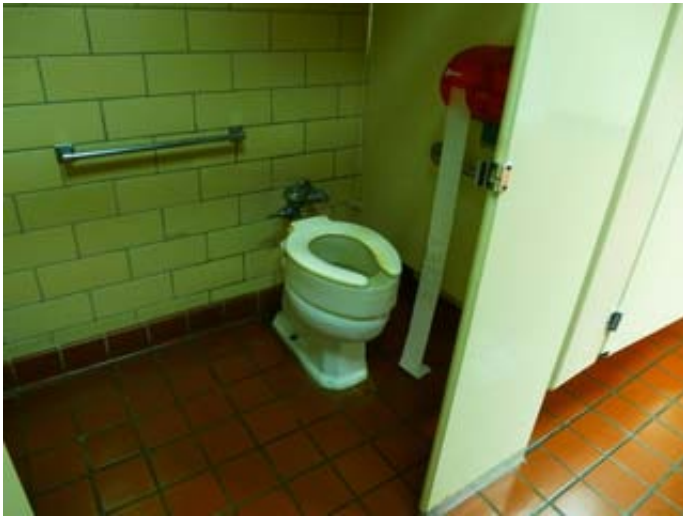
Description: The service entrance is not equipped with a reduced pressure back flow preventer. A water treatment system is provided and is in good condition. The domestic water supply piping in the overall facility is galvanized piping, was installed in 1959 and is in fair condition. The waste piping in the overall facility is cast iron, was installed in 1959, and is in fair condition. The school contains 2 Large Group Restrooms for boys, 2 Large Group Restrooms for girls, and 2 Restrooms for staff. Boys' Large Group Restrooms contain 0 ADA and 7 non-ADA floor mounted flush valve toilets, 0 ADA and 13 non-ADA floor mounted central flush urinals, as well as 0 ADA and 6 non-ADA wall mounted lavatories. Girls' Large Group Restrooms contain 0 ADA and 14 non-ADA floor mounted flush valve toilets, as well as 0 ADA and 7 non-ADA wall mounted lavatories. Staff Restrooms contain 0 ADA and 2 non-ADA floor mounted flush valve toilets, as well as 0 ADA and 2 non-ADA wall mounted lavatories. Condition of fixtures is fair. The facility is equipped with 0 ADA and 4 non-ADA electric water coolers, in fair condition. The 25 Elementary Classrooms are equipped with 0 ADA and 25 non-ADA sinks (no drinking fountains), in fair condition. Special Education Classroom is equipped with the required Restroom facilities, and fixtures are in fair condition. Kitchen is equipped with the required Restroom, and fixtures are in fair condition. Health Clinic is equipped with the required Restroom, and fixtures are in fair condition. Kindergarten / Pre-K Classrooms are not equipped with Restroom facilities. Kitchen fixtures consist of 1 double compartment sink, 1 triple compartment sink and 1 dishwasher, which are in good condition. The Kitchen is equipped with a satisfactory grease interceptor, and is in fair condition. The Kitchen is provided the required 140 degree hot water supply via a 91 gallon type water heater, which is in good condition. The school does not meet the OBC requirements for fixtures. Relative to LEED requirements, the school is not equipped with low flow type fixtures. Per OBC and OSDM requirements this facility should be equipped with 15 toilets, 4 urinals, 12 lavatories, 25 Classroom sink mounted drinking fountains, and 6 electric water coolers. Observations revealed that the school is currently equipped with 26 toilets, 13 urinals, 18 lavatories, 25 Classroom sinks without mounted drinking fountains, and 4 electric water coolers. ADA requirements are not met for fixtures and drinking fountains (see Item O). Custodial Closets are properly located and are adequately provided with required service sinks or floor drain sinks, which are in fair condition. Science Classroom, Lab utility sinks, gas connections, compressed air connections, and safety shower and eyewash are not provided, but are not required due to existing grade configuration. Due to existing grade configuration, no Biology or Chemistry Classroom acid waste systems are required. Adequate exterior wall hydrants are provided.

Rating: 3 Needs Replacement

Typical Floor Mounted Water Closet

Recommendations: Due to age, condition, LEED, and OSFC requirements, provide a total of 26 toilets, 13 urinals, 18 lavatories, 25 Classroom sink mounted drinking fountains, and 6 electric water coolers. Fixture totals are coordinated between Item E - Plumbing and Fixtures and Item O - Handicapped Access. Within Item E - Plumbing and Fixtures, provide 20 new toilets, 11 new urinals, 12 new lavatories, 3 new electric water coolers, and 25 new lavatory mounted type drinking fountains. See Item O - Handicapped Access, for the remainder of fixture replacements and additions related to ADA requirements. Replace galvanized water supply piping in the overall facility with copper piping. Replace sanitary waste piping in the overall facility due to age and condition. Replace grease interceptor due to age and condition. Provide new mop sink. Provide reduced pressure back flow preventer. See Item O - Handicapped Access, for replacement of fixtures related to ADA requirements. Provide required sink mounted type drinking fountains in Elementary Classroom spaces.

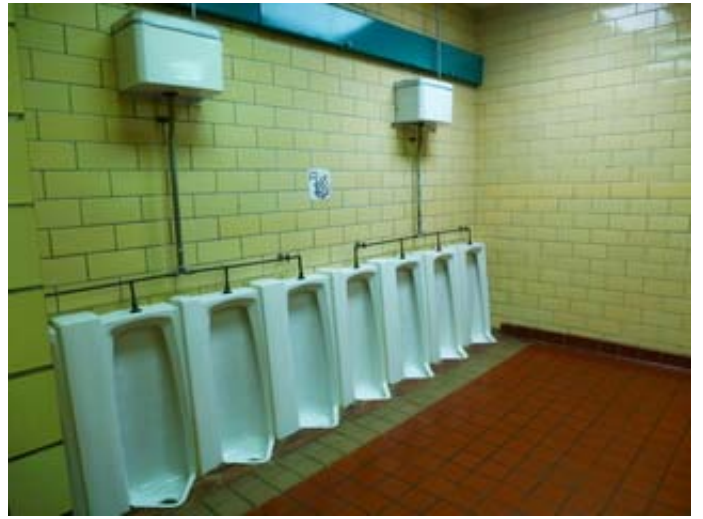
Typical Urinals

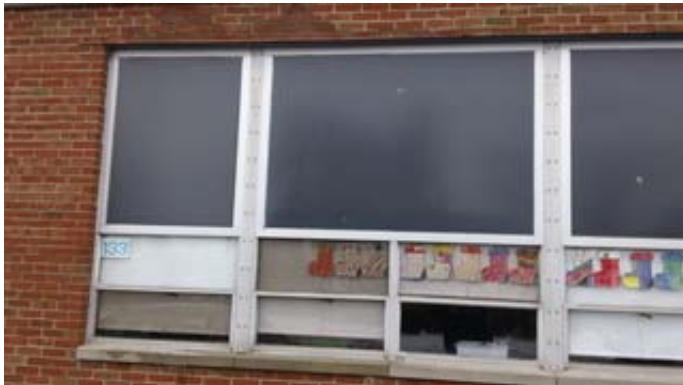
Description: The 1958 Original Construction is equipped with aluminum frame windows with single glazed type window system and is in poor condition. The window system features operable windows throughout the building, and operable windows are equipped with opening limiters in poor condition, but no insect screens were present. Window system seals are in poor condition, with moderate air and water infiltration being experienced. Window system hardware is in poor condition. The window system features no blinds. This facility is not equipped with any curtain wall systems. This facility does not feature any glass block windows. The exterior doors in the overall facility are equipped with aluminum and steel sidelights and transoms with single pane glazing in fair condition at the main entry. Exterior door vision panels are single pane at the main entry. Exterior transoms and door vision panels are double-pane at some locations that have been replaced. The school does not contain skylights. The school does not contain clerestories. Interior glass is not OSDM-compliant due to not being tempered. Window security grilles are not provided for ground floor windows. There is not a Greenhouse associated with this school.

Rating: 3 Needs Replacement

Typical Window Condition

Recommendations: Provide a new insulated window system with integral blinds to meet with Ohio School Design Manual requirements. Exterior door vision panel replacement is addressed in the replacement of exterior doors in Item S - Exterior Doors. Replace the two Main Entry storefronts and inner storefront on the south elevation of the facility due to poor condition. Costs associated with the replacement of window transoms and sidelights at exterior doors of the overall facility are included within the replacement of the exterior storefront systems. Refer to Item S - Exterior Doors and Item O - Handicapped Access, for exterior and interior door replacement. Existing window panel square footages are included within the insulated glass/panels square footage values provided in the table below. Gymnasium upper window panels have been replaced within the Door and Window Panel Replacement item in the table below.

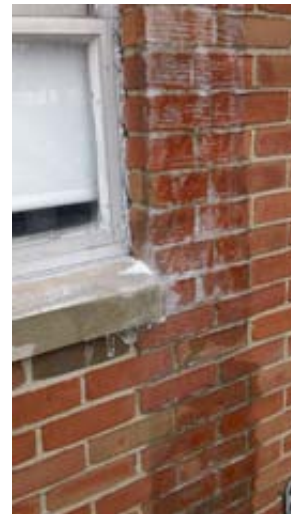
Ice Formation on the Facade Adjacent to a Window Unit

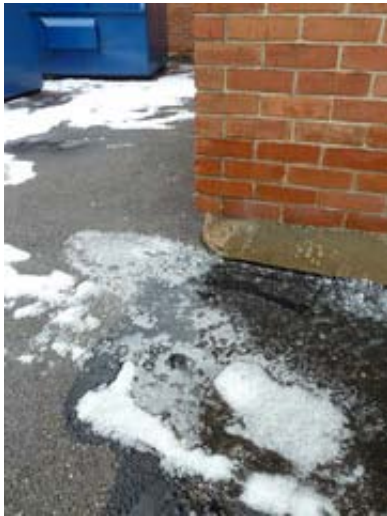
Description: The overall facility is equipped with concrete foundation walls on concrete spread footings. Moderate longitudinal cracking and moisture were documented along a portion of the west-face of the north Classroom wing, and additional moderate cracking was observed along this upper portion of the north Classroom wing. Significant corner damage and its repair were documented in this area, while a severed corner without repair was documented near the exterior trash area on the south face of the facility. The District reports that there has been no past leaking. The southwest corner of the building is the only documented location of standing water around the perimeter of the structure, which, due most likely to issues of ground settlement, could be a potential contributor to future foundation deterioration. The overall facility is equipped with concrete foundation walls on concrete spread footings, which displayed areas of minor cracking and spalling, were observed through the overall facility. The District reports that there has been no past leaking. No grading or site drainage deficiencies were noted around the perimeter of the structure that are contributing or could contribute to foundation / wall structural deterioration.

Rating: 2 Needs Repair

Deteriorated Concrete Foundation

Recommendations: Repair areas of cracking and spalling through the overall facility. Repair areas of depressed asphalt at the southwest corner of the facility in order to eliminate the potential for standing water around the foundation and to promote appropriate drainage. Costs associated with this work will be in Item P - Site Condition.

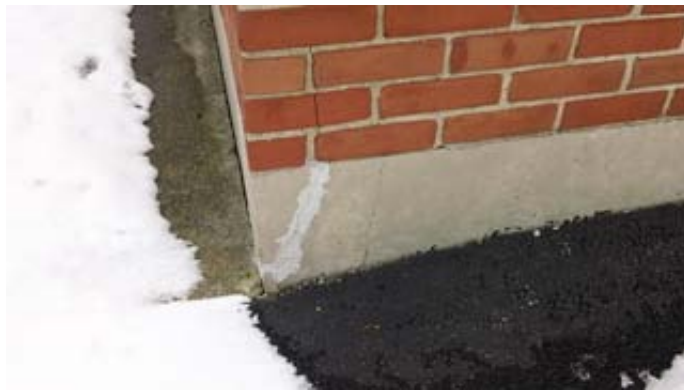
Damaged Concrete Foundation

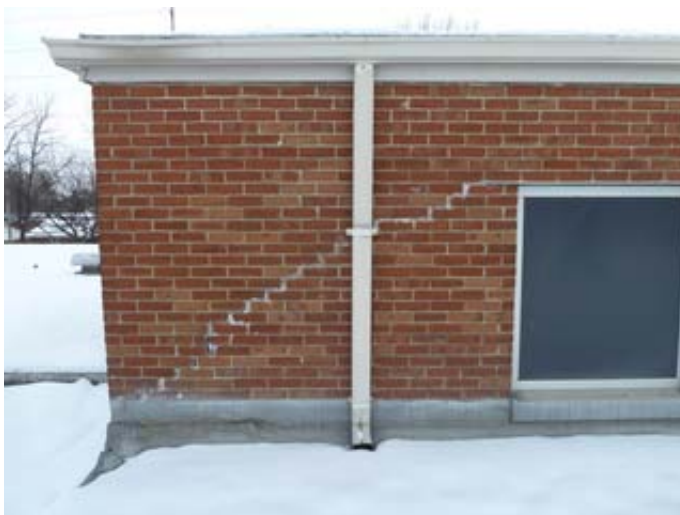
Description: The overall facility has a brick veneer on load bearing masonry wall system, which displayed locations of deterioration, and is in fair condition. The exterior masonry appears to have no caulked control joints. Control joints are not provided at lintel locations, at doors and windows, building corners, and wall offsets. The school does not contain expansion joints. Effects of settlement can be seen from the low roof on the north-facing Multipurpose Room brickwork, which appears to have previously been addressed with sealant. Moderate longitudinal cracking and moisture were documented along a portion of the west-face of the north Classroom wing, and additional moderate cracking was observed along this upper portion of the north Classroom wing. Significant corner damage and its repair were documented in this area, while a severed corner without repair was documented near the exterior trash area on the south face of the facility. The District reports that there has been no past leaking. Exterior walls in the overall facility are inadequately insulated. Brick veneer masonry walls are not cavity walls. Weep holes and vents are not provided. The exterior masonry has not been cleaned and sealed in recent years, and shows evidence of mortar deterioration at the wall base and window heads. Architectural exterior accent materials consist of stone sills, which are in poor condition. Interior walls are concrete masonry units and glazed block and are in fair condition. Interior masonry appears to have no control joints. Interior soffits are of plaster type construction, and in fair condition. Exterior window sills are stone, and are in poor condition, as is mentioned above. Interior window sills are marble, and are in good condition. The exterior lintels are steel, and are rusting and in fair condition. Chimneys are in fair condition. Masonry cleaning and tuckpointing is required. Canopies over entrances are concrete type construction, and are in fair condition. Exterior soffits are of plaster type construction, and in fair condition. The school is not equipped with a loading dock.

Rating: 2 Needs Repair

Exterior Masonry Wall Damage

Recommendations: Provide tuckpointing in all areas of mortar deterioration as required through the overall facility, including exterior window sills. Provide masonry cleaning and sealing as required through the overall facility, including exterior window sills. Sawcut and caulk new appropriately spaced control joints in existing masonry through the overall facility. Prep and paint exposed steel lintels through the overall facility. Exterior wall insulation deficiencies are addressed in Item J - General Finishes. Provide brick, insulation and CMU back-up infill at locations where unit ventilator louvers are being removed. Interior and exterior soffits need to be repainted. The associated cost of repainting exterior soffits can be found below. The associated cost of repainting interior soffits is included in Item J - General Finishes, under the full replacement of finishes and casework. Consult a structural or geotechnical engineer to analyze potential issues of settlement documented on the north-facing Multipurpose Room brickwork.

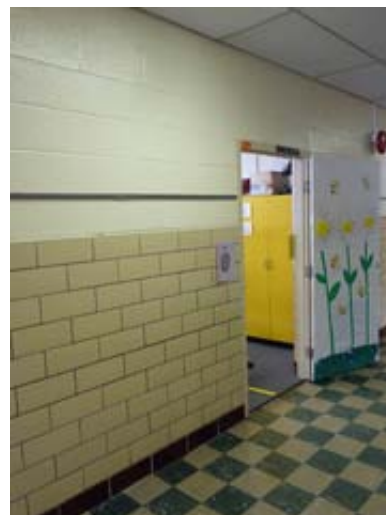
Interior Corridor Walls

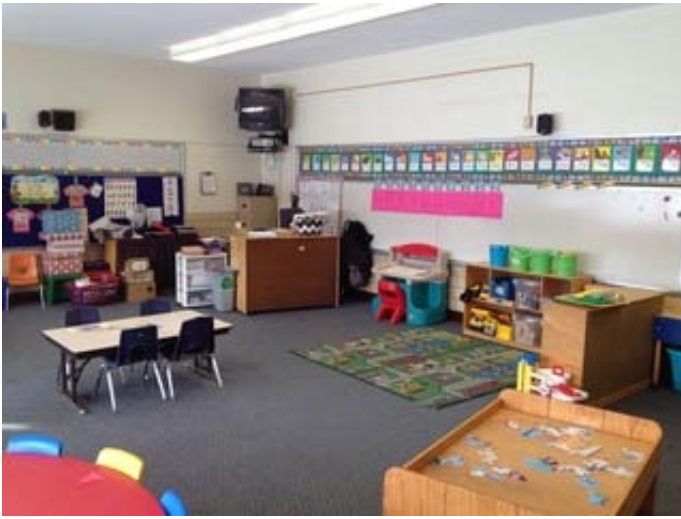
Description: The overall facility features conventionally partitioned Classrooms with carpet or VAT type flooring, painted plaster type ceilings, as well as CMU, glazed masonry unit and operable partition type wall finishes, and they are in poor condition. The overall facility has Corridors with VAT type flooring, ACT type ceilings, as well as painted CMU and glazed block type wall finishes, and they are in poor condition. The overall facility has Restrooms with quarry type flooring, plaster type ceilings, as well as glazed block type wall finishes, and they are in fair condition. Toilet partitions are metal, and are in poor condition. Classroom casework in the overall facility is wood type construction with plastic laminate tops, is inadequately provided, and in fair condition. The typical Classroom contains 10 lineal feet of casework. Classrooms are provided adequate chalkboards / markerboards / tackboards which are in fair condition. Classroom storage for student coats and backpacks is not provided. The metal lockers located in the Corridors are inadequately provided, and in fair condition. The Art program is equipped with a kiln in fair condition, and existing kiln ventilation is adequate. The facility is primarily equipped with metal non-louvered interior doors that are flush mounted without proper ADA hardware and clearances, and in fair condition. A moderate number of metal louvered doors are present. These doors are also flush mounted without proper ADA hardware and clearances, and in fair condition. The Gymnasium space has VAT type flooring, fiber plank type ceiling on open web steel joist, as well as CMU and ceramic tile type wall finishes, and they are in fair condition. Gymnasium basketball backboards are manually and electrically operated type, and are in good condition. The Media Center has carpet type flooring, painted plaster type ceilings, as well as CMU and ceramic tile type wall finishes, and they are in fair condition. Student Dining shares the Gymnasium space. OSDM-required fixed equipment for Stage is inadequately provided, and in poor condition. Existing Gymnasium / Student Dining / Media Center / and Music spaces are inadequately provided with appropriate sound attenuation acoustical surface treatments. Stage is undersized and used as Storage Room for the Gymnasium. The existing Kitchen is full service, is undersized based on current enrollment, and the existing Kitchen equipment, varies in age of installation, is in fair to poor condition. The Kitchen hood is in fair condition, and is not equipped with the required UL 300 compliant wet chemical fire suppression system. The required 6" overhang on all three exposed sides of the cooking equipment is not provided by the hood. Kitchen hood exhaust ductwork is not of proper construction, material, insulation, or installed as required by the OSDM and OBCMC. The walk-in cooler and freezer are located within the Kitchen spaces and are in poor condition.

Rating: 3 Needs Replacement

Typical Classroom Finishes

Recommendations: Provide complete replacement of finishes and casework due to condition and installation of systems outlined in Items (A / C / D / E / I / K / L / M / N / T / U / W). Funding for replacement of interior doors is provided in Item O - Handicapped Access, including doors here noted as being in fair condition. Replace toilet partitions as required, throughout the overall facility due to condition. Replace the toilet room accessories throughout the overall facility due to condition. Provide for the replacement of kitchen equipment, including reach-in cooler and freezer, due to age and condition. Provide a heat removal hood for the Art program kilns. Costs associated with this located in Item A - Heating Systems. Provide the Stage area with a Stage Curtain replacement due to hazardous material removal in Item T - Hazardous Material. Costs associated with the replacement of the non-compliant Stage stair railing are discussed in Item U - Life Safety. Provide a projector screen for the Stage to comply with OSDM fixed Stage equipment recommendations. Provide sound attenuation for the Multipurpose Area (Gymnasium/Student Dining and Stage) and the Media Center due to inadequate acoustical surface treatments. Replace non-electric Gymnasium backboards due to age. Replacement costs have also been provided in the table below in coordination with the abatement of materials in Item T - Hazardous Material.

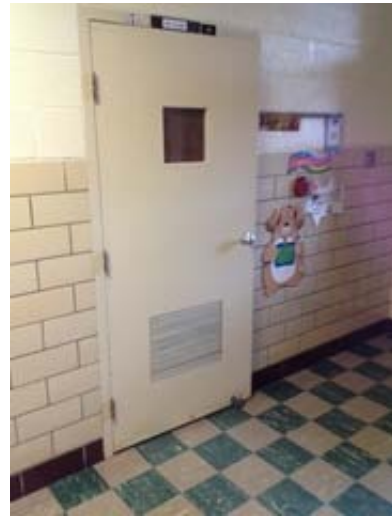
Typical Corridor Finishes

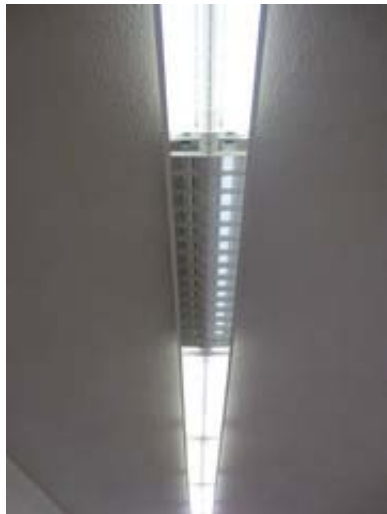
Description: The typical Classrooms in the overall facility are equipped with T-12 1x4 surface mount fluorescent fixtures with single level switching. Classroom fixtures are in poor condition, providing an average illumination of 20 FC, which is less than the 50 FC recommended by the OSDM. The typical Corridors in the overall facility are equipped with T-8 2x4 surface mount acrylic lensed fluorescent fixtures with single level switching. Corridor fixtures are in poor condition, providing an average illumination of 20 FC, thus complying with the 20 FC recommended by the OSDM. The Primary Gymnasium/Student Dining spaces are equipped with T-8 pendant mount fluorescent fixtures lighting, in good condition, providing an average illumination of 45 FC, which is less than the 50 (ES / MS) FC recommended by the OSDM. The Media Center is equipped with 2x4 surface mount T-8 acrylic lensed fluorescent fixture type lighting in poor condition, providing an average illumination of 67 FC, thus complying with the 50 FC recommended by the OSDM. The Student Dining (see Primary Gymnasium). The Kitchen spaces are equipped with 2x4 surface mount T-8 acrylic lensed fluorescent fixture type lighting with single level switching. Kitchen fixtures are in poor condition, providing an average illumination of 35 FC, which is less than the 75-80 FC recommended by the OSDM. The Service Areas in the overall facility are equipped with 2x4 suspended T-8 fluorescent fixture and incandescent type lighting in poor condition. The typical Administrative spaces in the overall facility are equipped with 2x4 surface mount T-8 acrylic lensed fluorescent fixture type lighting in poor condition, providing inadequate illumination based on OSDM requirements. The overall lighting systems of the facility are not compliant with Ohio School Design Manual requirements due to age and condition, inadequate lighting levels, lack of multi-level switching, the utilization of T-12 fluorescent and incandescent fixtures.

Rating: 3 Needs Replacement

Classroom Lighting Fixture

Recommendations: Provide complete replacement of lighting system due to condition, lighting levels, utilization of T-12 and incandescent fixtures, lack of multilevel switching.

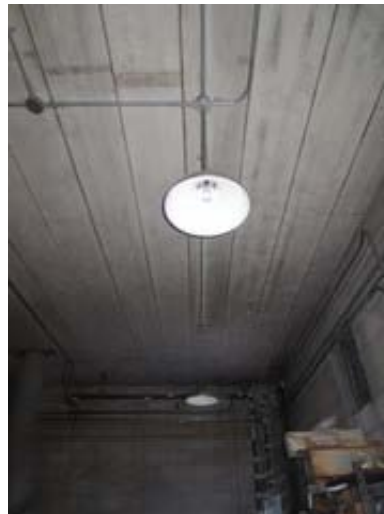
Service Area Incandescent Lighting Fixture

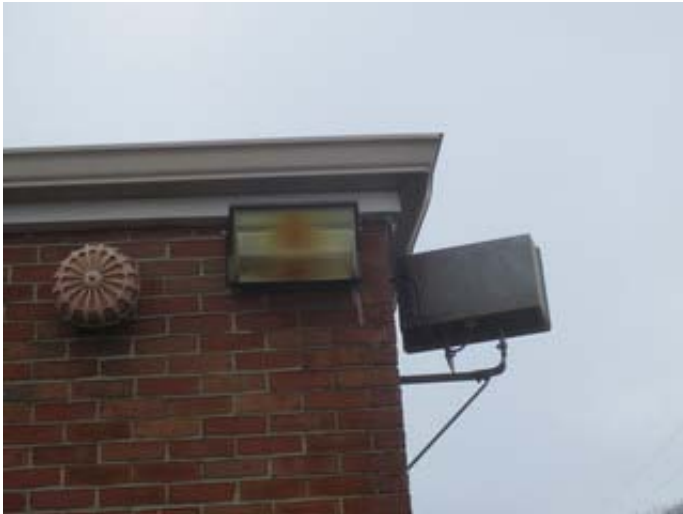
Description: The overall facility contains an CCTV type security system in poor condition. Motion detectors are not provided in main entries, central gathering areas, offices, main Corridors, and spaces where 6 or more computers are located. Exterior doors are equipped with door contacts. An automatic visitor control system is not provided. Compliant color CCTV cameras are provided at main entry areas but not parking lots, central gathering areas, and main Corridors. CCTV is not monitored in Administrative Area with an LCD monitor. A compliant computer controlled access control system integrating alarms and video signals, with appropriate UPS backup, is not provided. The system is not equipped with card / biometric readers. The security system is not adequately provided throughout, and the system is not compliant with Ohio School Design Manual guidelines. Playground fencing is located against vehicular traffic and parking spaces on the north elevation of the facility. Currently, the fencing does not feature any gates that limit pedestrian access into the Playground. The exterior site lighting system is equipped with recessed compact fluorescent entry lights in poor condition. Pedestrian walkways are not illuminated. Parking and bus pick-up / drop off areas are illuminated by pole mounted HID fixtures in good condition. The exterior site lighting system provides inadequate illumination due to sparse placement of fixtures.

Rating: 3 Needs Replacement

Exterior Site Lighting Fixtures

Recommendations: Provide complete replacement of security system to meet Ohio School Design Manual guidelines, including the Playground fencing due to condition and the need for improvements such as gated entrances. Provide complete replacement of exterior site lighting system to meet Ohio School Design Manual guidelines.

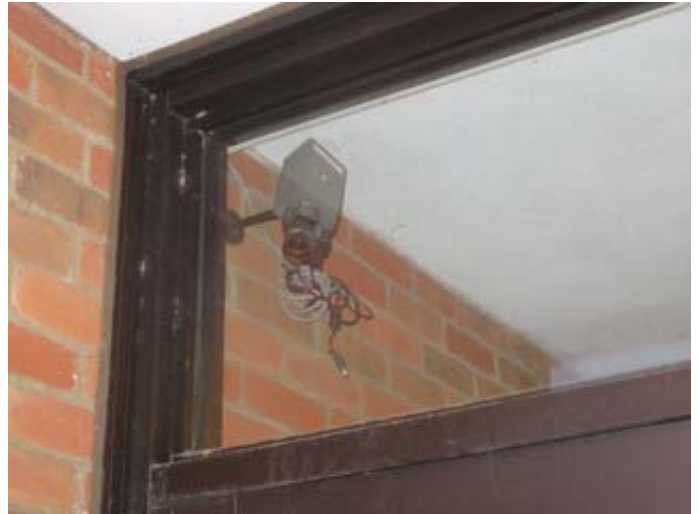
Entrance Camera

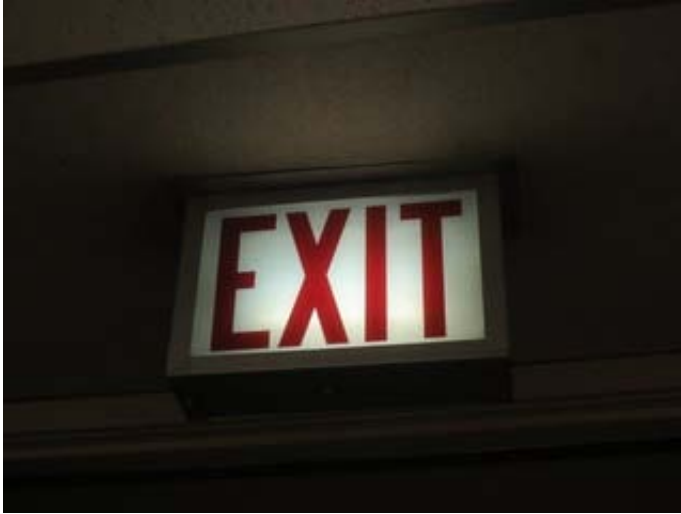
Description: The overall facility is equipped with an emergency egress lighting system consisting of incandescent, plastic construction, and non illuminated exit sign. The system is in poor condition. The facility is inadequately equipped with emergency egress floodlighting, and the system is in poor condition. The system is provided with appropriate battery backup. The system is not adequately provided throughout, and does not meet Ohio School Design Manual and Ohio Building Code requirements.

Rating: 3 Needs Replacement

Non-Compliant Exit Sign

Recommendations: Provide complete replacement of emergency / egress lighting system to meet Ohio School Design Manual and Ohio Building Code guidelines.

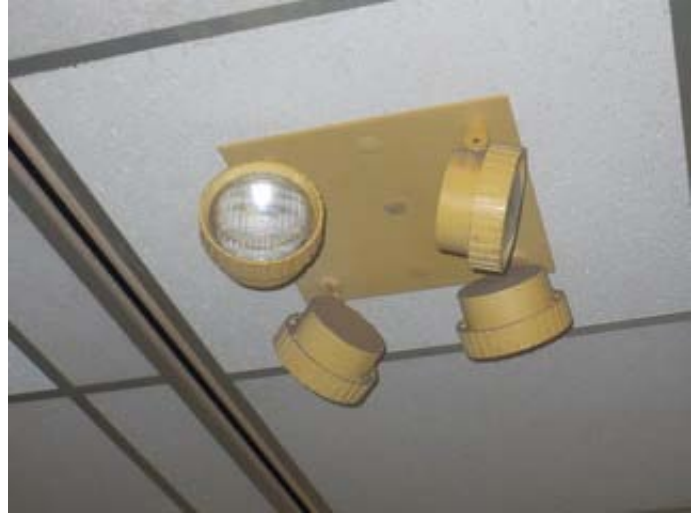
Emergency Egress Lighting Fixture

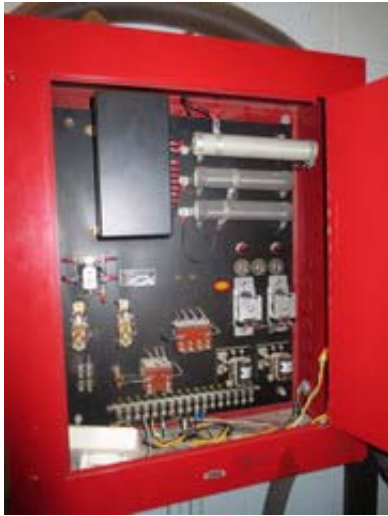
Description: The overall facility is equipped with a Standard type fire alarm system, installed in 1959 and in poor condition, consisting of manual pull stations, and bells indicating devices. The system is not automatic and is not monitored by a third party. The system is not equipped with sufficient audible horns. The system is not equipped with any strobe indicating devices, flow switches, tamper switches, smoke detectors, and heat sensors. The system thus will not support future fire suppression systems. The system is not compliant with Ohio Building Code, NFPA, and Ohio School Design Manual requirements.

Rating: 3 Needs Replacement

Fire Alarm Panel

Recommendations: Provide complete replacement of fire alarm system to meet OBC, NFPA, and Ohio School Design Manual guidelines.

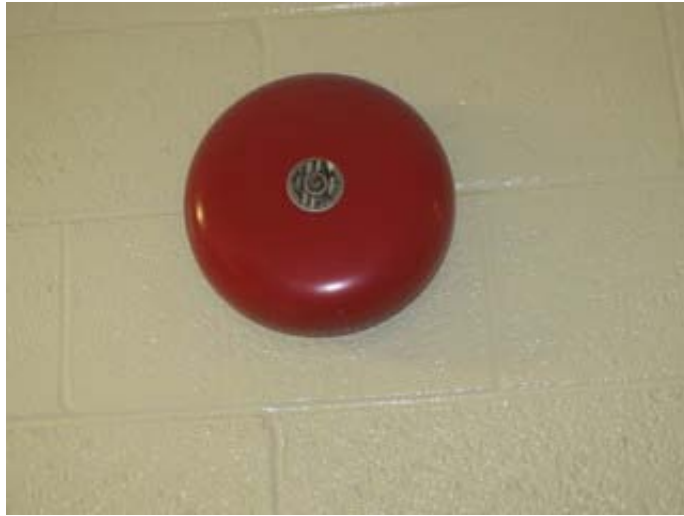
Fire Alarm Bell

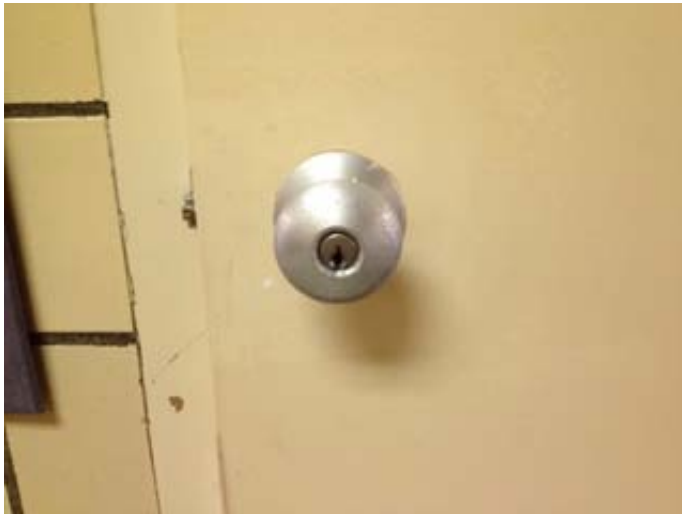
Rating: 3 Needs Replacement

Typical Classroom Door Handle

Recommendations: Provide ADA-compliant signage, power assist door opener, electric water coolers, toilets, sinks, urinals, toilet partitions, toilet accessories, door and frames and door hardware in the overall facility to facilitate the school's meeting of ADA requirements. Provide one lift for handicapped access to the Stage level due to space restrictions. Replace the ADA non-compliant interior ramp and provide a new, compliant ramp in its place. Provide a ramp for the north elevation entry due to the north elevation parking and potential need to accessible entrance. Funding for ramp railings is provided in Item U - Life Safety.

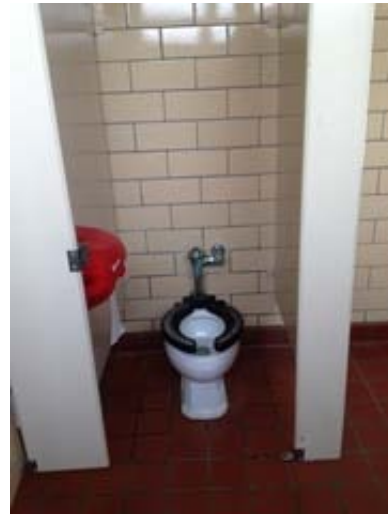
Typical Toilet Stall

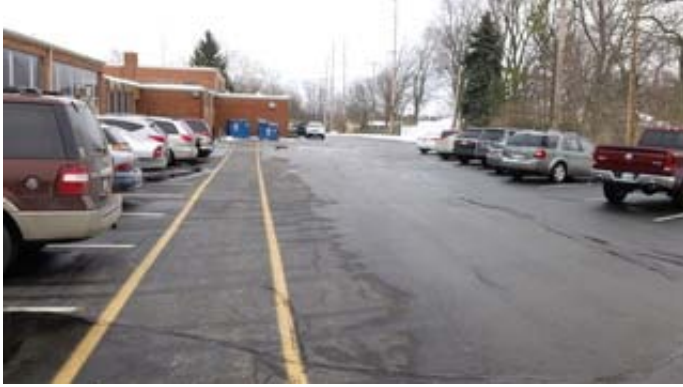
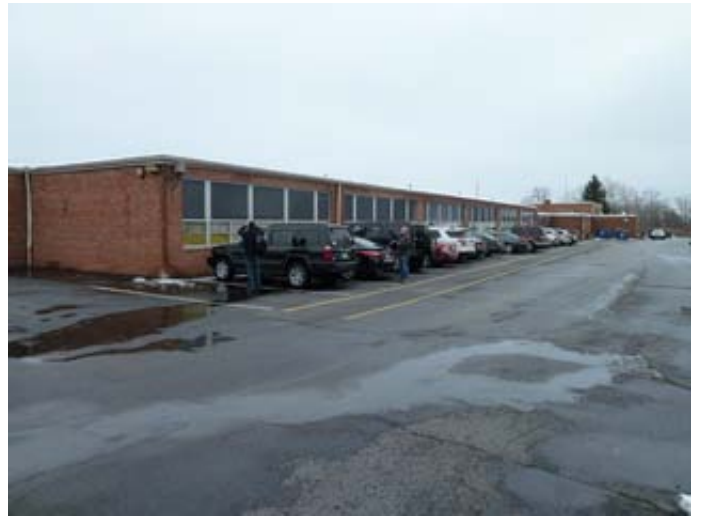
3 Needs Replacement

Parking Lot and Drive

Provide repaving at existing parking lots. Provide repaving of the Playground asphalt area due to poor condition. Provide catch basins and storm drainage in the parking lot area. Develop a bus loop and separate parent drop-off area. Provide new soft surface and hard surface play areas. Provide a concrete dumpster pad. Replace sidewalks and curbs due to inadequacies stated in the above Description. Also, provide a new concrete walk from the north elevation parking spaces to the north elevation entry. Provide guardrails for the recommended ramp (Item O - Handicapped Access) at the north elevation entry, and replace the non-compliant guardrails at the Main Entry. Funding for the replacement of the perimeter playground fencing is provided in Item L - Security Systems, within the funding for a complete security system replacement.

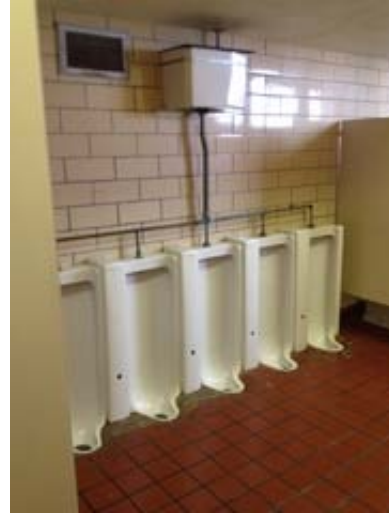
Urinals Double as Floor Drains

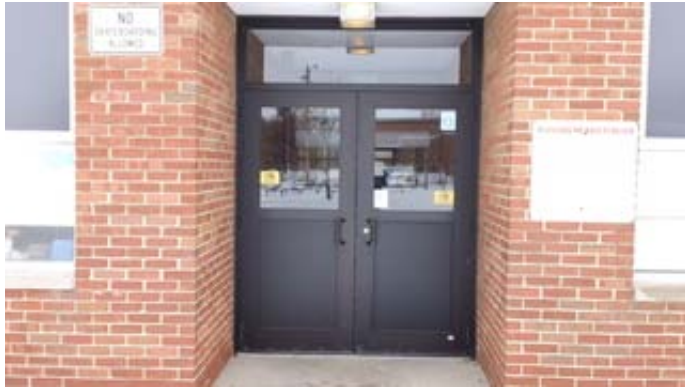
Description: Typical exterior entrance doors in the main entry are aluminum type construction, installed on aluminum frames, and in poor condition. Typical exterior doors at the main entry feature single glazed unprotected vision panels, transoms, and inappropriate hardware. Typical exterior entrance doors in the side entries are aluminum type construction, installed on aluminum frames, and in good condition. Typical exterior doors at the side entries feature insulated vision panels, and appropriate hardware. Typical exterior entrance doors for mechanical rooms are hollow metal type construction, installed on hollow frames, and in poor condition. Typical exterior doors at the mechanical entries feature no vision panels, and inappropriate hardware. The facility is equipped with roof access hatches, which are in poor condition. There are no overhead doors in the facility.

Rating: 3 Needs Replacement

Exterior Doors

Recommendations: Replace all exterior doors to comply with Ohio Building Code, ADA, and Ohio School Design Manual guidelines. Replace all hollow metal and single-glazed exterior doors, due to poor condition. Refer to Item B - Roofing for costs associated with replacing roof hatches.

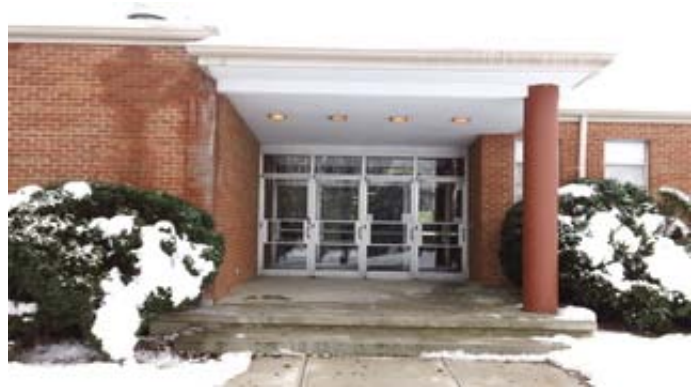
Main Entry Doors

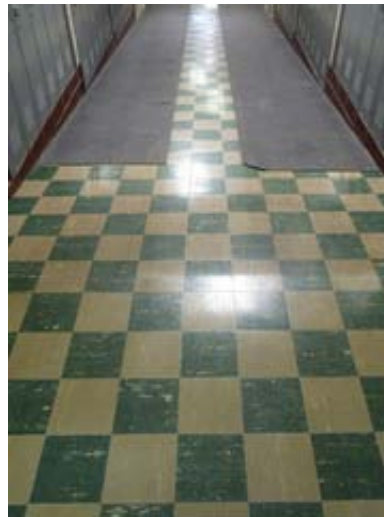
Existing Corridor Ramp without Handrails
