Building Information - Tipp City Exempted Village (45617) - Tipp City Enrichment Program

Program Type	Classroom Facilities Assistance Program (CFAP) - Regular
Setting	Small City
Assessment Name	Tipp City Enrichment Program with EEA & 2015 Costs
Assessment Date (on-site; non-EEA)	2015-03-31
Kitchen Type	No Kitchen
Cost Set:	2015
Building Name	Tipp City Enrichment Program
Building IRN	
Building Address	223 West Broadway
Building City	Tipp City
Building Zipcode	45371
Building Phone	937-667-8800
Acreage	5.50
Current Grades:	PK
Teaching Stations	26
Number of Floors	3
Student Capacity	346
Current Enrollment	184
Enrollment Date	2014-01-13
Enrollment Date is the date in which the current enrollment was taken.	
Number of Classrooms	18
Historical Register	NO
Building's Principal	Melissa Price
Building Type	Elementary

The Tipp City (TC) Enrichment Program Building, formerly known as Tippecanoe Central, is not on the National Register of Historic Buildings and was originally constructed in 1912. The three-story, brick and stone building measures approximately 29,288 square feet and is located in a small town residential setting. The existing facility features a conventionally partitioned des

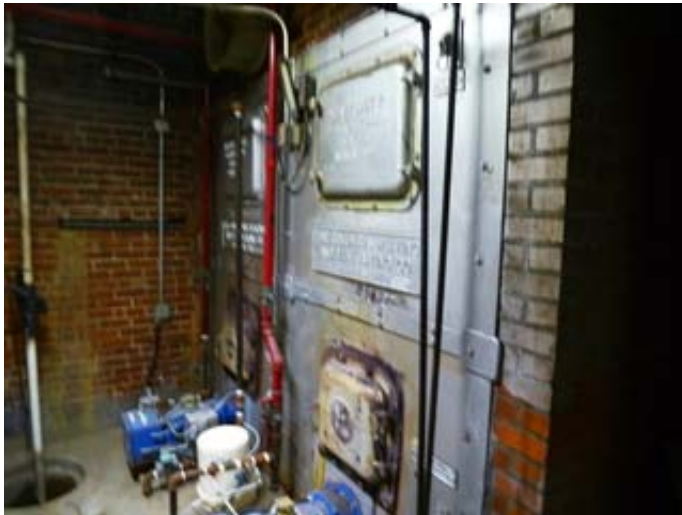
Description: The existing system for the overall facility is a gas fired forced air furnace, installed in 1916, and is in poor condition. 2-pipe vs. 4-pipe designations are not applicable in this facility because the heating source is a gas fired furnace. There are no boilers in this facility. The two gas fired furnaces, manufactured by Columbus Heating and Ventilation, were installed in 1916 and are in fair condition. The system does not comply with the 15 CFM per person fresh air requirements of the Ohio Building Code mechanical code and Ohio School Design Manual. The pneumatic type system temperature controls were installed in 1954 and are in poor condition. The system does not feature individual temperature controls in all spaces required by the OSDM. The overall system does not feature any central energy recovery systems. The facility is not equipped with louvered interior doors to facilitate Corridor utilization as return air plenums. The existing system is concrete/brick ducted, but the ductwork cannot be integrated into a possible future system due to arrangement, air volume, and routing of existing ductwork. The overall heating system is evaluated as being in safe but inefficient working order, and long term life expectancy of the existing system is not anticipated. The structure is not equipped with central air conditioning. The site does not contain underground fuel tanks.

Rating: 3 Needs Replacement

Existing Gas Fired Forced Air Furnace

Recommendations: Provide a new overall heating, ventilating, and air conditioning system to achieve compliance with Ohio Building Code and Ohio School Design Manual standards. Provide new DDC type temperature controls only meet Ohio Building Code and Ohio School Design Manual standards. Provide architectural soffits to accommodate the installation of ductwork.

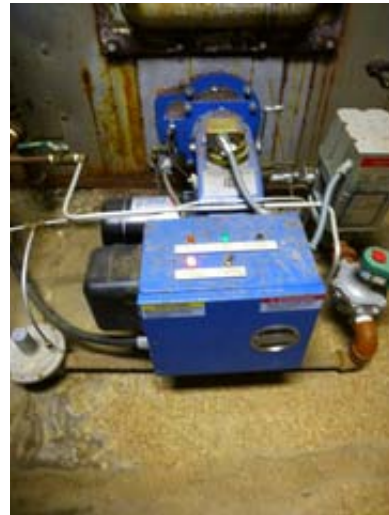
Existing Gas Burner

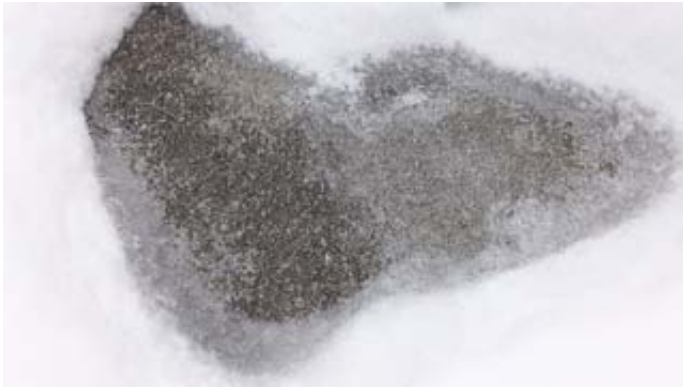
Description: The roof over the overall facility is a built-up asphalt roof membrane system that was installed in 1994 and is in poor condition. There are no District reports of current leaking. Signs of past leaking were observed during the physical assessment. Access to the roof was gained by a portable ladder along the outside of the building. There were no observations of standing water on the roof. Stone copings are in poor condition due to age. Roof storm drainage is addressed through a system of roof drains, which are improperly located, and in poor condition. The roof is not equipped with overflow roof drains though they will be required in areas of roof replacement. No problems requiring attention were encountered with any roof penetrations. There are not any covered walkways attached to this structure.

Rating: 3 Needs Replacement

Roof Membrane

Recommendations: The roof over the overall facility requires replacement to meet Ohio School Design Manual guidelines for age of system and due to condition. The flashing and copings on the overall facility require replacement due to condition. Provide tapered insulation to promote proper roof drainage. Due to existing conditions, roof drains require replacement. Install new overflow roof drains as per OBC requirements. Provide a roof hatch for roof access.

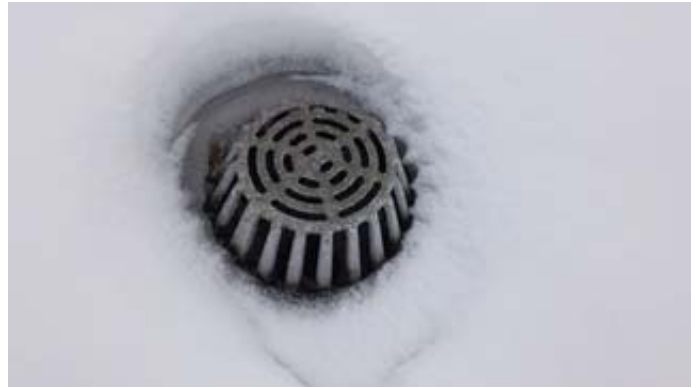
Roof Drain

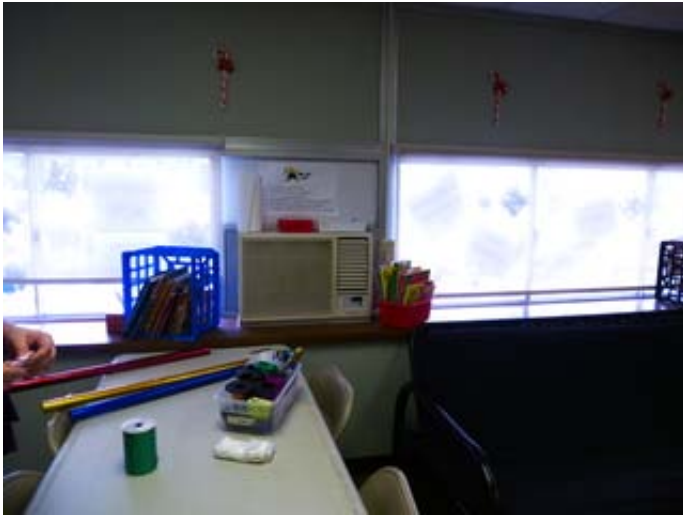
Description: The overall facility is not equipped with a central air conditioning system. Window units are provided in two locations. The ventilation system in the overall facility consists of gas fired forced air system, installed in 1916 and in poor condition, providing fresh air to Classrooms. Relief air venting is provided by being ducted back through the forced air system. The ventilation system does not meet the Ohio Building Code 15 CFM per occupant fresh air requirement. The overall system is not compliant with Ohio Building Code and Ohio School Design Manual requirements. Dust collection systems are not required in this facility. The facility does not feature an Art Room. General building exhaust systems for Restrooms, Storage Rooms, and Custodial Closets are inadequately placed, and in poor condition.

Typical Window A/C Unit

Recommendations: (The above rating of "1 Satisfactory" has been provided because the following items are discussed in other sections. This section would receive a "3 Needs Replacement" if associated costs appeared in the table below.) Provide an air conditioning system to meet with Ohio Building Code and Ohio School Design Manual requirements. Pricing is included in Item A - Heating System. Replace general building exhaust systems located in Restrooms, Storage Rooms, and Custodial Closets. Pricing is included in Item A - Heating System.

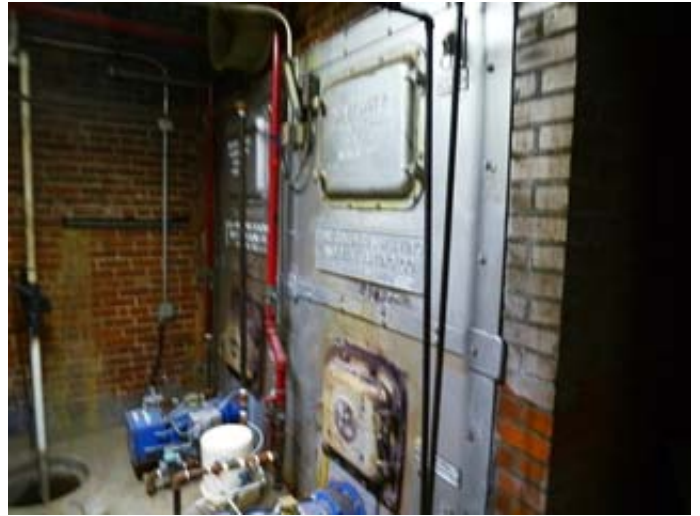
Gas Fired Forced Air Unit

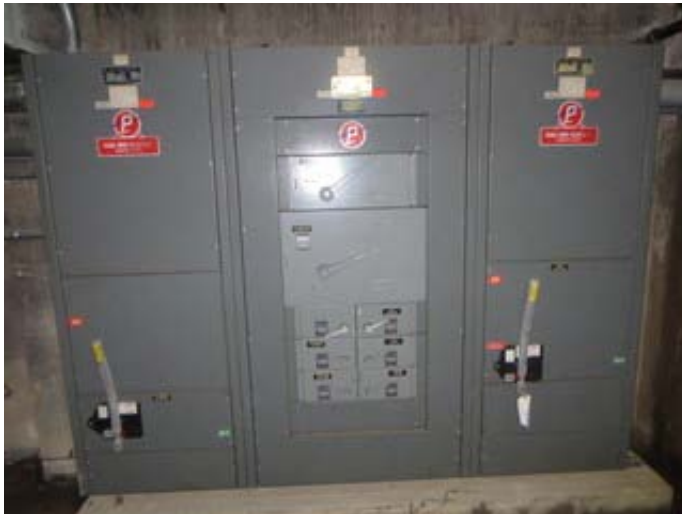
Description: The electrical system provided to the overall facility is a 240V, 200 AMP, 1 phase and 3 wire system installed in 1986, and is in poor condition. The electrical system in the building is an extension of that found in Broadway Elementary School. The panel system, modified in 1986, is in poor condition, and cannot be expanded to add additional capacity. The Classrooms are not equipped with adequate electrical outlets. The typical Classroom contains 4 general purpose outlets, 0 dedicated outlets for each Classroom computer, and 0 dedicated outlets for each Classroom television. Some Classrooms are equipped with as many as 5 general purpose outlets, while others are equipped with as few as 2 general purpose outlets. There are not any spaces that have no electrical outlets. The Corridors are not equipped with adequate electrical outlets for servicing. Adequate GFI protected exterior outlets are not provided around the perimeter of the building. The facility is not equipped with an emergency generator. Adequate lightning protection safeguards are not provided. The existing facility is not equipped with a Stage. The overall electrical system does not meet Ohio School Design Manual requirements in supporting the current needs of the school, and will be inadequate to meet the facility's future needs.

Rating: 3 Needs Replacement

Broadway Elementary Gear that Provides Distribution

Recommendations: The entire electrical system requires replacement to meet Ohio School Design Manual guidelines for overall capacity, Classroom capacity, due to condition and age, and the lack of OSDM-required features.

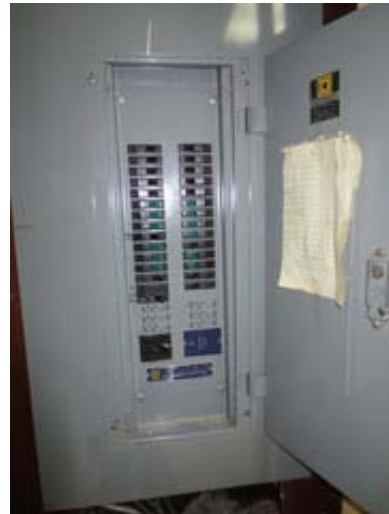
Electrical Panel

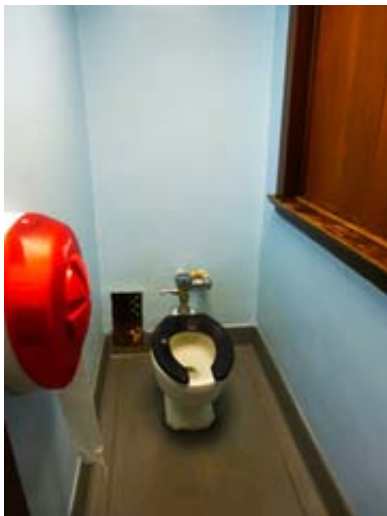
Description: The service entrance is not equipped with a reduced pressure back flow preventer. A water treatment system is not provided. The domestic water supply piping in the overall facility is galvanized, was installed in 1916, and is in poor condition. The waste piping in the overall facility is cast iron, was installed in 1916, and is in poor condition. The facility is equipped with a 40 gallon gas water heater in good condition. The school contains 1 Large Group Restroom for boys (no longer in service), 1 Large Group Restroom for girls (no longer in service), 1 Locker Room Restroom (no longer in service) and 4 Shared Restrooms. The Boys' Large Group Restroom contains 0 ADA and 4 non-ADA floor mounted flush valve toilets, 0 ADA and 4 non-ADA floor mounted flush valve urinals, as well as 0 ADA and 2 non-ADA wall mounted lavatories. The Girls' Large Group Restroom contains 0 ADA and 4 non-ADA floor mounted flush valve toilets, as well as 0 ADA and 1 non-ADA wall mounted lavatories. The Locker Room Restroom contains 0 ADA and 2 non-ADA floor mounted flush valve toilets, 0 ADA and 2 non-ADA wall mounted lavatories, as well as 0 ADA and 2 non-ADA showers. Shared Restrooms contain 0 ADA and 4 non-ADA floor mounted flush valve toilets, as well as 0 ADA and 4 non-ADA wall mounted lavatories. Condition of fixtures is poor. The facility is equipped with 0 ADA and 4 non-ADA drinking fountains. The Elementary Classrooms are not equipped with ADA sink mounted type drinking fountains. Due to existing grade configuration, the facility is not equipped with Special Education, Kitchen, and Health Clinic spaces. The school does not meet the OBC requirements for fixtures. Relative to LEED requirements, the school is not equipped with low flow type fixtures. Per OBC and OSDM requirements this facility should be equipped with 4 toilets, 1 urinal, 4 lavatories, 4 Classroom sink mounted drinking fountains, and 2 electric water coolers. Observations revealed that the school is currently equipped with 4 toilets, 4 urinals, 4 lavatories, and 4 electric water coolers. ADA requirements are not met for fixtures and drinking fountains (see Item O - Handicapped Access). Custodial Closets are properly located and are adequately provided with required service sinks or floor drain sinks, which are in fair condition. Science Classroom / Lab utility sinks, gas connections, compressed air connections, and safety shower / eyewash are not provided, but are not required due to existing grade configuration. Due to existing grade configuration, no Biology or Chemistry Classroom acid waste systems are required. Adequate exterior wall hydrants are not provided.

Rating: 3 Needs Replacement

Existing Non-ADA Floor Mounted Toilet

Recommendations: Due to age, condition, LEED, and OSFC requirements, provide a total of 4 toilets, 4 urinals, 4 lavatories, 8 Classroom sink mounted drinking fountains, and 4 electric water coolers. Fixture totals are coordinated between Item E - Plumbing and Fixtures and Item O - Handicapped Access. Within Item E - Plumbing and Fixtures, provide 1 new electric water cooler and 8 new lavatory mounted type drinking fountains (one sink for each active Classroom space). See Item O - Handicapped Access, for the remainder of fixture replacements and additions related to ADA requirements. Replace galvanized water supply piping in the overall facility with copper piping. Replace sanitary waste piping in the overall facility due to age and condition. Replace mop sinks due to age and condition. Provide exterior wall hydrants.

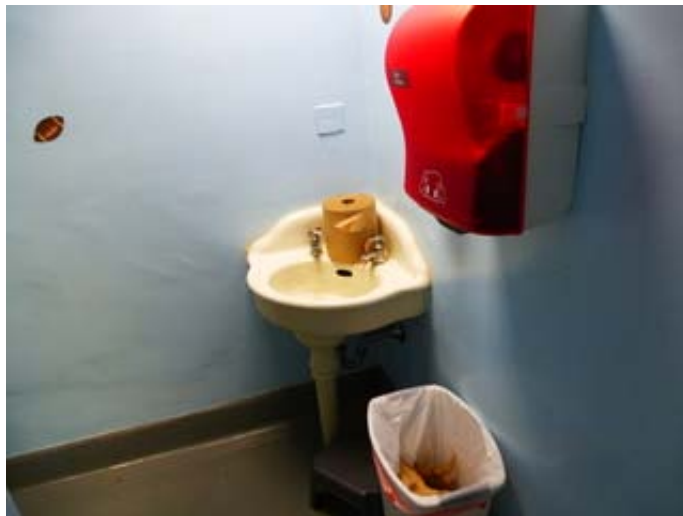
Existing Non-ADA Wall Mounted Lavatory

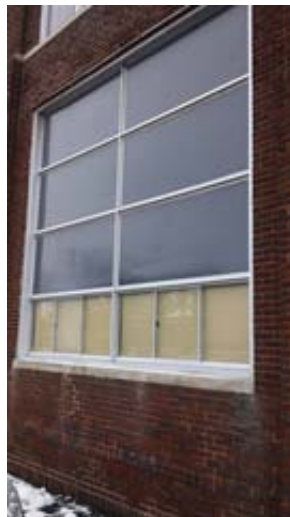
Description: The overall facility is equipped with metal windows with single glazed type window systems, which were installed in 1960's and are in poor condition. The window systems feature operable windows throughout the building and are equipped with opening limiters in poor condition. No insect screens are present. Window system seals are in poor condition, with moderate air and water infiltration being experienced. Window system hardware is in poor condition. The window system features surface mounted roller shades, which are in poor condition. This facility is not equipped with any curtain wall systems. This facility does not feature any glass block windows. The exterior doors in the overall facility are equipped with steel sidelights and transoms with single pane glazing, in poor condition. Exterior door vision panel glazing is also single pane. The school does not contain skylights. The school does not contain clerestories. Interior glass is not OSDM-compliant due to not being safety glass. Window security grilles are not provided for ground floor windows. There is not a Greenhouse associated with this school.

Rating: 3 Needs Replacement

Rear Exterior Window

Recommendations: Provide a new insulated window system with integral blinds to meet with Ohio School Design Manual requirements. Exterior door vision panel replacement is addressed in the replacement of exterior doors in Item S - Exterior Doors. Replace the window transoms at the east and north elevation entrances. Existing window panel square footages are included within the insulated glass/panels and exterior transom glazing square footage values provided in the table below. Replace all non-compliant interior glazing with 1/4" tempered glass.

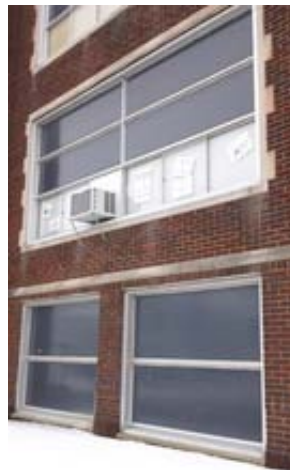
Front Exterior Window

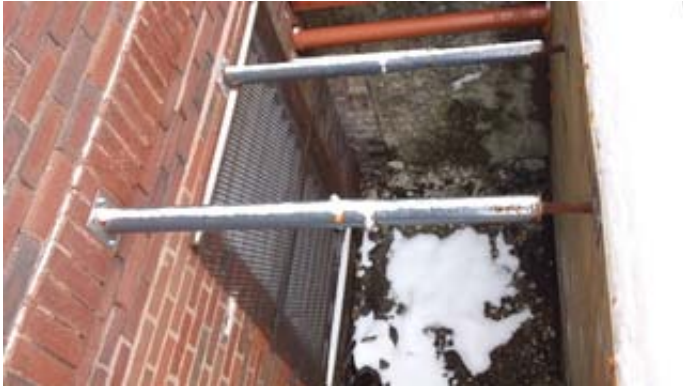
Description: The overall facility is equipped with concrete foundation walls on concrete spread footings, which displayed no locations of significant differential settlement, cracking, or leaking, and are in good condition. No significant issues related to foundation cracking or spalling were encountered. The District reports that there has been no past leaking. No grading or site drainage deficiencies were noted around the perimeter of the structure that are contributing or could contribute to foundation or wall structural deterioration. The exterior stair accessing the lower level Mechanical Room at the rear of the building has a retaining wall that is failing and is currently being braced in place.

Rating: 3 Needs Replacement

Failing Retaining Wall to Lower Level

Recommendations: Remove and rebuild the exterior retaining wall and access stairs down to the lower level Mechanical Room at the rear of the building.

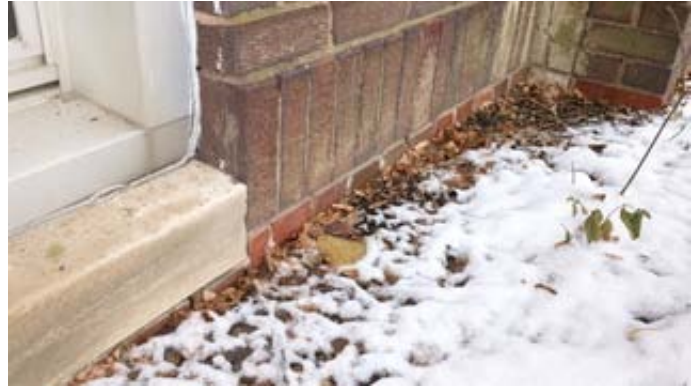
Typical Foundation at Grade

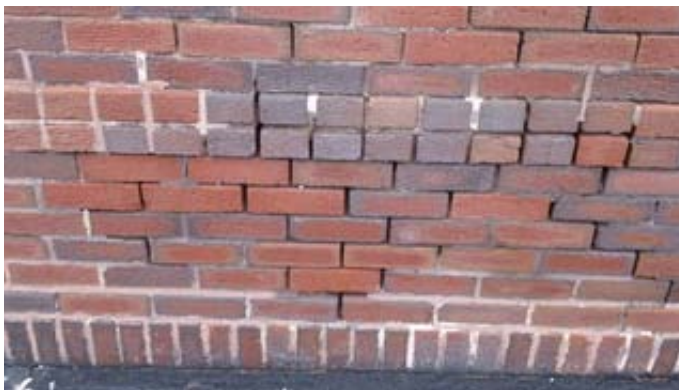
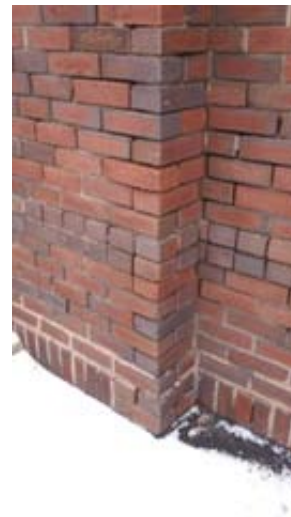
Description: The overall facility has a brick veneer on load bearing masonry wall, which displayed locations of deterioration, and is in poor condition. The exterior masonry appears to have inappropriately spaced and inadequately caulked control joints in poor condition. Control joints are not provided at lintel locations, at doors and windows, building corners, and wall offsets. The school does not contain expansion joints and none are needed, as there is no indication of exterior masonry cracking or separation. Exterior walls in the overall facility are inadequately insulated. Brick veneer masonry walls are not cavity walls. Mortar joints have deteriorated at numerous locations around the entire building. Weep holes and vents are not provided or required. The exterior masonry has not been cleaned and sealed in recent years, and shows evidence of mortar deterioration throughout the facade. Architectural exterior accent materials consist of stone, which is in fair condition. Interior walls are plaster covered concrete masonry units, and are in fair condition. Interior masonry appears to have inadequately spaced and caulked control joints in poor condition. Interior soffits are of plaster type construction, and in fair condition. The window sills are stone, and are in fair condition. The exterior lintels are precast steel members that are rusting and in fair condition. Chimneys are in fair condition. Canopies over entrances are plaster type construction, and are in fair condition. The school is not equipped with a loading dock.

Rating: 2 Needs Repair

Exterior Brick Wall

Recommendations: Provide tuckpointing in all areas of mortar deterioration as required through the overall facility. Repoint exterior stone window sills. Provide masonry cleaning, sealing, and caulking as required through the overall facility. Sawcut and caulk new appropriately spaced control joints in existing masonry through the overall facility. Prep and paint exposed steel lintels through the overall facility. Exterior wall insulation deficiencies are addressed in Item J - General Finishes. Interior and exterior soffits need to be repainted. The associated cost of repainting exterior soffits can be found below. The associated cost of repainting interior soffits is included in Item J - General Finishes, under the full replacement of finishes and casework.

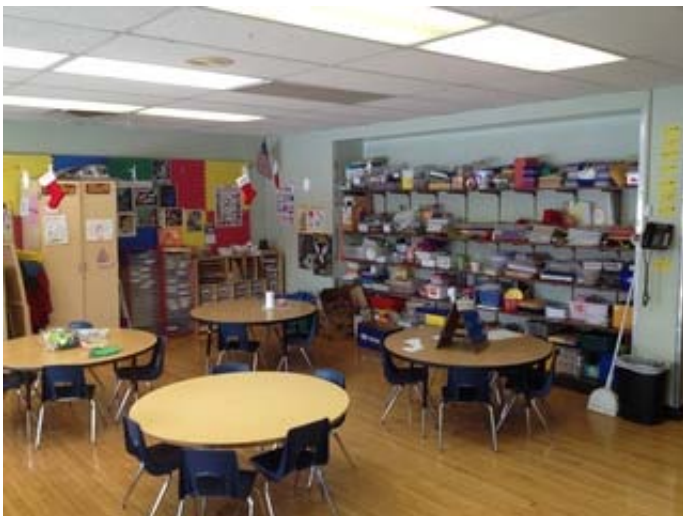
Description: The overall facility features conventionally partitioned Classrooms with wood, carpet, or asbestos tile type flooring, acoustical lay-in type ceilings, as well as hard plaster type wall finishes, and they are in poor condition. The overall facility has Corridors with VAT, VCT, or painted concrete type flooring, acoustical lay-in type ceilings, as well as hard plaster type wall finishes, and they are in poor condition. The overall facility has Restrooms with painted concrete type flooring, concrete type ceilings, as well as hard plaster type wall finishes, and they are in poor condition. Toilet partitions are wood, and are in poor condition. Classroom casework is not provided in the overall facility. Classrooms are not provided adequate chalkboards, markerboards, tackboards which are in poor condition. The lockers, located in the Corridors, are adequately provided, and are in poor condition. The building does not feature an Art program. The facility is equipped with wood non-louvered interior doors that are recessed without proper ADA hardware and clearances, and in poor condition. There is not a Gymnasium space in the building. Students use the Gymnasium in Broadway Elementary School, which is attached to the building. The Media Center has wood type flooring, acoustical lay-in type ceilings, as well as hard plaster type wall finishes, and they are in poor condition. There is not a Student Dining space in the building. Students dine at Broadway Elementary School, which is attached to the building. The building does not feature a Kitchen space. Food for students is prepared by the Kitchen in Broadway Elementary School, which is attached to the building.

Rating: 3 Needs Replacement

Typical Classroom Finishes

Recommendations: Provide complete replacement of finishes and casework due to condition and installation of systems outlined in Items (A / C / D / E / I / K / L / M / N / T / U / W). Funding for replacement of interior doors is provided in Item O - Handicapped Access, including doors that are in poor condition. The replacement of toilet partitions and toilet accessories has been coordinated with Item O - Handicapped Access. Provide wall insulation, furring, and gypsum wall board along exterior walls. Provide sound attenuation for the Media Center due to inadequate acoustical surface treatments. Replacement costs have also been provided in the table below in coordination with the abatement of materials in Item T - Hazardous Material.

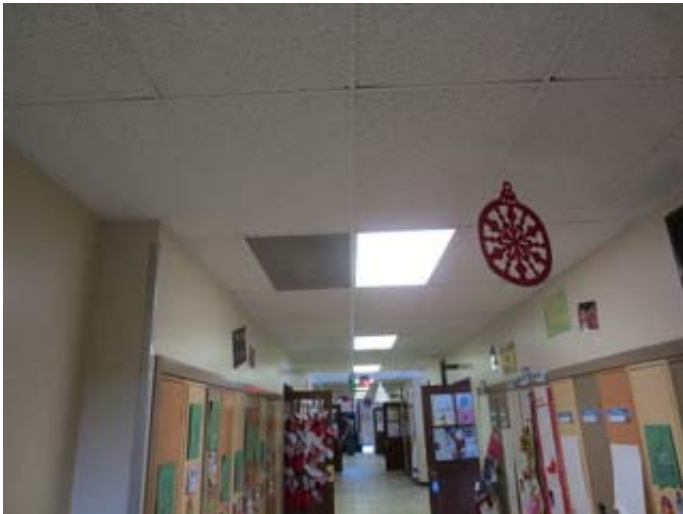
Description: The typical Classrooms in the overall facility are equipped with T-8 2x4 lay-in acrylic lensed fluorescent fixtures with single level switching. Classroom fixtures are in poor condition, providing an average illumination of 65 FC, thus complying with the 50 FC recommended by the OSDM. The typical Corridors in the overall facility are equipped with T-8 2x4 lay-in acrylic lensed fluorescent fixtures with single level switching. Corridor fixtures are in poor condition, providing an average illumination of 25 FC, thus complying with the 20 FC recommended by the OSDM. The Media Center is equipped with 2x4 lay-in T-8 fluorescent fixture type lighting in poor condition, providing an average illumination of 54 FC, thus complying with the 50 FC recommended by the OSDM. The Student Dining spaces are located in the attached Broadway Elementary School. The Kitchen spaces are located in the attached Broadway Elementary School. The Service Areas in the overall facility are equipped with industrial fluorescent T-8 fixture type lighting in poor condition. The typical Administrative spaces in the overall facility are equipped with 2x4 lay-in T-8 fluorescent fixture type lighting in poor condition, providing adequate illumination based on OSDM requirements. The overall lighting systems of the facility are not fully compliant with Ohio School Design Manual requirements due to age and condition and lack of multi-level switching.

Rating: 3 Needs Replacement

Corridor Lighting

Recommendations: Provide complete replacement of lighting system due to condition and lack of multilevel switching.

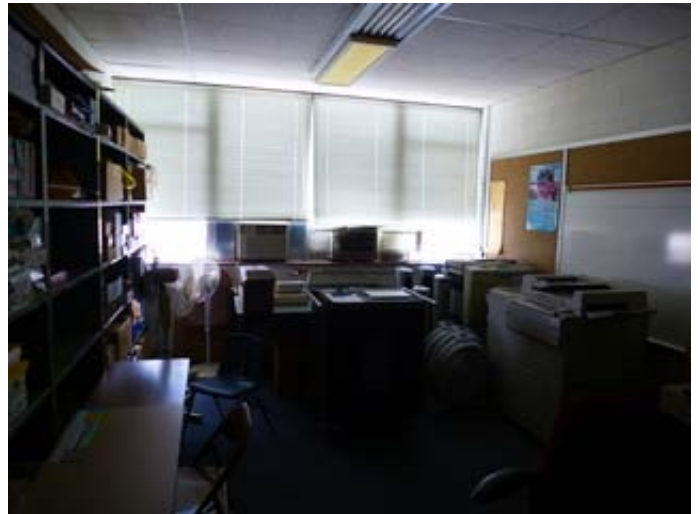
Storage Lighting Fixture

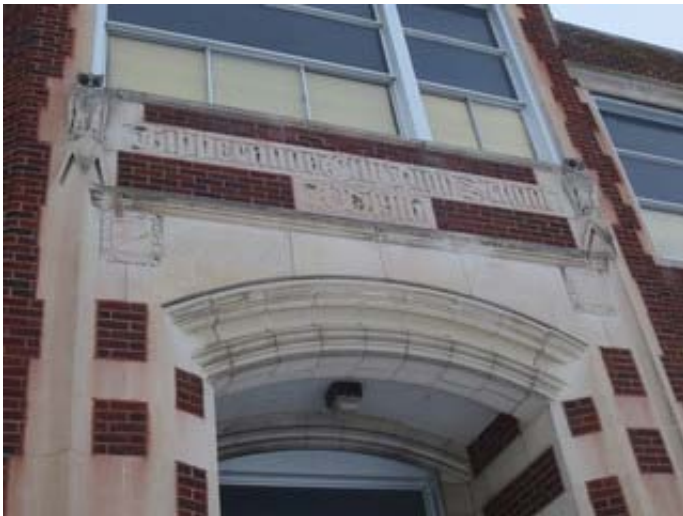
Rating: 3 Needs Replacement

Exterior Entry Lighting

Recommendations: Provide a new security system to meet Ohio School Design Manual guidelines. Provide complete replacement of exterior site lighting system to meet Ohio School Design Manual guidelines. Due to the age group of the students, it is important for proper fencing and security measures to be in place. The proximity to Broadway Elementary School provides access to a fenced playground environment for the TC Enrichment Program students. If students travel through Broadway Elementary School to access the playground area, then a safe route is in place that protects students from the parking lot and Maintenance Building located between the TC Enrichment Program Building and the playground area. Refer to the Broadway Elementary School Assessment for further recommendations regarding the existing playground fencing. If students utilize the open areas to the east of the TC Enrichment Program Building, fencing would be recommended to protect students from surrounding vehicular and pedestrian traffic, but the need for fencing is dependent on whether or not this area of the site is used for school instruction/play. Funding for any potential fencing in this area would be provided under the complete replacement of the security system.

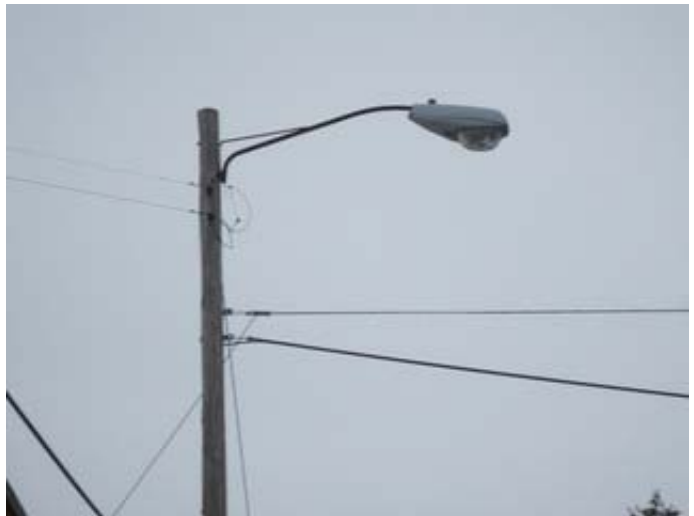
Exterior Site Lighting

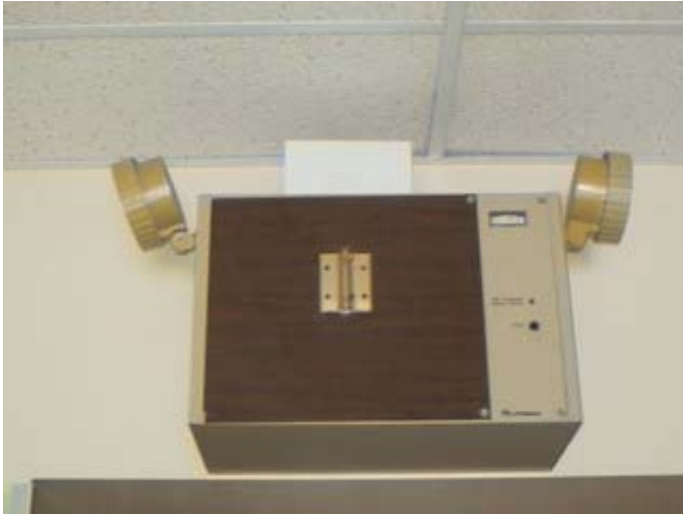
Description: The overall facility is equipped with an emergency egress lighting system consisting of non compliant red lettered, incandescent, cast aluminum construction and non illuminated exit signs, and the system is in poor condition. The facility is inadequately equipped with emergency egress floodlighting, and the system is in poor condition. The system is provided with appropriate battery backup. The system is not adequately provided throughout, and does not meet Ohio School Design Manual and Ohio Building Code requirements.

Rating: 3 Needs Replacement

Emergency Egress Lighting Fixture

Recommendations: Provide complete replacement of new emergency / egress lighting system to meet Ohio School Design Manual and Ohio Building Code guidelines.

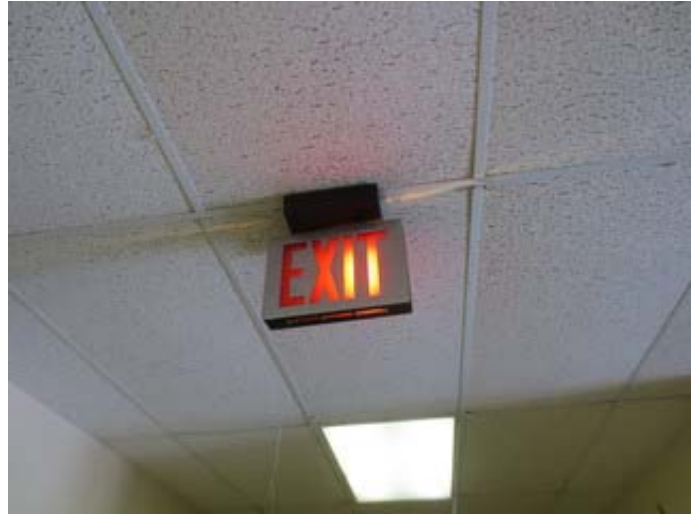
Incandescent Exit Sign

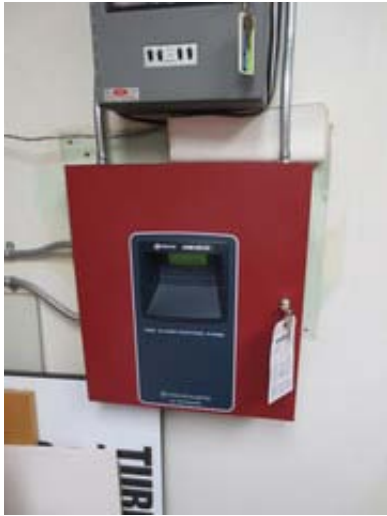
Description: The Fire Alarm Control Panel is located in Broadway Elementary School. The overall facility is equipped with a Honeywell Fire-Lite MS-5UD type fire alarm system, installed in 2000, and in good condition, consisting of manual pull stations, and horn and strobe indicating devices. The system is not automatic and is monitored by a third party. The system is not equipped with sufficient audible horns / strobe indicating devices, and smoke detectors. The system is not equipped with any flow switches, tamper switches and heat sensors. The system thus will not support future fire suppression systems. The system is not fully compliant with Ohio Building Code, NFPA, and Ohio School Design Manual requirements.

Rating: 3 Needs Replacement

Broadway Elementary School Fire Alarm Panel

Recommendations: Provide complete replacement of fire alarm system to meet OBC, NFPA, and Ohio School Design Manual guidelines.

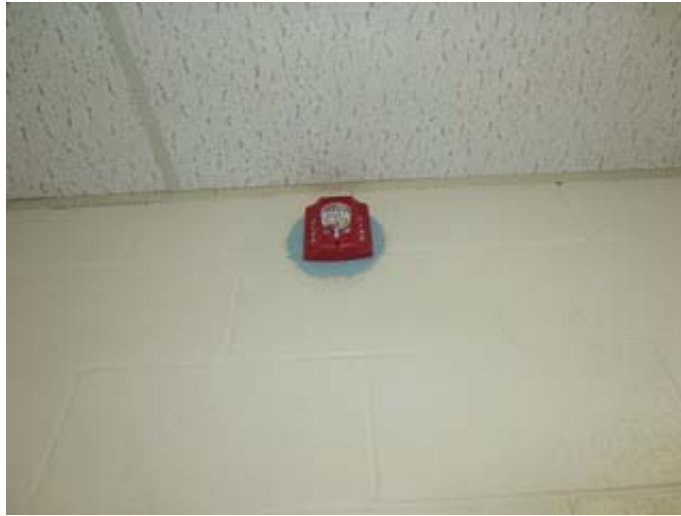
Fire Alarm Device

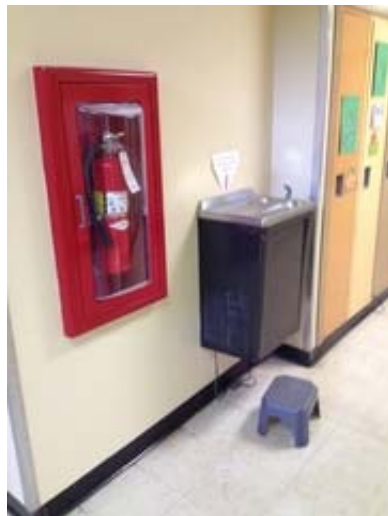
Rating: 3 Needs Replacement

Water Fountain

Recommendations: Provide ADA-compliant signage, power assist door opener, elevator, electric water coolers, toilets, sinks, urinals, toilet partitions, toilet accessories, doors and frames, door hardware in the overall facility to facilitate the school's meeting of ADA requirements. Parking issues are discussed in Item P - Site Condition. Provide an ADA compliant ramp at the north elevation entry to access the building. Refer to Item U - Life Safety for costs associated with the replacement of non-compliant stair railings and the addition of interior stairwell enclosures. Refer to Item P - Site Condition, for costs associated with exterior stair and guardrail replacement.

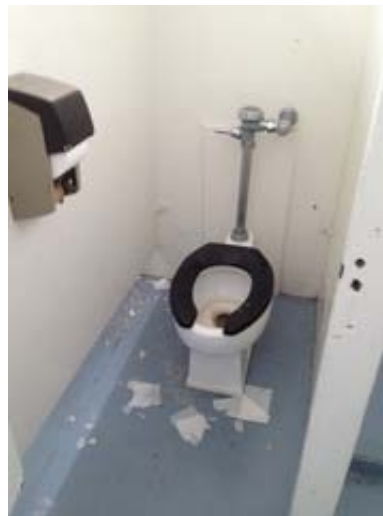
Toilet

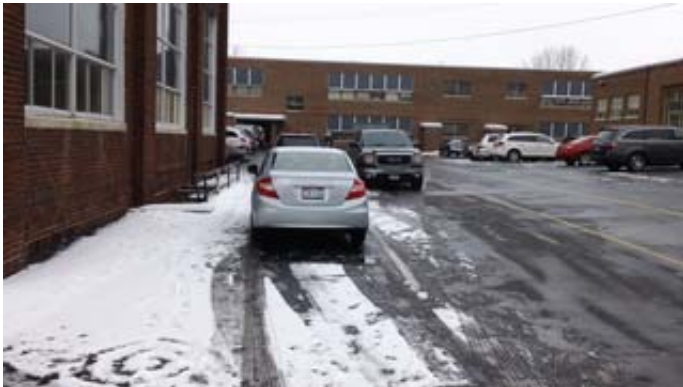
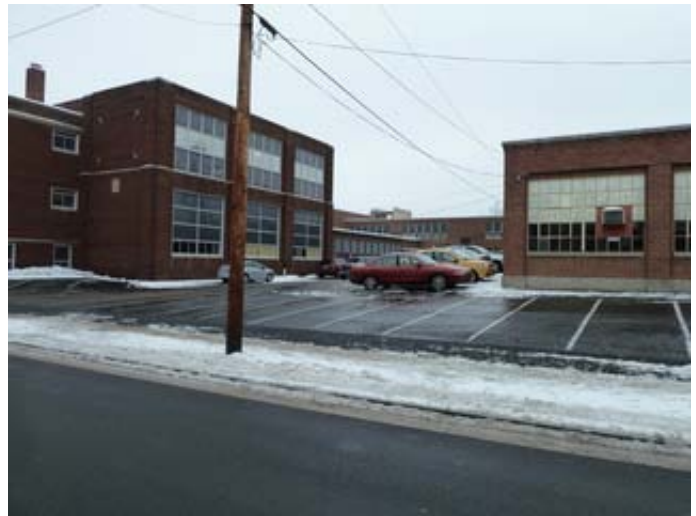
2 Needs Repair

Current Parking Area

Provide additional parking spaces to meet OSDM guidelines, including adequate provisions for the disabled. Replace all non-compliant exterior guardrails and railings. Provide additional guardrails for the proposed north elevation ramp referenced in Item O - Handicapped Access. Refer to the Broadway Elementary School Assessment for further information regarding site improvement costs.

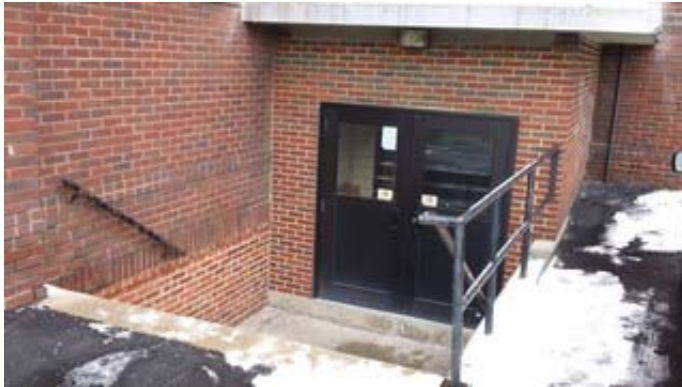
Description: Typical exterior doors in the overall facility are aluminum type construction, installed on aluminum frames, and in fair condition. Typical exterior doors feature single glazed tempered glass vision panels, and inappropriate hardware. Entrance doors in the overall facility are aluminum type construction, installed on aluminum frames, and in fair condition. Entrance doors feature single glazed tempered glass vision panels, transoms, and inappropriate hardware. The facility is not equipped with any roof access doors.

Rating: 3 Needs Replacement

Rear Exterior Door

Recommendations: Replace all exterior doors to comply with Ohio Building Code, ADA, and Ohio School Design Manual guidelines. Refer to Item F - Windows, for further information regarding costs associated with transom glazing replacement. Due to the replacement of exterior doors, costs associated with vision panel replacement will be included in the funding for new door systems.

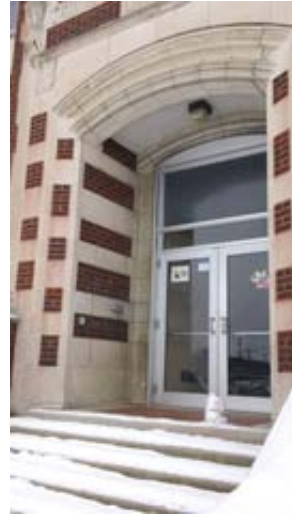
Front Exterior Door

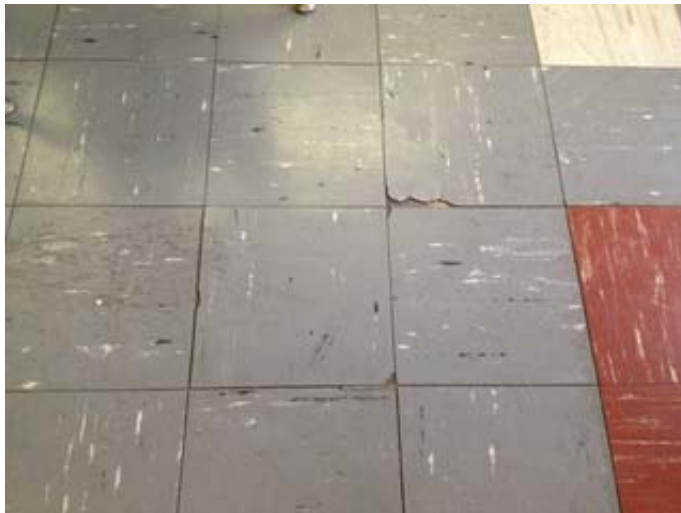
Description: The School District provided the AHERA three year reinspection reports, prepared by Westech Environmental Solutions and dated July 29, 2013, documenting known and assumed locations of asbestos and other hazardous materials. Floor tile and floor tile mastic, carpet mastic, ceiling tile, cove base mastic, acoustical ceiling tile and acoustical ceiling tile mastic, drywall/joint compound, texture compound on drywall, wall panels, fume hood, laboratory counters/sinks, sink undercoating, cement boards, window and door caulking, fire doors and solid core doors, hard plaster, and window panels containing hazardous materials are located in the overall facility in poor condition. These materials were described in the report to be in friable and non-friable condition moderate damage. There are no underground storage tanks on the site. Due to the construction date, there is a potential for lead based paint. Fluorescent lighting will require special disposal.

Rating: 3 Needs Replacement

VAT Floor Tile

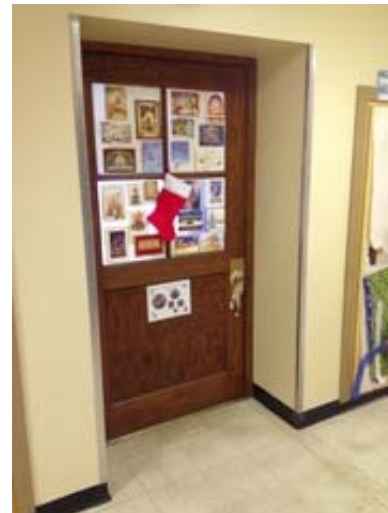
VAT Floor Tile and Door

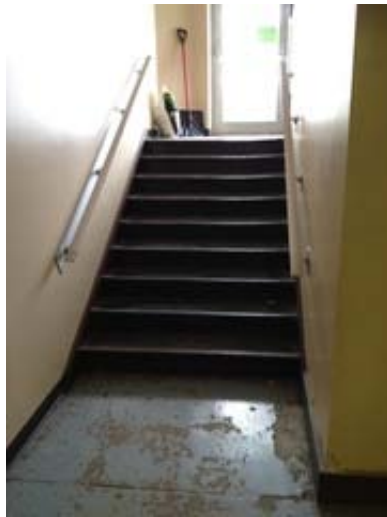
Rating: 3 Needs Replacement

Stairway

Recommendations: Provide a new automated fire suppression system to meet Ohio School Design Manual guidelines. Provide increased water service of a capacity sufficient to support the fire suppression system. Refer to Item R - Water Supply, for costs associated with this scope of work. Provide additional fire extinguishers to comply with Ohio Building Code. Provide new emergency generator, with funding provided via complete replacement of electrical system in Item D - Electrical Systems. Provide new handrails to meet the requirements of the Ohio Building Code. Provide fire-rated enclosures around existing stair towers.

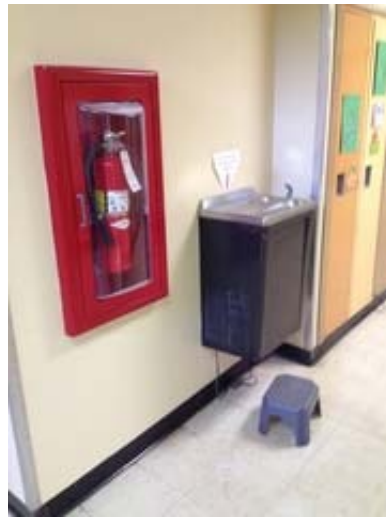
Fire Extinguisher Cabinet

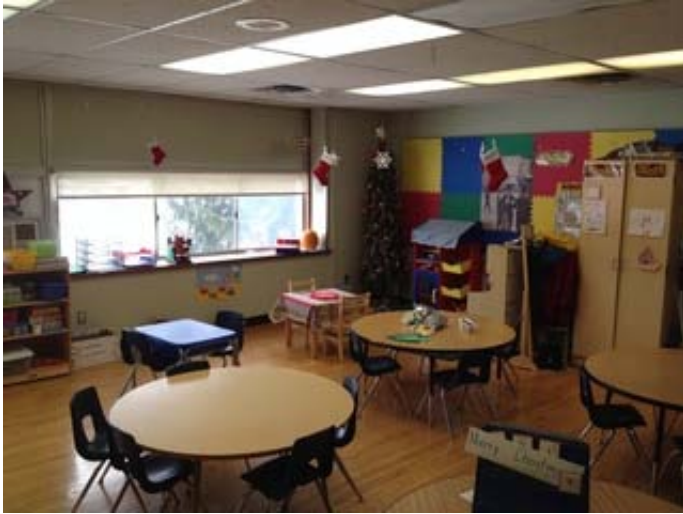
Rating: 3 Needs Replacement

Classroom Furniture

Recommendations: Provide for replacement of outdated or inadequate furnishings.

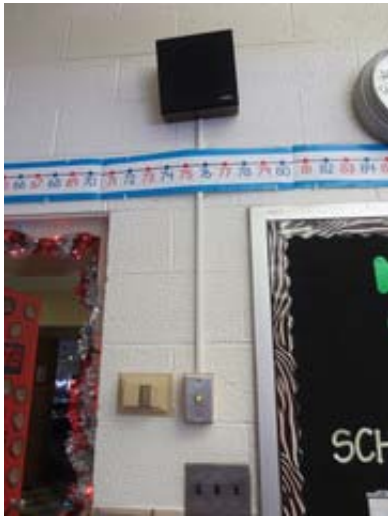
Rating: 3 Needs Replacement

PA System

Recommendations: Provide complete replacement of technology systems to meet Ohio School Design Manual requirements.

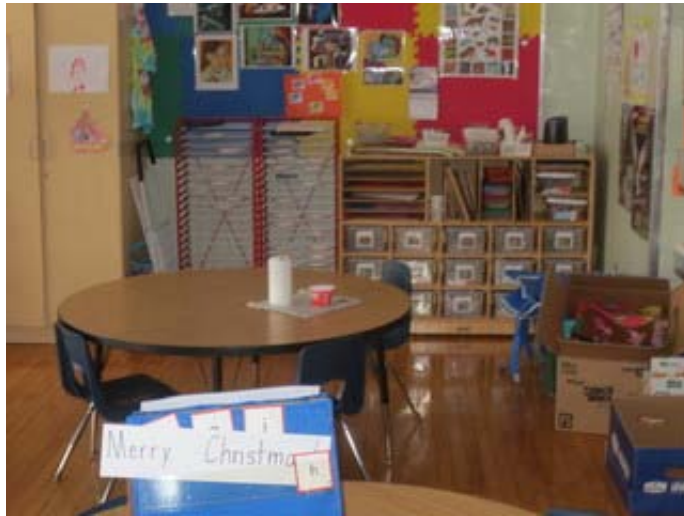
Typical Classroom Without Computers
