**Building Information - Tipp City Exempted Village SD (45617) - Tippecanoe Middle**

Program Type	Classroom Facilities Assistance Program (CFAP) - Regular
Setting	Small City
Assessment Name	Tippecanoe Middle with EEA, 2019 Costs & 2018 Reno Scope Update
Assessment Date (on-site; non-EEA)	2015-03-31
Kitchen Type	Full Kitchen
Cost Set:	2019
Building Name	Tippecanoe Middle
Building IRN	66464
Building Address	555 North Hyatt Street
Building City	Tipp City
Building Zipcode	45371
Building Phone	937-667-8454
Acreage	43.00
Current Grades:	6-8
Teaching Stations	39
Number of Floors	2
Student Capacity	596
Current Enrollment	607
Enrollment Date	2015-02-04
Enrollment Date is the date in which the current enrollment was taken.	
Number of Classrooms	37
Historical Register	<b>NO</b>
Building's Principal	Greg Southers
Building Type	Middle

Tippecanoe Middle School, which is not on the National Register of Historic Buildings, and originally constructed in 1964, is two-story, 100,139 square foot brick school building located in a small town, predominantly residential setting, with adjacencies to medium-sized commercial facilities. Two additions have been added to the building since its Original Cons

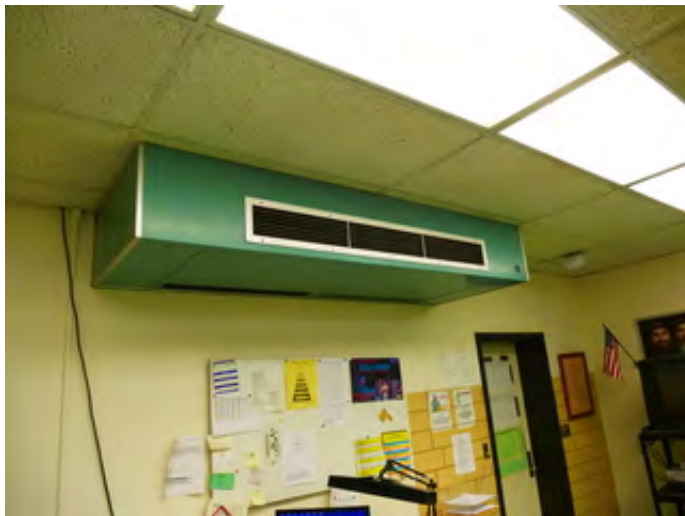
**Description:** The existing system for the 1964 Original Construction and 1972 Addition is a gas fired boiler with heating water pumps located in a separate building to the south of the school (which also serves Nevin Coppock Elementary School), installed in 1959, and is in fair condition. 2-pipe vs. 4-pipe designations are not applicable in this facility, as no central air conditioning is provided. The two gas fired boilers, manufactured by Atlas, were installed in 1959 and are in fair condition. Heating water is distributed to terminal units consisting of unit ventilators, cabinet heaters, unit heaters, and air handlers. The terminal equipment was installed in 1964 and is in fair condition. The system does not comply with the 15 CFM per person fresh air requirements of the Ohio Building Code mechanical code and Ohio School Design Manual. The pneumatic type system temperature controls were installed in 1964 and 1972 and are in fair condition. The system does feature individual temperature controls in all spaces required by the OSDM. The overall system does not feature any central energy recovery systems. The facility is not equipped with widespread louvered interior doors to facilitate Corridor utilization as return air plenums. (Louvered doors are replaced in Items J and O.) The existing system, 1972 Addition, is ducted, but the ductwork cannot be integrated into a possible future system due to arrangement, air volume, and routing of existing ductwork. The existing system, 1964 Original Construction, is not ducted, and floor to structural deck heights will not accommodate the installation of properly sized ductwork for a future Ohio School Design Manual approved system. The overall heating system is evaluated as being in safe but inefficient working order, and long term life expectancy of the existing system is not anticipated. The 1972 Addition is equipped with central air conditioning. The site does not contain underground fuel tanks.

**Rating:** 3 Needs Replacement

Existing Ceiling Mounted Unit Ventilator

**Recommendations:** Provide new overall heating, ventilating, and air conditioning system to achieve compliance with Ohio Building Code and Ohio School Design Manual standards. Provide new DDC type temperature controls only meet Ohio Building Code and Ohio School Design Manual standards. Provide architectural soffits to accommodate the installation of ductwork. POST-ASSESSMENT NOTE: Rii 6-5-19 Applied a Deduct Add Other below to reflect dollars spent in 2018 for an HVAC upgrade.

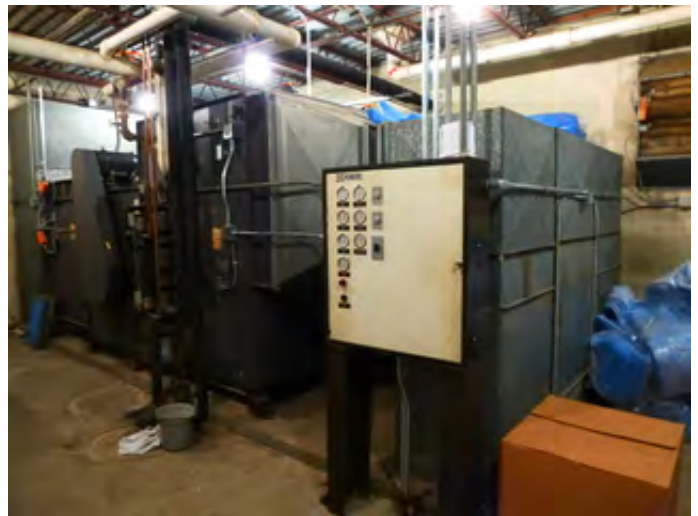
Existing Air Handler

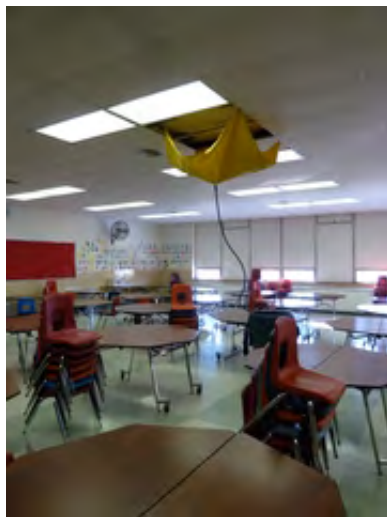
**Description:** The roofing over the 1964 Original Construction and 1972 Addition is a membrane roofing system that was installed between 2007 and 2009. It is in poor condition. The roofing over the 2004 Addition is a standing seam metal roofing system, which is in fair condition. There are District reports of current leaking. Leaking was witnessed in the Student Dining area during the physical assessment, which was documented in the photograph provided below. Access to the Roof was gained by a ship ladder in fair condition from the Gymnasium Mezzanine level to the Upper Mechanical Room, and two compliant steps, in fair condition, from the Mechanical Room to a roof access door in poor condition. Roof ladders are provided to all roof levels, and are in poor condition. Fall safety protection cages are not provided, and are not required. There were no observations of standing water on the roof. Metal cap flashings are in poor condition. Roof storm drainage is addressed through a system of roof drains, which are improperly located, and in fair to poor condition. The roof is not equipped with overflow roof drains, though they will be required in areas of roof replacement. Drainage from the membrane roof over the Art Room is facilitated by a system of gutters and downspouts in poor condition. The Main Entry canopy and north elevation canopy feature downspouts to facilitate drainage, which are in fair condition. The 2004 Addition standing seam roof drainage is addressed through a system of gutters and downspouts in fair condition. All roof penetrations are in poor condition and should be replaced. There are not any covered walkways attached to this structure.

**Rating:** 3 Needs Replacement

Student Dining Water Infiltration

**Recommendations:** The roofing over the 1964 Original Construction and 1972 Addition requires replacement to meet Ohio School Design Manual guidelines for age of system and due to poor condition. Remove all existing roof insulation. Provide a minimum of 4" new polyiso rigid roof insulation across the roof system of the 1964 Original Construction and 1972 Addition. Metal flashing on the overall facility requires replacement due to both their current condition and the replacement of the existing roofing system. Roof drains require replacement due to poor condition. Each roof drain will require an associated overflow drain. Replace the existing gutter and downspout system associated with the Art Room roof, due to poor condition. Supplement the new system with an additional downspout to promote proper drainage. Replace the existing roof ladders due to poor condition. Replace existing roof access door. Cost associated with this replacement is discussed in Item S - Exterior Doors. Provide a guardrail for the ship ladder to the Mechanical Room. Costs associated with this item are discussed in Item U - Life Safety. POST-ASSESSMENT NOTE: Rii 6-4-19 8,000 SF of roofing replacement and roof insulation scope removed from Original Construction, per renovations carried out in 2018. All roofing replacement and roof insulation scope removed from 1972 Addition, per renovations carried out in 2018.

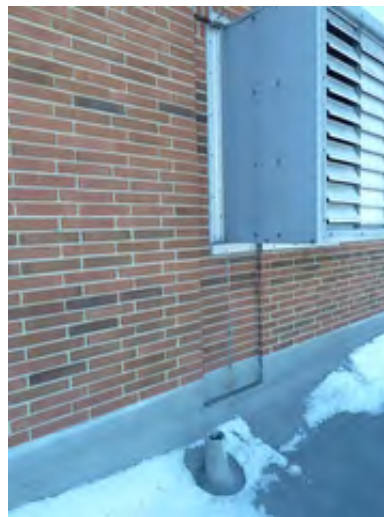
Typical Roof Termination

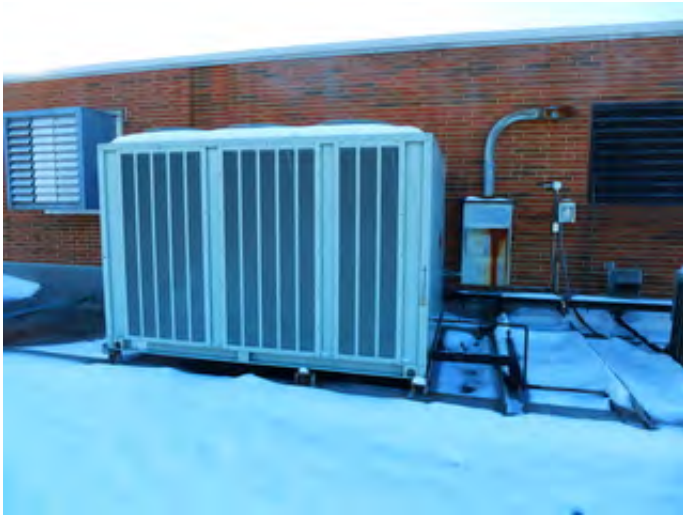
**Description:** The 1964 Original Construction is not equipped with a central air conditioning system. The 1972 Addition is equipped with a split system air handling unit type central air conditioning system, which is in fair condition. Window units are provided in the office locations of the Original Construction. Ductless split system is provided in the coach's office of the Original Construction. The ventilation system in the Original Construction consists of unit ventilators, installed in 1964 and in fair condition, providing fresh air to Classrooms, and air handlers, installed in 1964 and in fair condition, providing fresh air to other miscellaneous spaces such as Gymnasiums, Student Dining. The ventilation system in the 1972 Addition consists of air handlers, installed in 1972 and in fair condition, providing fresh air to Classrooms, and air handlers, installed in 1972 and in fair condition, providing fresh air to other miscellaneous spaces such as the Media Center. Relief air venting is provided by central relief fans. The ventilation system does not meet the Ohio Building Code 15 CFM per occupant fresh air requirement. The overall system is not compliant with Ohio Building Code and Ohio School Design Manual requirements. Dust collection systems are required in this facility to support Industrial Welding Program, and existing equipment is adequate. The Art program is equipped with a kiln, and existing kiln ventilation is adequate, and in fair condition. General building exhaust systems for Restrooms, Storage Rooms, Art Rooms and Custodial Closets are adequately placed, and in fair condition.

**Rating:** 3 Needs Replacement

Existing Air Cooled Condensing Unit

**Recommendations:** Provide an air conditioning system to meet with Ohio Building Code and Ohio School Design Manual requirements. Replace general building exhaust systems located in Restrooms, Storage Rooms, and Custodial Closets. Pricing for these items is included in the scopes of work provided in Item A - Heating System. Replace the existing dust collection system due to age and condition.

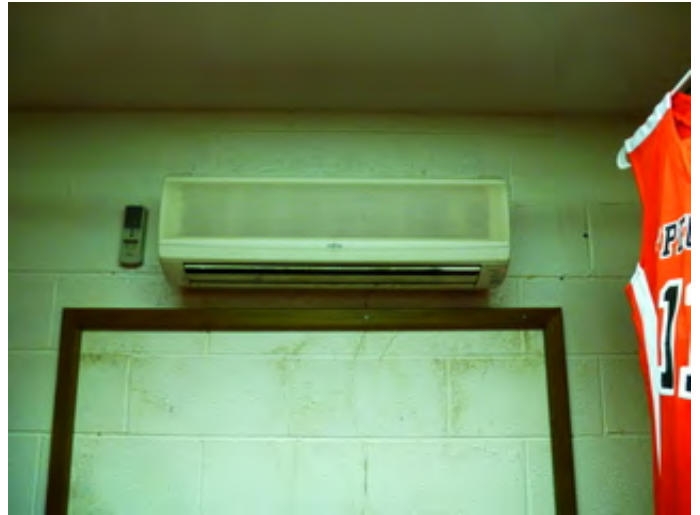
Existing Ductless Split System

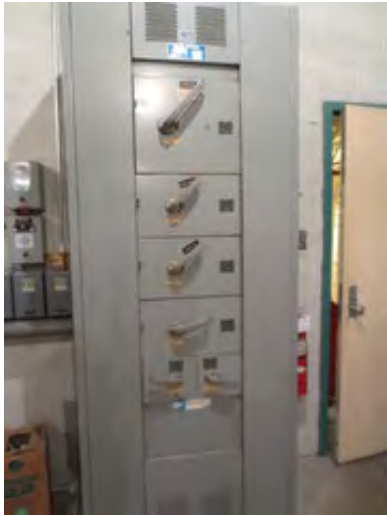
**Description:** The electrical system provided to the 1964 Original Construction is a 120/208 volts, 2000 amp, 3 phase and 4 wire system installed in 1964, and is in poor condition. The electrical system provided to the 1972 Addition is a 120/208 volts, 1200 amp, 3 phase and 4 wire system installed in 1972, and is in good condition. The system in the 1972 Addition is a separate electrical service fed from the single district owned transformer. Original Construction electrical main gear has severe smoke damage from previous fire in mechanical room. Power is provided to the school by a single district owned transformer located outside, and in good condition. The panel system, installed in 1964 and 1972, is in poor condition, and cannot be expanded to add additional capacity. The Classrooms are not equipped with adequate electrical outlets. The typical Classroom contains 4 general purpose outlets, 0 dedicated outlets for each Classroom computer, and 0 dedicated outlets for each Classroom television. Some Classrooms are equipped with as many as 6 general purpose outlets, while others are equipped with as few as 2 general purpose outlets. There are not any spaces that have no electrical outlets. The Corridors are equipped with adequate electrical outlets for servicing. Adequate GFI protected exterior outlets are provided around the perimeter of the building. The facility is not equipped with an emergency generator. Adequate lightning protection safeguards are not provided. The existing facility is not equipped with a Stage. The overall electrical system does not meet Ohio School Design Manual requirements in supporting the current needs of the school, and will be inadequate to meet the facility's future needs.

**Rating:** 3 Needs Replacement

Electrical Distribution Equipment

**Recommendations:** The entire electrical system requires replacement to meet Ohio School Design Manual guidelines for overall capacity, Classroom capacity, due to condition and age and lack of OSDM-required features. POST-ASSESSMENT NOTE: Rii 6-5-19 Applied a Deduct Add Other below to reflect dollars spent in 2018 for an Electrical upgrade.

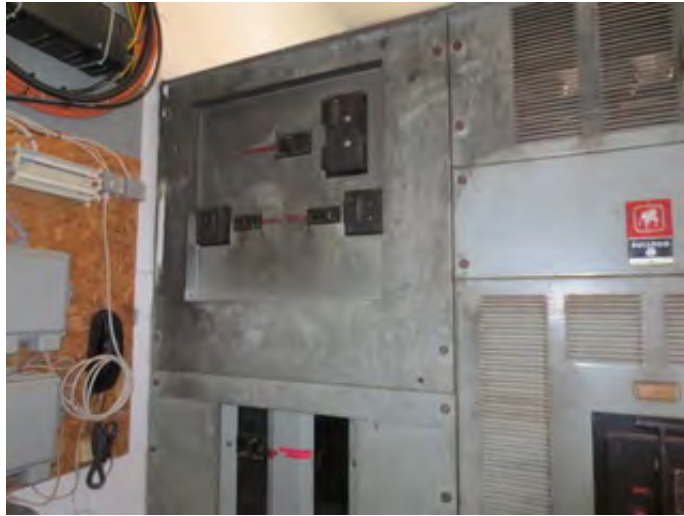
Main Electric Gear Smoke/Fire damage

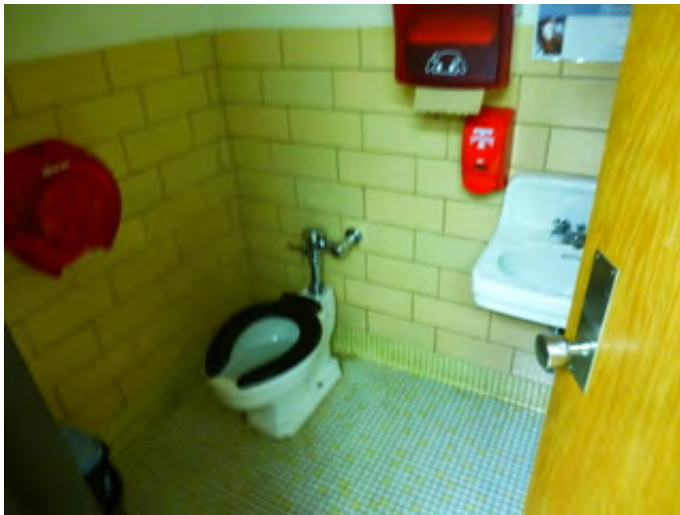
Existing Floor Mounted Toilet and Wall Mounted Lavatory

Rating:	3 Needs Replacement
Recommendations:	<p>Due to age, condition, LEED, and OSFC requirements, provide a total of 43 toilets, 31 urinals, 44 lavatories, 1 Classroom sink mounted drinking fountain, and 10 electric water coolers. Fixture totals are coordinated between Item E - Plumbing and Fixtures and Item O - Handicapped Access. Within Item E - Plumbing and Fixtures, provide 29 new toilets, 30 new lavatories, 26 new urinals, 5 new electric water coolers, and 1 new lavatory mounted type drinking fountain. See Item O - Handicapped Access for the remainder of fixture replacements and additions related to ADA requirements. Replace water supply piping in the overall facility with copper piping due to age and condition. Replace sanitary waste piping in the overall facility due to age and condition. Provide Kitchen with grease interceptor. Provide reduced pressure back flow preventer. Provide new mop sinks. Provide the Science Classrooms with the required gas connections, compressed air connections, and safety shower / eyewash stations.</p>

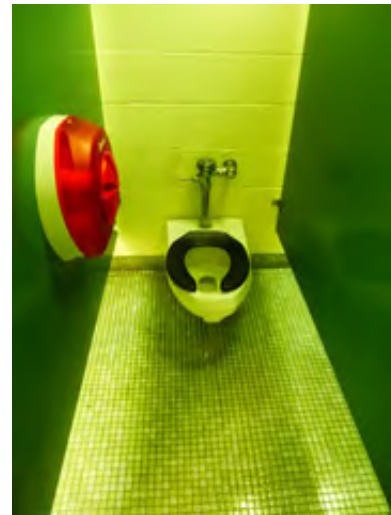
Existing Wall Mounted Toilet

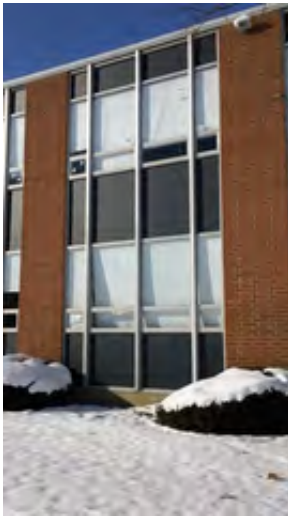
The 1964 Original Construction is equipped with aluminum frame windows with single glazed type window systems, which are generally in poor condition. The window systems feature both fixed and operable windows in the 1964 Original Construction, and operable windows are equipped with opening limiters in poor condition. Window systems do not feature insect screens. Window system seals are in fair to poor condition, with moderate air and water infiltration being experienced. Window system hardware is in poor condition. The window systems feature pull-down shades, which are in fair condition. Aluminum frame curtain wall systems are found in the 1964 Original Construction, in fair to poor condition. Curtain walls are located on the two-story, east-facing Classrooms, as well as the east-facing façade of the Art Room and the south-facing façade of the Student Dining area. Top, bottom, and intermediate sections feature black spandrel panels in fair condition. One aluminum storefront assembly is located on the north elevation of the facility, which appears to feature double glazed, insulated type systems. This facility does not feature any glass block windows. The Special Education Classroom is an interior space that receives no daylighting. In order to introduce light and achieve OSDM-compliance for daylighting, installation of a roof monitor will be required. Classrooms of the 1972 Addition do not feature windows. These spaces do not meet the minimum requirements set in place by the Ohio School Design Manual for vision glazing, which will require extensive work including, but not limited to, demolition and installation of lintels and window systems. Interior Classrooms are Computer Lab spaces, therefore these spaces do not require daylighting or vision glazing per the Ohio School Design Manual. One interior Classroom, Classroom 133, will require the installation of a roof monitor. Due to the proximity to the two-story Gymnasium space, a roof monitor facing east or west is the most feasible daylighting strategy. The second level of the 2004 Addition is equipped with one aluminum frame window with double glazed insulated glazing. The window features both fixed and operable segments. The operable segments appear to feature tempered glazing. The system is in fair condition. The exterior doors in the 1964 Original Construction are aluminum and steel type construction, with sidelights and transoms with single pane glazing, in poor condition. Wire mesh is only utilized in two glazing systems in the Original Construction, one of which is a sidelight of the main entry door system. The other is a window system adjacent to the Loading Dock area. The exterior doors in the 1972 Addition are aluminum type construction, with sidelights and transoms with double glazed insulated glazing, in fair condition. Exterior door vision panels are double glazed insulated glazing. The 2004 Addition does not feature exterior doors due to its adjacency to existing exterior doors. The school does not contain skylights. The school does not contain any clerestories. Interior glass is not OSDM-compliant due to not being safety glass. The interior features one hollow metal storefront window system to the Main Office. This system has surface-mounted blinds, is in fair condition, and does not feature safety glass. Additional metal storefronts are featured in the Media Center, in the form of modular wall systems. These walls appear to utilize safety glass and are in fair condition. Window security grilles are not provided for ground floor windows. There is not a Greenhouse associated with this school.

3 Needs Replacement

Typical Original Construction Two-Story Window System

Provide a new insulated window system with integral blinds to meet with Ohio School Design Manual requirements. Replace window transoms and sidelights at exterior doors of the 1964 Original Construction and 1972 Addition. Replace Main Office storefront glazing with tempered glazing. Replace the two handicap-access storefront systems on the west elevation of the facility due to condition. Replace the interior system with a new aluminum system featuring tempered glazing. Each storefront features a power-assist door, and each new assembly will require a power-assist mechanism. Funding for the power assist mechanism is provided in Item O - Handicapped Access. Replace curtain wall systems in the 1964 Original Construction. Provide roof monitors to the Special Education Classroom of the 1964 Original Construction in order to provide daylighting. In the 1972 Addition, provide one roof monitor to Classroom 133 in order to provide daylighting. Provide windows to the Classrooms of the 1972 Addition in order to achieve OSDM-compliance for vision glazing and daylighting. Square footages used below for funding will achieve the minimum 5% vision glazing to comply with the Ohio School Design Manual. Although door and window panels are removed in Item T - Hazardous Material, the replacement of these panels is included in the curtain wall/storefront system square footages below.

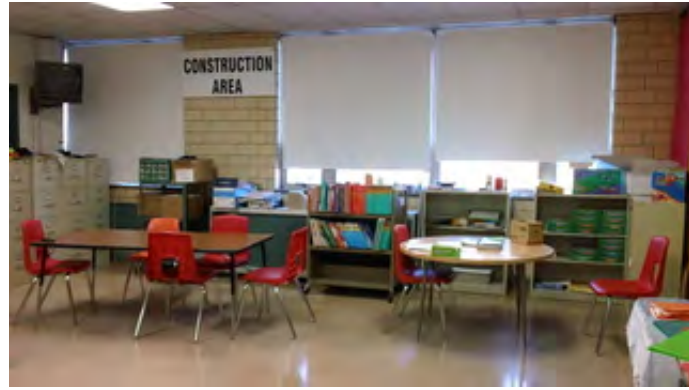
Typical Classroom Window System

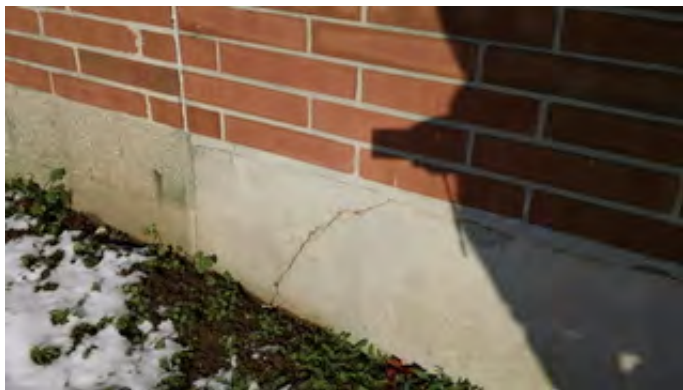
**Description:** The 1964 Original Construction is equipped with concrete and concrete block foundation walls on concrete footings, which displayed locations of cracking at transitions and openings, and is generally in fair condition. The 1972 Addition is equipped with concrete masonry unit foundation walls on concrete footings, which displayed minimal locations of cracking, and are in fair condition. The 2004 Addition is equipped with concrete foundation walls on concrete footings, which displayed minimal locations of cracking, and are in fair condition. Areas of minor cracking and spalling were observed throughout the overall facility. The District reports that there has been no past leaking. No grading or site drainage deficiencies were noted around the perimeter of the structure that are contributing or could contribute to foundation / wall structural deterioration.

**Rating:** 2 Needs Repair

Transition between Original Construction and 1972 Addition

**Recommendations:** Repair areas of cracking and spalling as needed throughout the overall facility.

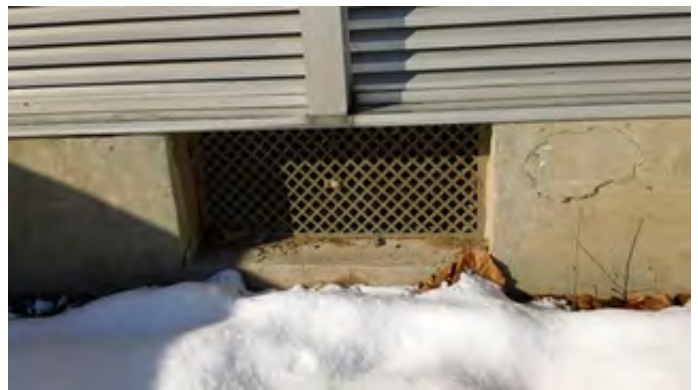
Foundation Condition at an Opening

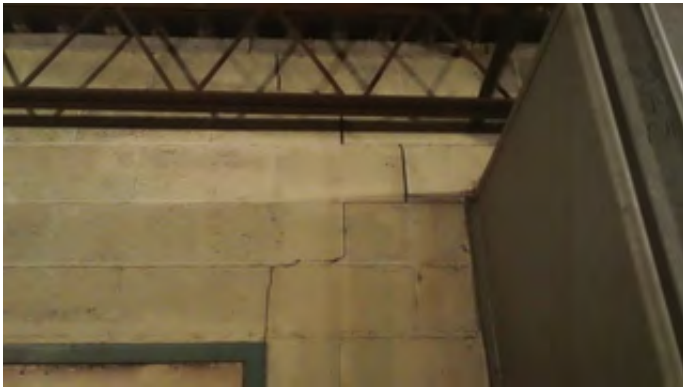
Damage Caused by a Lack of Control Joints

Rating:	2 Needs Repair
Recommendations:	<p>Provide tuckpointing in all areas of mortar deterioration as required through the overall facility. Provide masonry cleaning and sealing as required through the overall facility. Install control joints in existing masonry in the 1964 Original Construction and 1972 Addition to alleviate building stresses at corners, openings, and long expanses of wall assemblies. Replace damaged brick throughout the facility. Recaulk existing control joints as needed through the overall facility. Provide infill masonry due to the replacement of unit ventilators. Prep and paint exposed steel lintels throughout the 1964 Original Construction and 1972 Addition. Prep and paint the exposed steel canopy adjacent to the 2004 Addition (part of the 1964 Original Construction). Replace concrete sills throughout the 1964 Original Construction due to condition. Exterior wall insulation deficiencies are addressed in Item J. Funding for the replacement of the Loading Dock asphalt is discussed in Item P - Site Condition. Concrete patching and repairs are also discussed in Item P - Site Condition. Interior and exterior soffits need to be repainted. The associated cost of repainting exterior soffits can be found below. The associated cost of repainting interior soffits is included in Item J - General Finishes, under the full replacement of finishes and casework.</p>

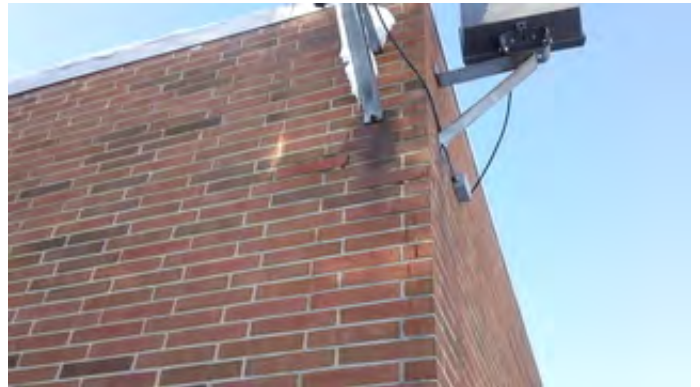
Corner Exterior Masonry Cracking

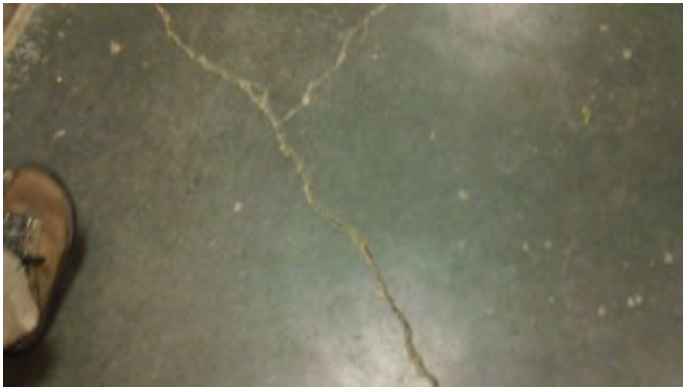
**Description:** The floor construction of the base floor of the overall facility is poured-in-place concrete slab on grade type construction, and is in fair condition. There is no crawl space. The floor construction of the second floor of the 1964 Original Construction is cast-in-place concrete type construction, and is in fair condition. Ceiling to structural deck spaces are insufficient to accommodate HVAC, electrical, and plumbing scopes of work in required renovations from Item A - Heating System. Sufficient space can be provided by lowering the ceiling height. The roof construction of the 1964 Original Construction consists primarily of steel decking on open web steel joist type construction in fair condition. Select areas that house mechanical equipment above drop ceiling levels, such as in the Kitchen and the Band Storage Room, feature tectum on open web steel joist type construction in fair condition. The Gymnasium and Wood Shop roof constructions consist of tectum decking on open web steel joist type construction in fair condition. The roof construction of the 1972 and 2004 Additions consists of steel decking on open web steel joist type construction in fair condition.

**Rating:** 2 Needs Repair

Locker Room Exposed Concrete Flooring Cracking

**Recommendations:** In the Locker Room areas, and other areas that feature an exposed concrete slab flooring system, repair visible cracking. Due to the proposed replacement of acoustical ceiling tiles, which is discussed in Item J - General Finishes, it will be possible to lower the height of the ceilings to properly accommodate the proposed ductwork.

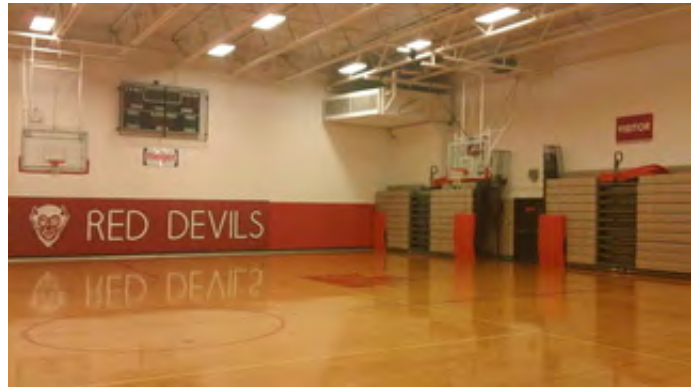
Typical Gymnasium Roof Structure

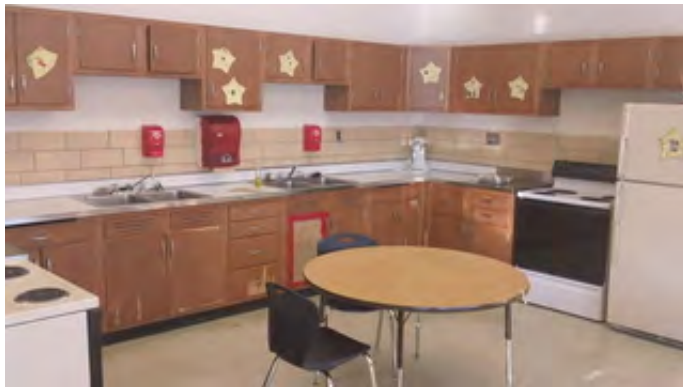
**Rating:** 3 Needs Replacement

Consumer Science Lab Typical Finishes

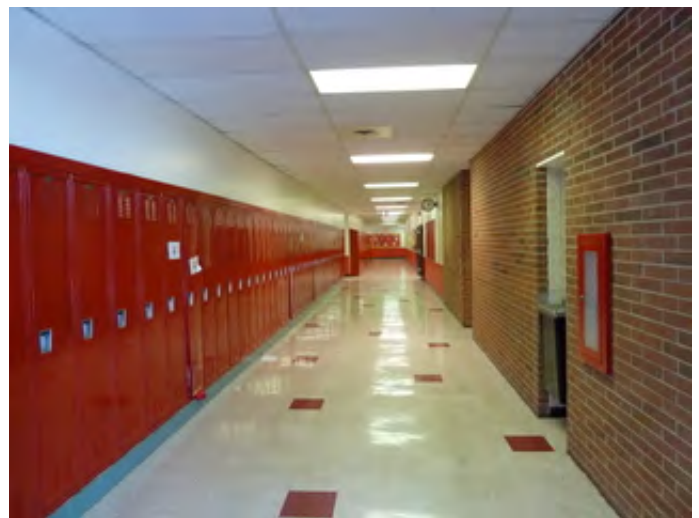
1972 Addition Corridor Finishes

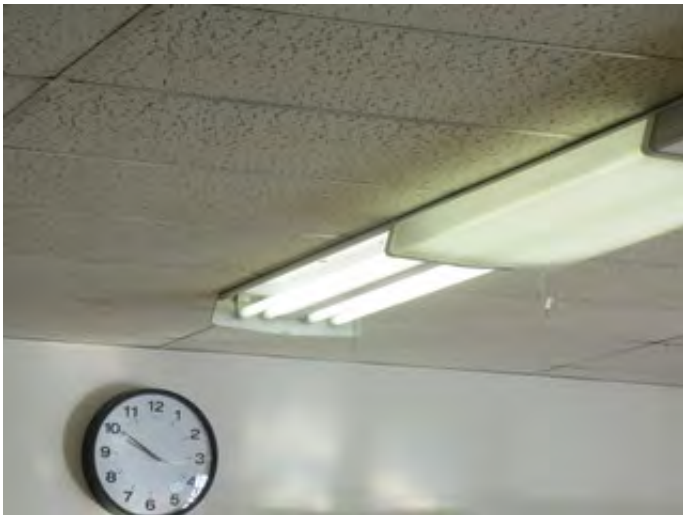
**Rating:** 3 Needs Replacement

Classroom Lighting Fixture

**Recommendations:** Provide complete replacement of lighting system due to condition, the lack of multilevel switching, inadequate lighting levels and the utilization of incandescent fixtures.

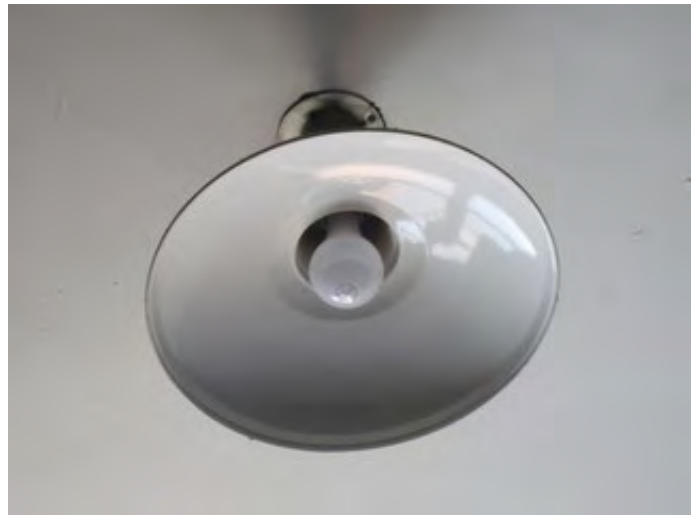
Service Area Incandescent Lighting Fixture

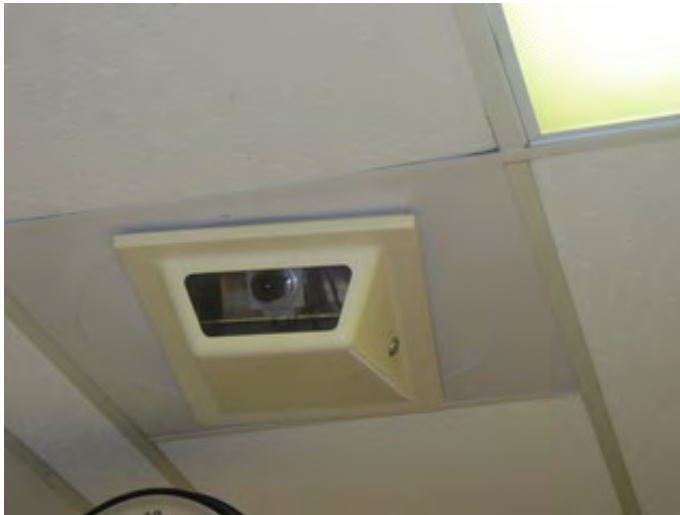
**Rating:** 3 Needs Replacement

Inoperable Security Camera

**Recommendations:** Provide complete replacement of security system to meet Ohio School Design Manual guidelines. Provide complete replacement of exterior site lighting system to meet Ohio School Design Manual guidelines. POST-ASSESSMENT NOTE: Rii 6-4-19 Exterior Site Lighting replaced and supplemented in 2018. Scope removed from assessment. POST-ASSESSMENT NOTE: Rii 6-4-19 Added funding to provide Secure Main Entrance Vestibule.

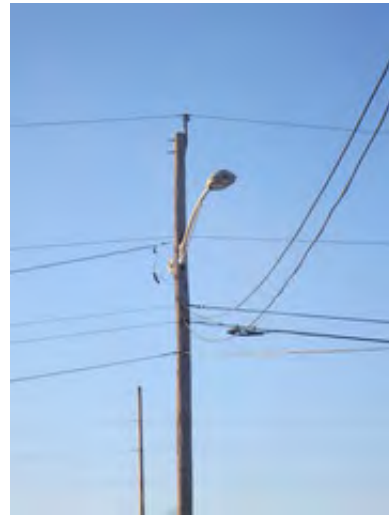
Site Lighting Fixture

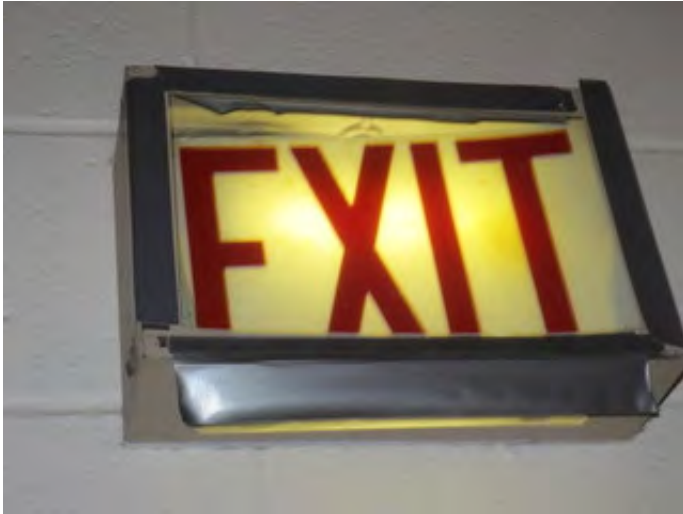
**Rating:** 3 Needs Replacement

Exit Sign

**Recommendations:** Provide complete replacement of emergency / egress lighting system to meet Ohio School Design Manual and Ohio Building Code guidelines.

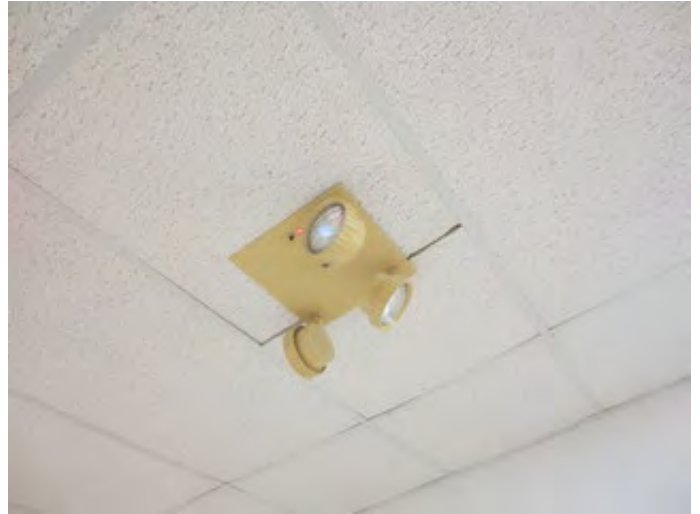
Emergency Egress Lighting Fixture

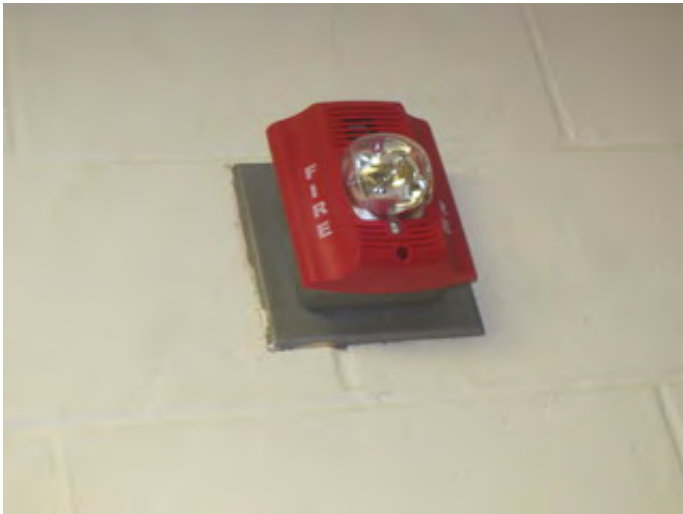
Fire Alarm Device

**Recommendations:** Provide complete replacement of fire alarm system to meet OBC, NFPA, and Ohio School Design Manual guidelines. POST-ASSESSMENT NOTE: Rii 6-5-19 Applying a Deduct Add Other to remove scope spent during a 2018 partial renovation of the building.

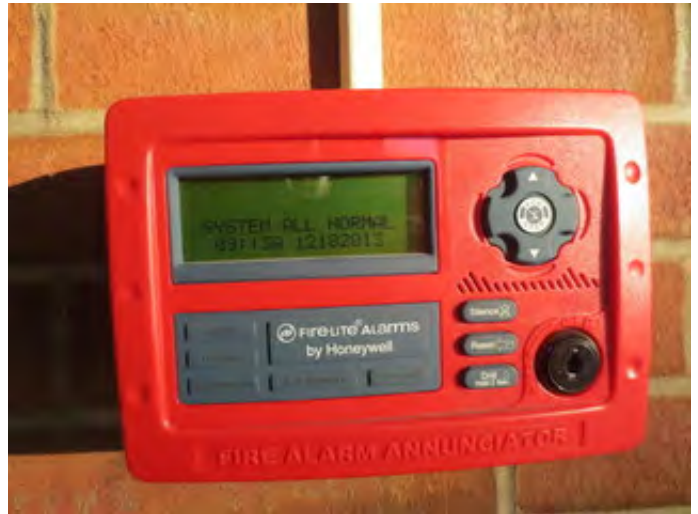
Fire Alarm Annunciator Panel

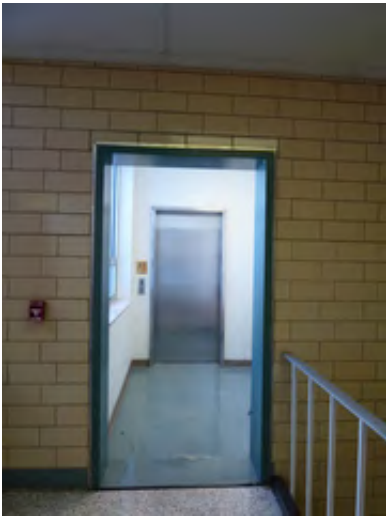
Second Level Elevator Landing

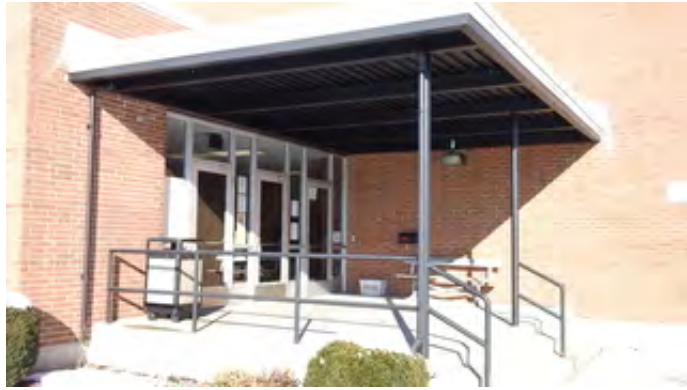
Inaccessible Main Entry

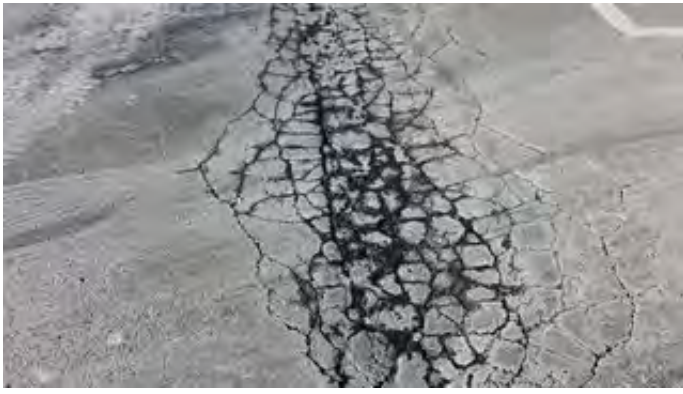
Condition of Asphalt Paving

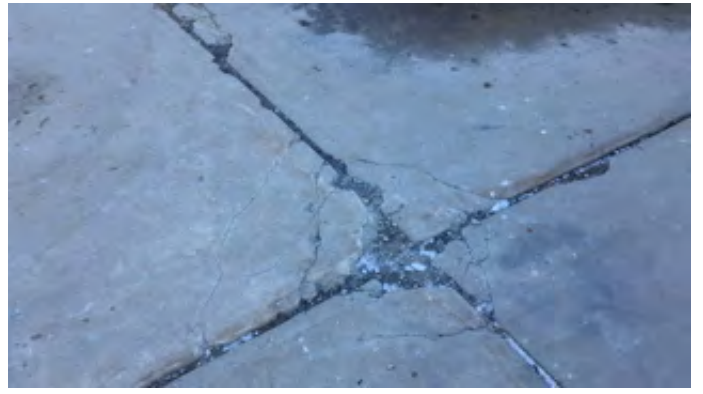
Typical Concrete Damage at the West Elevation Entry

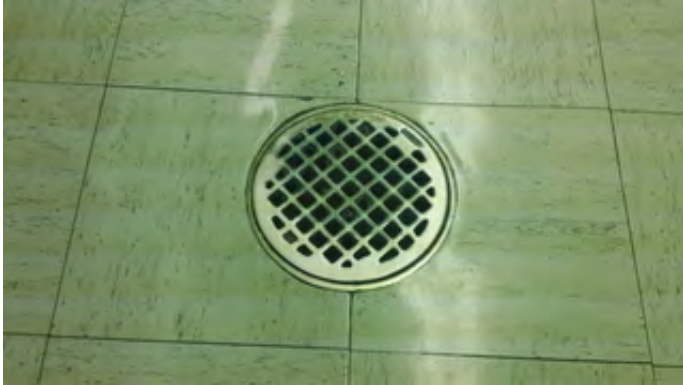
Kitchen Floor Drain

Recommendations: Existing conditions require no renovation or replacement at the present time.

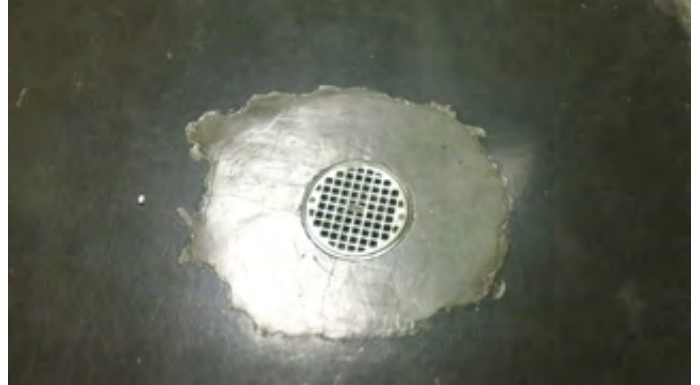
Repaired Locker Room Floor Drain

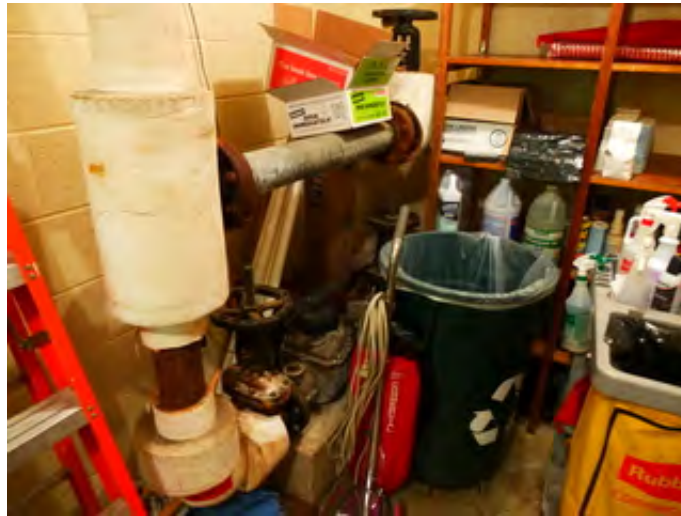
Existing Water Service

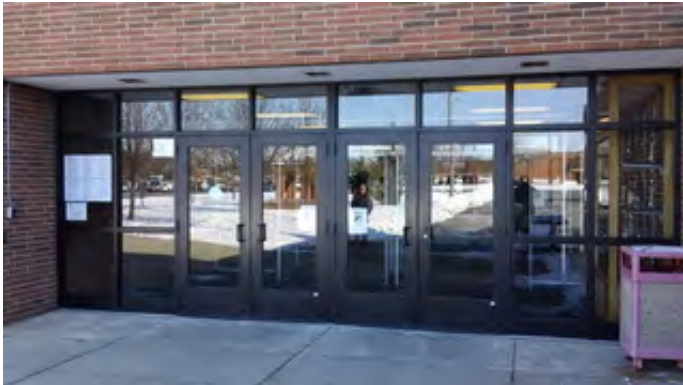
West Elevation Handicap-Accessible Entry

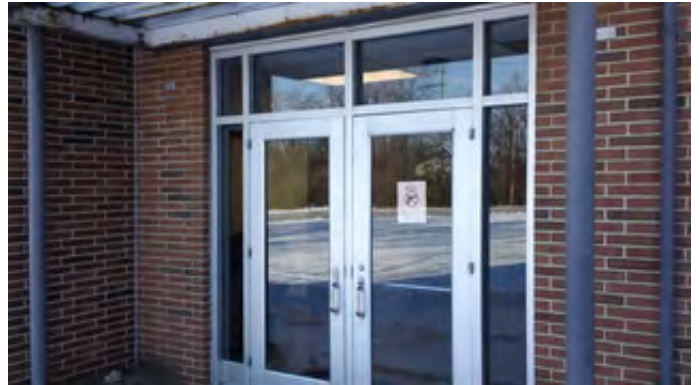
North Elevation Entry Typical Exterior Doors

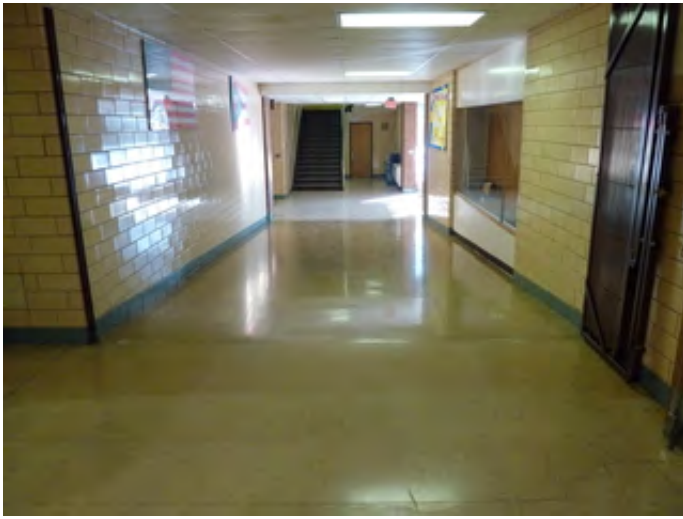
1964 Original Construction VAT Flooring

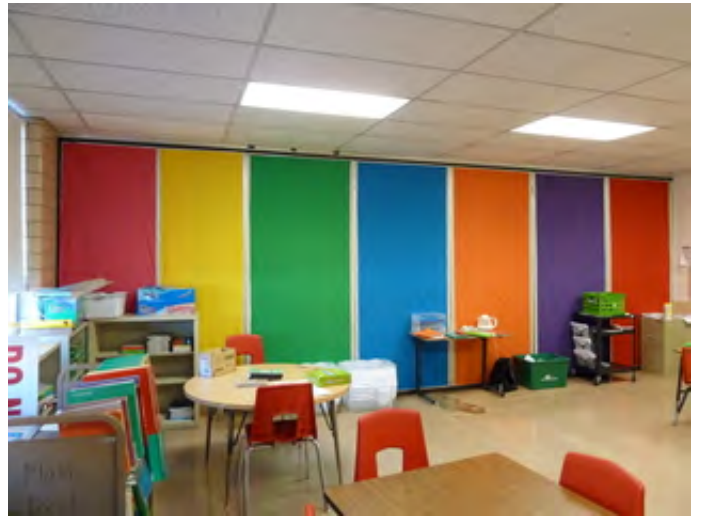
Typical Classroom Fluorescent Lighting

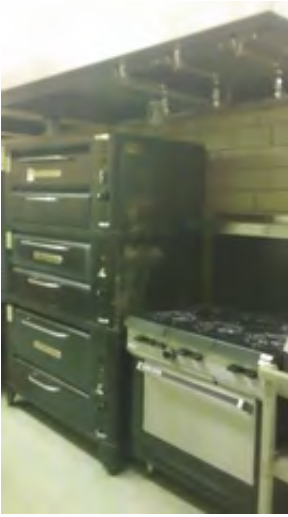
Kitchen Fire Suppression Hood

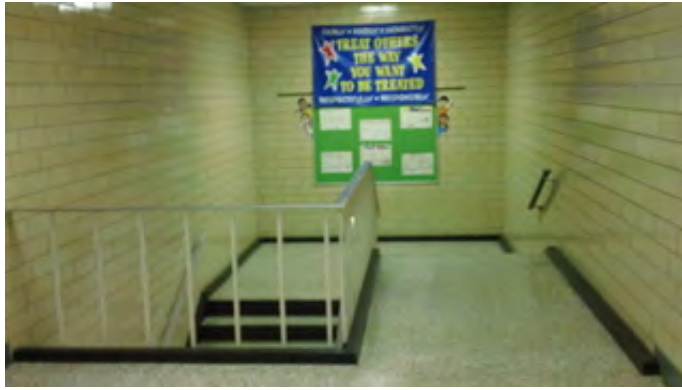
Typical Stairwell Railing System

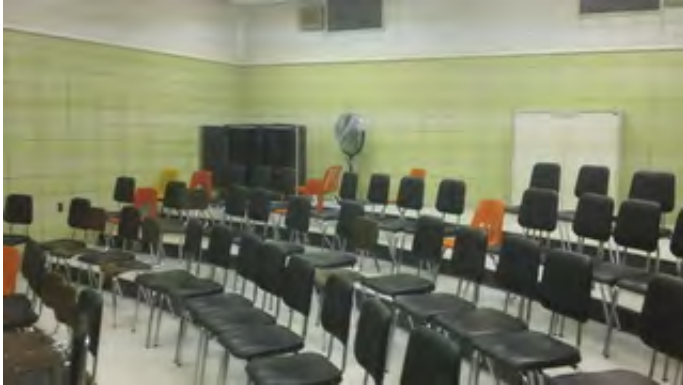
Band Room Loose Furnishings

**Recommendations:** Provide for replacement of outdated or inadequate furnishings.

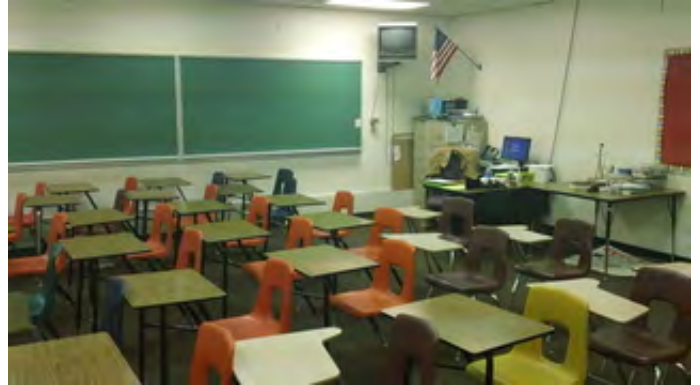
Typical Classroom Loose Furnishings

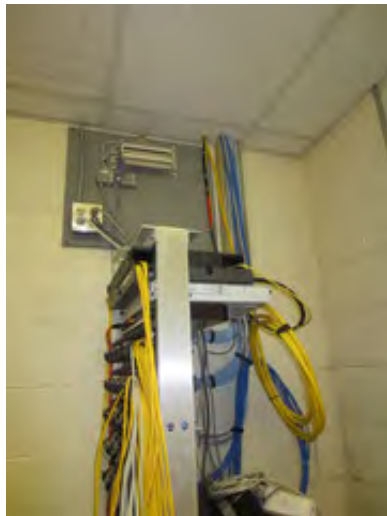
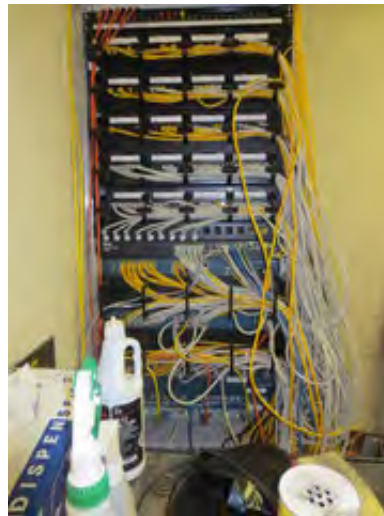
Main Data Distribution Rack
