Broadway Business Cost Analysis

OFCC FacilitiesAssessment - March 2015

Assessment Consultant - Legat and Kingscott Architects

Building Information - Tipp City Exempted Village (45617) - Broadway Elementary

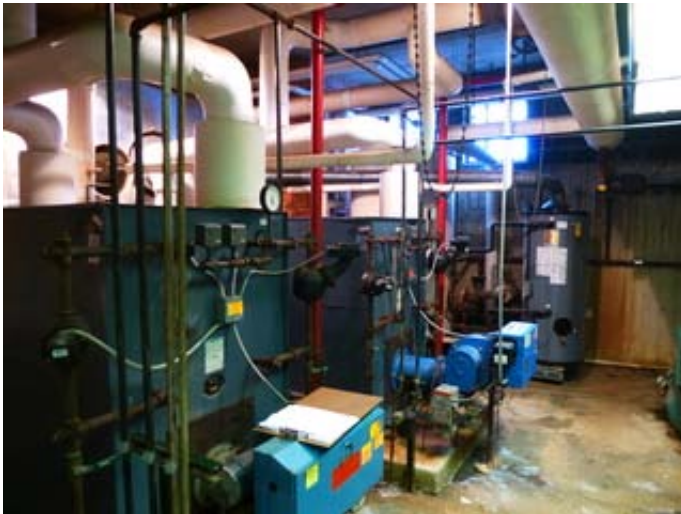
The existing system for the overall facility is a gas fired steam boiler, installed in 1951 and 1995, and is in fair condition. The boiler plant, which services Broadway Elementary School, is located in a separate Maintenance Building behind the school, and tunnels related to this system are located beneath the shared parking lot between Broadway Elementary School and the Tipp City (TC) Enrichment Program Building. The Maintenance Building structure was not assessed during the Physical Assessment. 2-pipe vs. 4-pipe designations are not applicable in this facility, as no central air conditioning is provided. The two gas-fired steam boilers, manufactured by Weil McLain, were installed in 1995 and are in fair condition, and one gas fired boiler (used only as backup), manufactured by Kewanee, was installed in 1951 and is in poor condition. Steam is distributed to terminal units consisting of unit ventilators, cabinet heaters, unit heaters and fin tubes. The terminal equipment was installed in 1951 and 1967 and is in fair condition. The system does comply with the 15 CFM per person fresh air requirements of the Ohio Building Code mechanical code and Ohio School Design Manual. The pneumatic type system temperature controls were installed in 1951 and 1967 and are in fair condition. The system does feature individual temperature controls in all spaces required by the OSDM. The overall system does not feature any central energy recovery systems. The facility is equipped with a moderate quantity of louvered interior doors to facilitate Corridor utilization as return air plenums. (Louvered doors are replaced in Item J - General Finishes and Item O - Handicapped Access, if applicable.) The existing system is not ducted, and floor to structural deck heights will not accommodate the installation of properly sized ductwork for a future Ohio School Design Manual approved system. The overall heating system is evaluated as being in safe but inefficient working order, and long term life expectancy of the existing system is not anticipated. The structure is not equipped with central air conditioning. The site does not contain underground fuel tanks.

Existing Steam Boilers

Provide new overall heating, ventilating, and air conditioning system to achieve compliance with Ohio Building Code and Ohio School Design Manual standards. Convert to a ducted system to facilitate efficient exchange of conditioned air. Provide new DDC type temperature controls to meet Ohio Building Code and Ohio School Design Manual standards. Provide architectural soffits to accommodate the installation of ductwork. Refer to Item T - Hazardous Material, for information regarding the abatement of boiler system hazardous materials in the Maintenance Building.

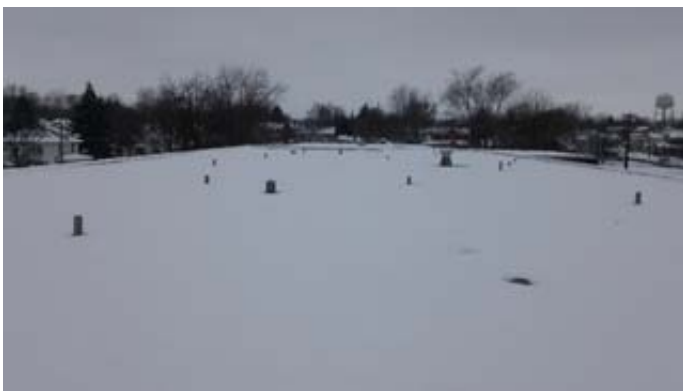
Description: The roofing system of the overall facility is a built-up asphalt roof membrane, was replaced from 1992-1993, and is in poor condition. There are District reports of current leaking. Signs of past leaking were observed during the physical assessment. Access to the roof was gained by an access door in poor condition. Fall safety protection cages are not required, and are not provided. There were no observations of standing water on the roof. Metal cap flashings with built-up asphalt roof membrane adhered up and over the metal cap flashings are in poor condition. Roof storm drainage is addressed through a system of roof drains, which are improperly located, and in good condition. The roof is not equipped with overflow roof drains, though they are needed on this building. All roof penetrations are in poor condition and should be replaced.

1951 Original Construction Roof

Recommendations: The roofing system over the overall facility requires replacement to meet Ohio School Design Manual guidelines for age of system and due to condition. Remove all existing roof insulation. Provide a minimum of 4" new polyiso rigid roof insulation over the overall facility. The flashings and copings for the overall facility require replacement due to condition. Due to existing conditions, additional roof drains are required as well as emergency overflow drains. Replace the existing roof access door. Costs associated with this replacement will be included in the scope for exterior door replacement in Item S - Exterior Doors. Provide new roof access ladders. Remove all existing roof membrane, insulation, metal copings, and metal soffit systems at the small one-story appendage to the 1951 Original Construction. Replace with a new roofing system, minimum 4" new polyiso roof insulation, metal soffit, and metal copings. Remove all existing roof membrane, insulation, metal copings, and metal soffit systems at the roof overhang at the rear entry of the 1967 Addition. Replace with a new roofing system, minimum 4" new polyiso roof insulation, metal soffit, and metal copings. Due to the deteriorating concrete overhang, provide wood blocking to secure new metal copings and transitions.

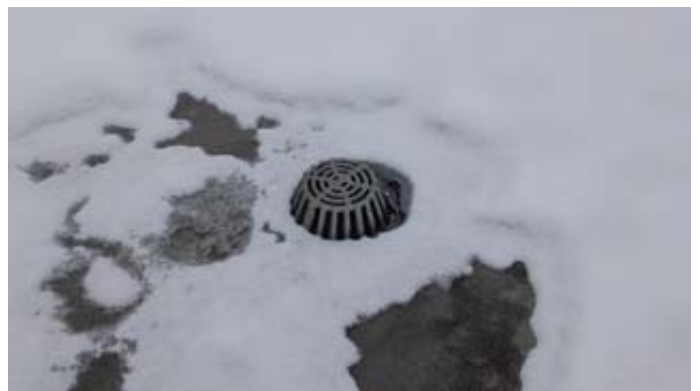
Typical Roof Drain

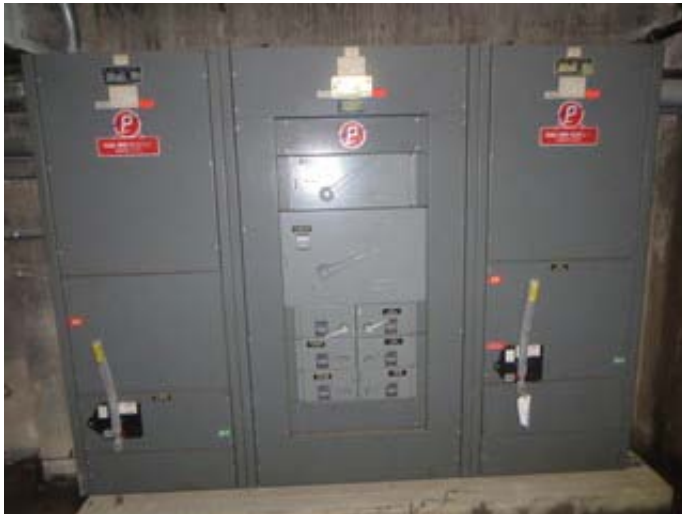
Description: The electrical system provided to the 1951 Original Construction is a 120/208V, 800A, 3 phase and 4 wire system replaced in 1986, and is in good condition, located in the Mechanical Systems Building adjacent to the school. This electric service also serves the electrical distribution in the Tippecanoe Central (TC) Enrichment Program Building. The electrical system provided to the 1967 Addition is a 120/208V, 400A, 3 phase and 4 wire system replaced in 2001, and is in good condition. The system in the 1967 Addition is a separate metered electrical service. Power is provided to the school by two district owned, pad-mounted transformers located outside the building and in good condition. The panel system, installed in the 1951 Original Construction, is in poor condition, and cannot be expanded to add additional capacity. The panel system, installed in the 1967 Addition, is in poor condition, and cannot be expanded to add additional capacity. The Classrooms are not equipped with adequate electrical outlets. The typical Classroom contains 5 general purpose outlets, 3 dedicated outlets for each Classroom computer, and 0 dedicated outlets for each Classroom television. Some Classrooms are equipped with as many as 5 general purpose outlets, while others are equipped with as few as 3 general purpose outlets. There are not any spaces that have no electrical outlets. The Corridors are equipped with adequate electrical outlets for servicing. Adequate GFI protected exterior outlets are not provided around the perimeter of the building. The facility is not equipped with an emergency generator. Adequate lightning protection safeguards are not provided. Stage lighting power system including control panel, breakers, and dimmers is not provided and does not meet OSDM requirements. The overall electrical system does not meet Ohio School Design Manual requirements in supporting the current needs of the school, and will be inadequate to meet the facility's future needs.

Main Electric Distribution

Recommendations: The entire electrical system requires replacement to meet Ohio School Design Manual guidelines for overall capacity, due to condition and age, and lack of OSDM-required features.

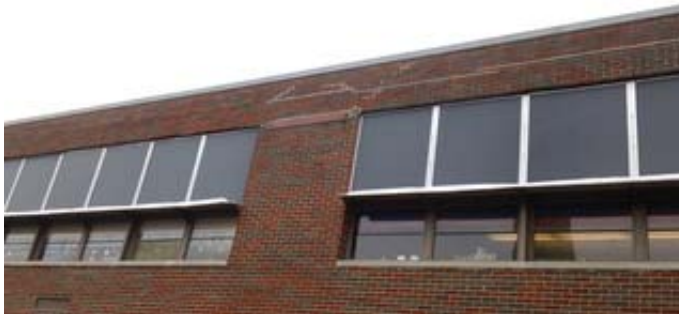
Description: The overall facility is equipped with aluminum windows with single glazed type window system, and are in poor condition. The window system features operable windows throughout the building, and operable windows are equipped with opening limiters in poor condition. No insect screens are present. Window system seals are in poor condition, with moderate air and water infiltration being experienced. Window system hardware is in poor condition. The window system features no blinds. This facility is not equipped with any curtain wall systems. This facility does not feature any glass block windows. The window system does feature painted steel sunshades in the rear of the building, which are in poor condition. The exterior doors in the overall facility are aluminum and steel with sidelights and transoms with single pane glazing, in poor condition. Exterior door vision panels are also single pane. The school does not contain skylights. The school does not contain clerestories. Interior glass is not OSDM-compliant due to not being safety glazing. Window security grilles are not provided for ground floor windows. There is not a Greenhouse associated with this school.

1951 Original Construction Windows

Recommendations: Provide a new insulated window system with integral blinds to meet with Ohio School Design Manual requirements. Costs associated with the replacement of window transoms and sidelights at exterior doors of the overall facility are included within the replacement of the exterior storefront systems. Replace transoms over interior doors and all other non-compliant interior glazing with 1/4" tempered glass. Exterior door vision panel replacement is addressed in the replacement of exterior doors in Item S - Exterior Doors. Scrape/sand sunshades and repaint.

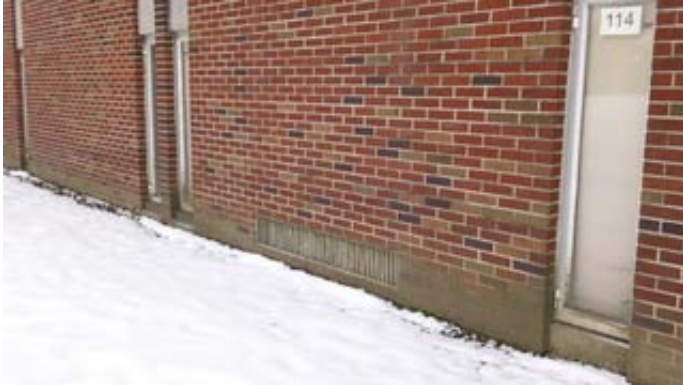
Description: The overall facility is equipped with concrete foundation walls on concrete spread footings, which displayed no locations of significant differential settlement, cracking, or leaking, and are in good condition. Areas of minor cracking and spalling were observed through the 1951 Original Construction. The District reports that there has been no past leaking. No grading or site drainage deficiencies were noted around the perimeter of the structure that are contributing or could contribute to foundation / wall structural deterioration.

Masonry Foundation

Recommendations: Repair areas of cracking and spalling where present in the 1951 Original Construction.

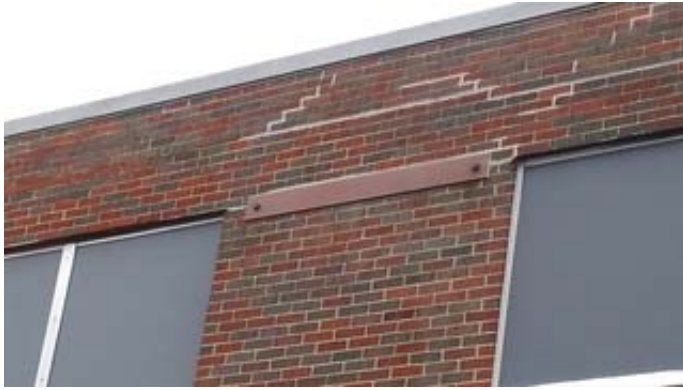
There is a structural issue along the north side exterior wall and south side exterior wall of the academic wing of the 1951 Original Construction. The walls are connected to each other via steel bracing to secure in place.

1951 Original Construction Classroom Wing Wall Bracing

Recommendations: Provide tuckpointing in all areas of mortar deterioration as required through the overall facility. Provide masonry cleaning and sealing through the overall facility. Sawcut and caulk new appropriately spaced control joints in existing masonry through the overall facility. Prep and paint exposed steel lintels through the overall facility. Exterior wall insulation deficiencies are addressed in Item J - General Finishes. Provide brick, insulation and CMU back up infill at locations where unit ventilator louvers are being removed. Removal and reconstruction of the exterior walls that are currently being braced together is necessary. Overall extent of replacement should be determined by a structural engineer. Interior and exterior soffits need to be repainted. The associated cost of repainting exterior soffits can be found below. The associated cost of repainting interior soffits is included in Item J - General Finishes, under the full replacement of finishes and casework.

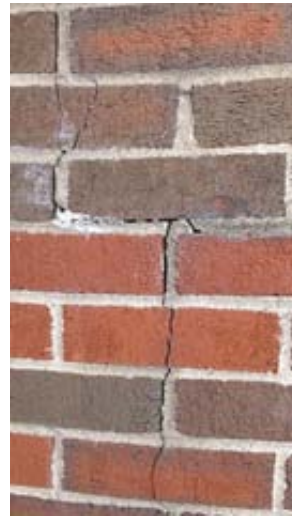
Description: The overall facility features a brick veneer on load bearing masonry wall system, which displayed locations of deterioration, and is in fair condition. The exterior masonry appears to have no control joints. Control joints are not provided at lintel locations, at doors and windows, building corners, and wall offsets. The school does not contain expansion joints. There is indication of exterior masonry cracking and separation, and it has been recommended that control joints be added throughout the facility to mediate this movement. Exterior walls in the overall facility are inadequately insulated. Brick veneer masonry walls are not cavity walls. Weep holes and vents are not provided or required. The exterior masonry has not been cleaned and sealed in recent years, and shows evidence of mortar deterioration. Architectural exterior accent materials consist of concrete panels and sills, which are in fair condition. The exterior walls contain openings and louvers for the unit ventilators within the building. With the addition of a new HVAC system, these unit ventilators will be removed. Therefore, the openings for these unit ventilators will need to be filled in with materials matching adjacent materials. The Facilities Director informed us that a portion of the 1951 Original Construction (Classroom wing) has been reinforced from front to back of the building above the second floor ceiling because the walls are moving away from the building. This will need structural engineering investigation and possible complete replacement. Interior wall construction consists of concrete masonry units, glazed block, or masonry framed partitions with plaster. Each construction type is in fair condition. Interior masonry walls appear to have no control joints. Interior soffits are of plaster type construction, and are in fair condition. The window sills are marble, glazed block, or painted steel, and are in good condition. The exterior lintels are precast steel members that are rusting and in fair condition. Chimneys are in good condition. Canopies over entrances are concrete type construction, and are in fair condition. Exterior soffits are of plaster type construction, and are in fair condition. The school is not equipped with a loading dock.

Cracking due to Insufficient Control Joints

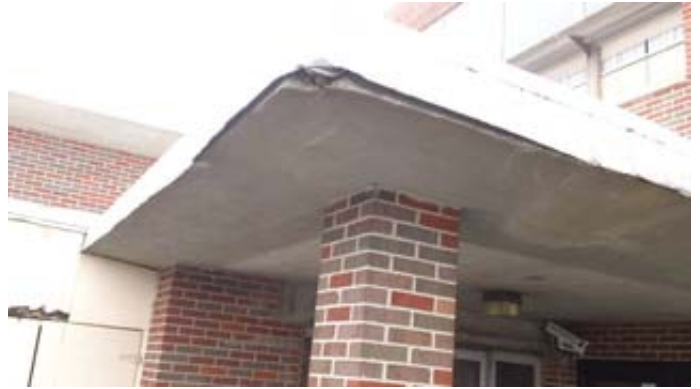
Concrete Overhang at North Entry

Other: Repair Concrete Overhang	\$3,000.00	lump sum		Required		\$3,000.00	Repair the concrete overhang at the North Entrance in the 1951 Original Construction.
Other: Replace Flashing and Counterflashing	\$30.00	ln.ft.		390 Required		\$11,700.00	Remove and replace all through wall flashing and counterflashing at roof/vertical wall transition points.
Sum:			\$1,400,999.60	\$946,600.00	\$454,399.60

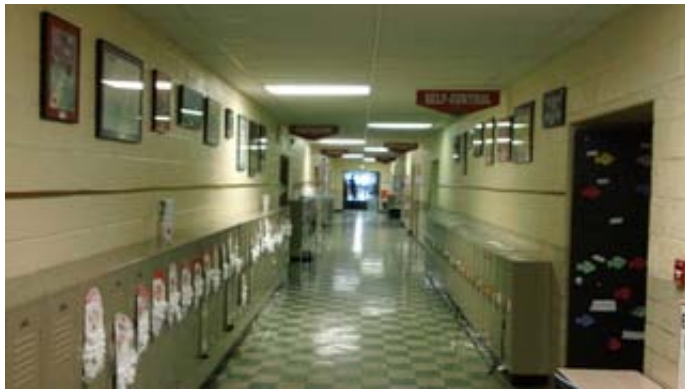
Description: The overall facility features conventionally partitioned Classrooms with carpet over VAT type flooring, acoustical lay in type ceilings, as well as CMU type wall finishes, and they are in poor condition. The overall facility has Corridors with VAT type flooring, acoustical lay in type ceilings, as well as CMU and glazed concrete masonry units type wall finishes, and they are in poor condition. The overall facility has Restrooms with quarry tile type flooring, acoustical lay in type ceilings, as well as glazed concrete masonry units type wall finishes, and they are in fair condition. Toilet partitions are metal, and are in poor condition. Classroom casework in the overall facility is wood type construction with plastic laminate tops, is inadequately provided, and in poor condition. Casework provided in a typical Classroom ranges from 12 to 34 feet. Classrooms are not provided adequate chalkboards, markerboards, and tackboards, which are in poor condition. Lockers located in the Corridors are adequately provided, and are in poor condition. The Art program is equipped with a kiln in fair condition. The facility is equipped with wood louvered and non-louvered interior doors. Interior Classroom doors of the 1951 Original Construction are primarily recessed, without proper ADA hardware or clearances, and in poor condition. Interior Classroom doors of the 1967 Addition are primarily flush mounted, without proper ADA hardware or clearances, and in poor condition. The facility features two Gymnasium spaces. The Gymnasium located in the 1951 Original Construction has rubberized "Tartan" type flooring, hard plaster type ceilings, as well as CMU type wall finishes, and they are in poor condition. There are no bleachers, but fixed concrete stands are provided, which feature wooden seats in poor condition. Gymnasium basketball backboards are fixed type, and are in fair condition. The Auxiliary Gymnasium located in the 1967 Addition has rubberized "Tartan" type flooring, hard plaster type ceilings, as well as CMU type wall finishes, and they are in poor condition. Gymnasium basketball backboards are both fixed and manually operated type, and are in fair condition. The Media Center, located in the 1951 Original Construction, has carpet type flooring, acoustical lay in type ceilings, as well as CMU type wall finishes, and they are in poor condition. The Student Dining area, located in the 1967 Addition, has VAT type flooring, hard plaster type ceilings, as well as masonry and plaster type wall finishes, and they are in poor condition. OSDM-required fixed equipment for the Stage areas is inadequately provided, and in fair condition. Existing Gymnasium, Auxiliary Gymnasium, Student Dining, Media Center, and Music spaces (Stage areas of the 1951 Gymnasium and the 1967 Auxiliary Gymnasium) are not provided with appropriate sound attenuation acoustical surface treatments. The existing Kitchen is full service, is undersized based on current enrollment, and the existing Kitchen equipment, installed in 1951, is in fair condition. The Kitchen hood is in poor condition, and is not equipped with the required UL 300 compliant wet chemical fire suppression system. The required 6" overhang on all three exposed sides of the cooking equipment is not provided by the hood. Kitchen hood exhaust ductwork is not of proper construction, material, insulation, or installed as required by the OSDM and OBCMC. A walk-in cooler and freezer are located within the Kitchen spaces, and are in poor condition.

Typical Corridor Finishes

Recommendations: Provide complete replacement of finishes and casework due to installation of systems outlined in Items (A / C / D / E / I / K / L / M / N / T / U / W). Funding for replacement of interior doors is provided in Item O - Handicapped Access, including doors here noted as being in poor condition. Replace toilet partitions as required throughout the overall facility, due to condition. Replace the Toilet Room accessories throughout the overall facility, due to condition. Replace all Kitchen equipment and the Kitchen hood due to age and condition. Replace the kiln for the Art program due to condition. Replace synthetic gymnasium flooring in both Gymnasiums. Refer to Item T - Hazardous Material, for further information regarding synthetic Gymnasium flooring. Replace basketball backboards due to condition. Fur out interior walls with metals studs and add insulation and abuse resistant GWB. Replace original wood seats in the 1951 Gymnasium with new seating. Provide sound attenuation acoustical surface treatments in the Primary Gymnasium, Auxiliary Gymnasium, Student Dining Area, Media Center, and Music spaces (Stage areas of the 1951 Gymnasium or the 1967 Auxiliary Gymnasium). In order to comply with OSDM required fixed Stage equipment, provide a projection screen for the 1951 Gymnasium Stage area and stair railings for the 1967 Auxiliary Gymnasium Stage area. Costs associated with the addition of Stage railings are provided in Item U - Life Safety. Replacement costs have also been provided in the table below in coordination with the abatement of materials in Item T - Hazardous Material.

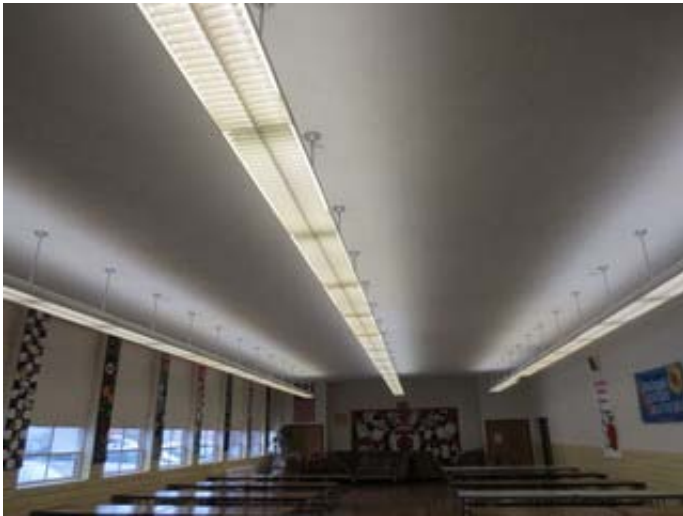
Student Dining Lighting Fixtures

Recommendations: Provide complete replacement of the lighting system due to condition, lighting levels, utilization of T-12 fixtures, and the lack of multilevel switching.

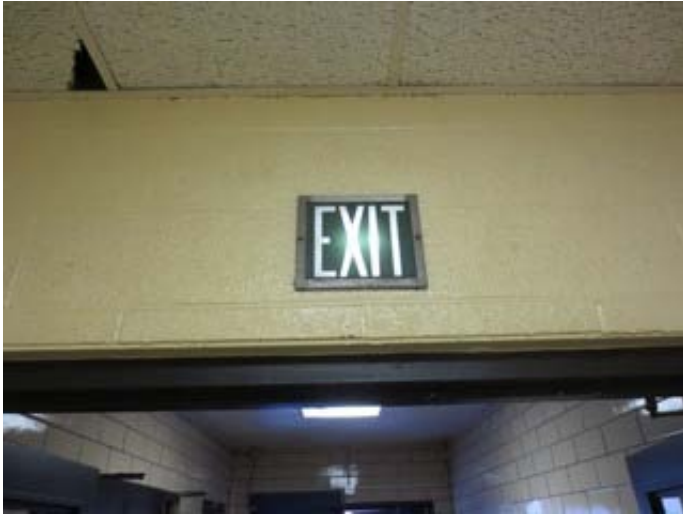
Incandescent Exit Sign

Recommendations: Provide complete replacement of new emergency / egress lighting system to meet Ohio School Design Manual and Ohio Building Code guidelines.

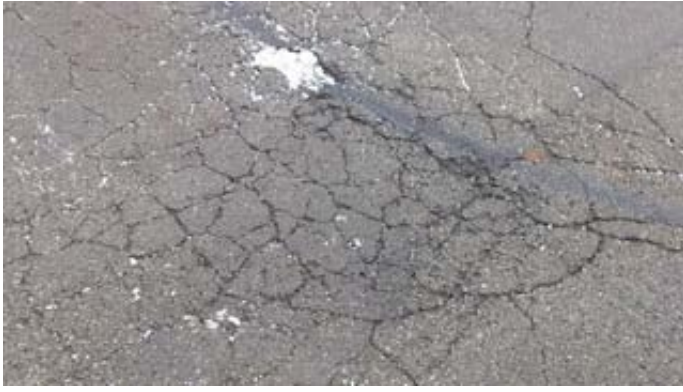
Cracking Asphalt

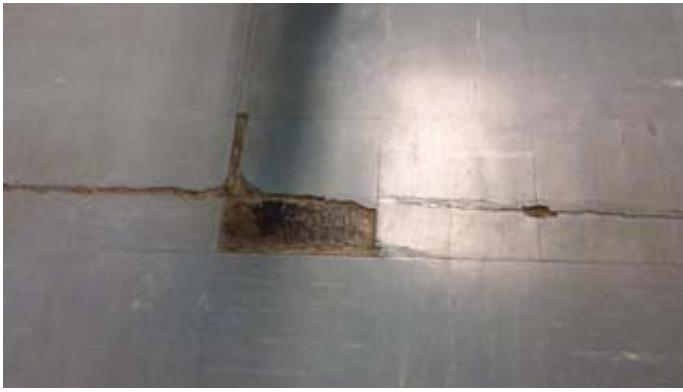
ACT Floor Tile
