## LT Ball Business Cost Analysis

OFCC Facilities Assessment - March 2015

Assessment Consultant - Legat and Kingscott Architects

**Building Information - Tipp City Exempted Village (45617) - L.T. Ball Intermediate**

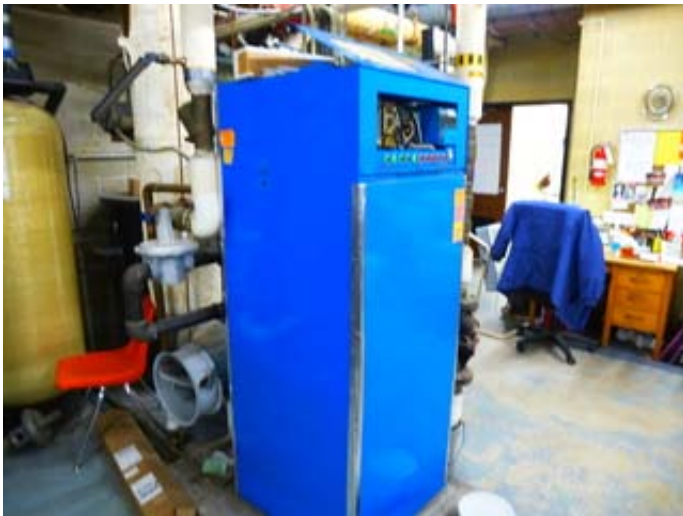
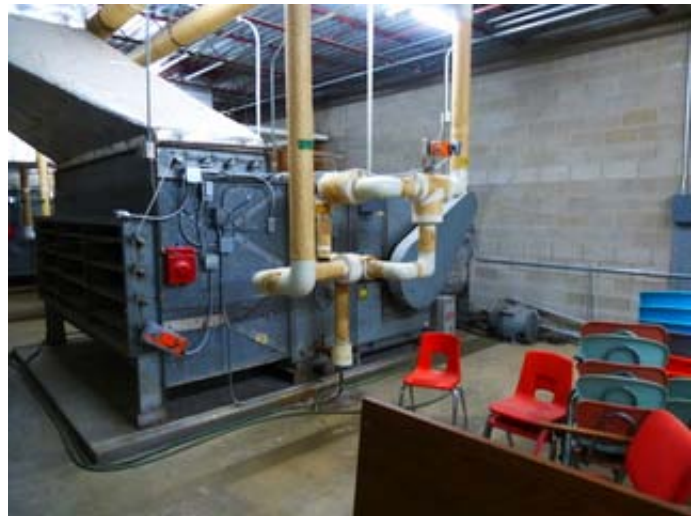
**Description:** The existing system for the overall facility is a gas fired boiler with heating water circulation pumps, installed in 1990, and is in fair condition. The heating and chilled water system in the overall facility is a 2-pipe system, without a capacity for simultaneous heating and cooling operation, which is not compliant with the OSDM requirements for basic system type. The one gas fired boiler, manufactured by Paterson Kelly, was installed in 1990 and is in fair condition. Heating water is distributed to terminal units consisting of variable volume boxes (with back-up electric reheat), cabinet heaters, unit heaters and air handlers. The terminal equipment was installed in 1990 and is in fair condition. The system does not comply with the 15 CFM per person fresh air requirements of the Ohio Building Code mechanical code and Ohio School Design Manual. The Direct Digital Controls type system temperature controls were installed in 2012 and are in good condition. The system does not feature individual temperature controls in all spaces required by the OSDM. The overall system does not feature any central energy recovery systems. The facility is not equipped with louvered interior doors to facilitate Corridor utilization as return air plenums. The existing system is ducted, but the ductwork cannot be integrated into a possible future system due to arrangement, air volume, and routing of existing ductwork. The overall heating system is evaluated as being in safe but inefficient working order, and long term life expectancy of the existing system is anticipated. The structure is equipped with central air conditioning. The site does not contain underground fuel tanks.

**Rating:** 3 Needs Replacement

Existing Boiler

Existing Air Handler

**Recommendations:** Provide new overall heating, ventilating, and air conditioning system to achieve compliance with Ohio Building Code and Ohio School Design Manual standards. Replace existing ductwork to facilitate efficient exchange of conditioned air. Modify existing DDC type temperature controls to meet Ohio Building Code and Ohio School Design Manual standards.

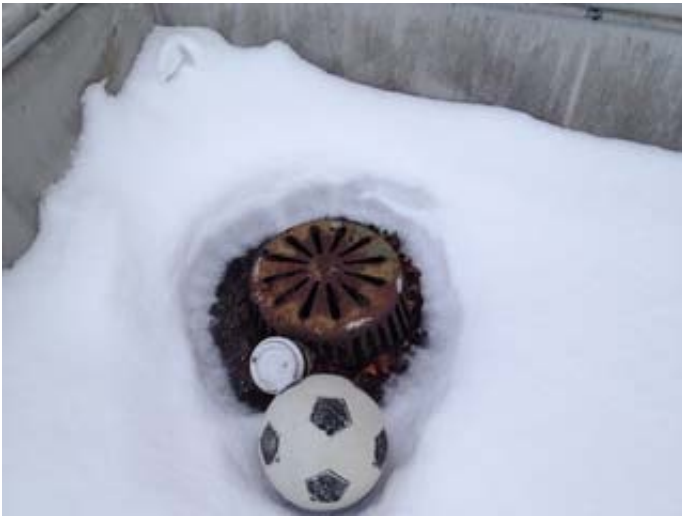
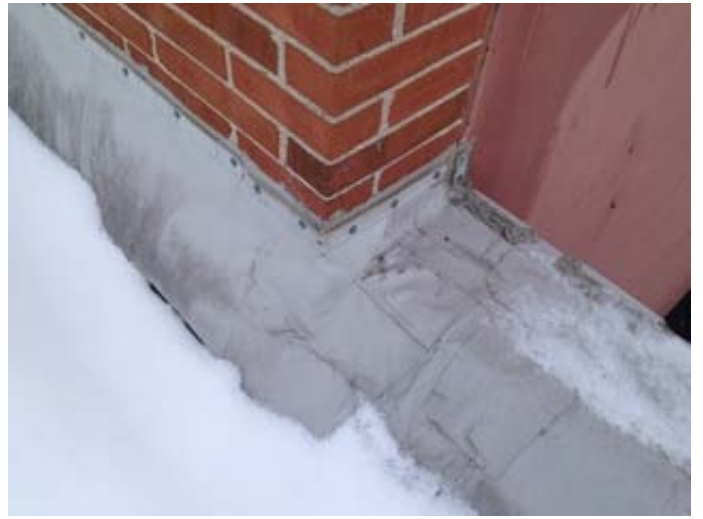
**Description:** The roof over the overall facility is a membrane roofing system. Replacement of this system is being phased and began in 2010. Two-thirds of the roof has been replaced to date, and efforts to complete the final one-third of the roof replacement are projected through 2015. Each entrance features a mansard roof canopy structure with asphalt shingles in fair condition. This system does not feature any gutter or downspout systems. There are no District reports of current leaking. Signs of past leaking were observed on acoustic ceiling tiles throughout the facility during the physical assessment. Access to the primary roof level is gained by an access ladder and access door, which are in poor condition. Access to higher roof levels is gained by access ladders from the primary roof level, which are also in poor condition. Fall safety protection cages are not required and have not been provided. There were no observations of standing water on the roof. Due to the recent replacement of two-thirds of the roofing system and its overall fair condition, the following descriptions refer solely to the remaining one-third of the roofing. Stone coping is in fair condition but will require replacement due to the installation of the new membrane system. Roof storm drainage is addressed through a system of roof drains, which are improperly located, and in poor condition. The roof is not equipped with overflow roof drains, though they are needed on this building. Roof penetrations of the final one-third of the roofing system are in poor condition and should be replaced. Although only one-third roofing replacement is recommended below due to previous roofing replacements, replacement of the other two-thirds is dependent upon the quality of the material and installation at the time of renovation. If this two-thirds square footage of roofing requires replacement at that time, the District will have to consult existing roof warranties if applicable.

**Rating:** 3 Needs Replacement

Typical Roof Vent Condition

Membrane Roof Condition

**Recommendations:** As is stated in the above description, replacement of the roofing system has been an ongoing initiative since 2010. Due to the complete replacement of two-thirds of the roof, it will be recommended below that the final third be replaced and that associated roofing features, such as cap flashing and coping, roof insulation, roof drains, and overflow drains, be coordinated with this recommendation. Based on the square footage of the northwest roof, two additional drains will be required to meet Plumbing Code. Mansard roof assemblies over primary entrances require shingle replacement due to age and condition. Provide gutters and downspouts for mansard roof assemblies to allow for proper drainage and to prevent the formation of hanging ice over entrance walkways (as was documented during the physical assessment). Replace existing roof access ladders due to poor condition, with new ladders compliant with current OSHA standards. Replace the existing roof access ships ladder from the Mezzanine level, compliant with current OSHA standards. Funding for the replacement of the roof access door is included in Item S - Exterior Doors.

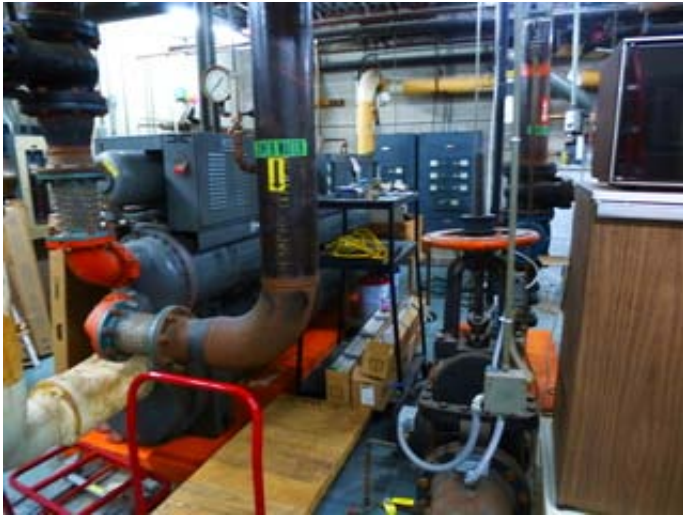
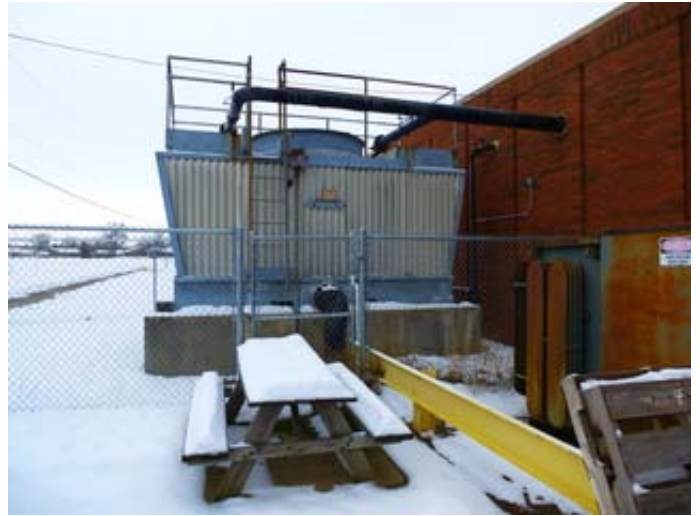
**Description:** The overall facility is equipped with a water cooled chiller, which is in fair condition. The ventilation system in the overall facility consists of five air handlers, installed in 1974 and in fair condition, providing fresh air to Classrooms, and air handlers, installed in 1974 and in fair condition, providing fresh air to other miscellaneous spaces such as the Gymnasium, Student Dining and Media Center. A separate packaged split system, installed in 1990, in fair condition, provides air to the Office spaces. Relief air venting is provided by ceiling plenums being ducted back through central relief fans. The ventilation system does not meet the Ohio Building Code 15 CFM per occupant fresh air requirement. The overall system is not compliant with Ohio Building Code and Ohio School Design Manual requirements. Dust collection systems are not required in this facility, and no system is provided. The Art program is equipped with a kiln, and existing kiln ventilation is adequate, and in good condition. General building exhaust systems for Restrooms, Storage Rooms and Custodial Closets are adequately placed, and in fair condition.

Existing Chiller

Existing Cooling Tower

**Recommendations:** Provide an air conditioning system to meet with Ohio Building Code and Ohio School Design Manual requirements. Pricing is included in Item A - Heating System. Replace general building exhaust systems located in Restrooms, Storage Rooms and Custodial Closets.

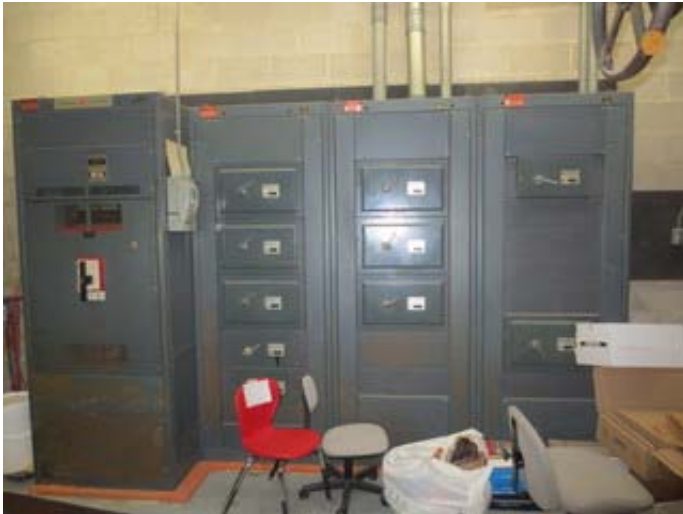
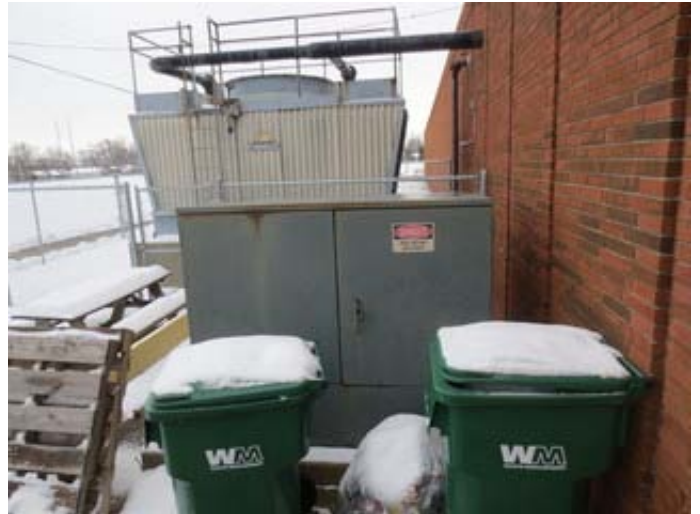
**Description:** The electrical system provided to the overall facility is a 277/480 volt, 2000 amp, 3 phase and 4 wire system installed in 1974, and is in fair condition. Power is provided to the school by a single district owned, pad-mounted transformer located outside of building, which is in good condition. The panel system, installed in 1974, is in fair condition, and cannot be expanded to add additional capacity. The Classrooms are not equipped with adequate electrical outlets. The typical Classroom contains 4 general purpose outlets, 0 dedicated outlets for each Classroom computer, and 0 dedicated outlets for each Classroom television. Some Classrooms are equipped with as many as 5 general purpose outlets, while others are equipped with as few as 2 general purpose outlets. There are not any spaces that have no electrical outlets. The Corridors are equipped with adequate electrical outlets for servicing. Adequate GFI protected exterior outlets are not provided around the perimeter of the building. The facility is not equipped with an emergency generator (Refer to item U for specific emergency generator information). Adequate lightning protection safeguards are not provided. Stage lighting power system including control panel, breakers, and dimmers is inadequately provided, in poor condition and does not meet OSDM requirements. The overall electrical system does not meet Ohio School Design Manual requirements in supporting the current needs of the school, and will be inadequate to meet the facility's future needs.

**Rating:** 3 Needs Replacement

Main Electrical Gear

District Owned Transformer

**Recommendations:** The entire electrical system requires replacement to meet Ohio School Design Manual guidelines Classroom capacity, due to condition, age, and a lack of OSDM-required features.

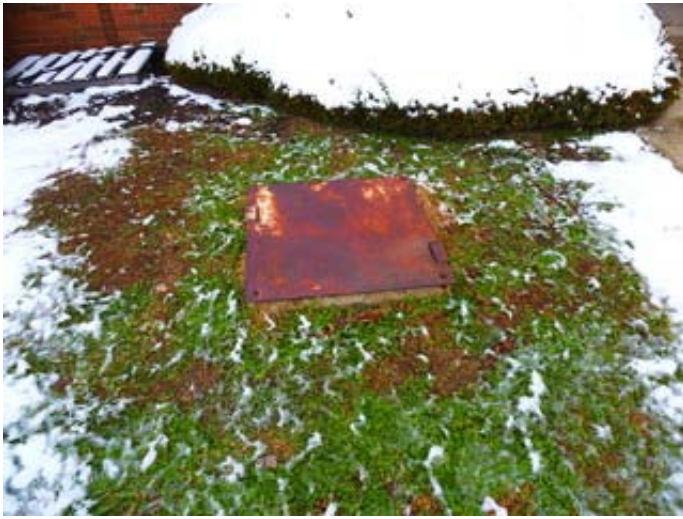
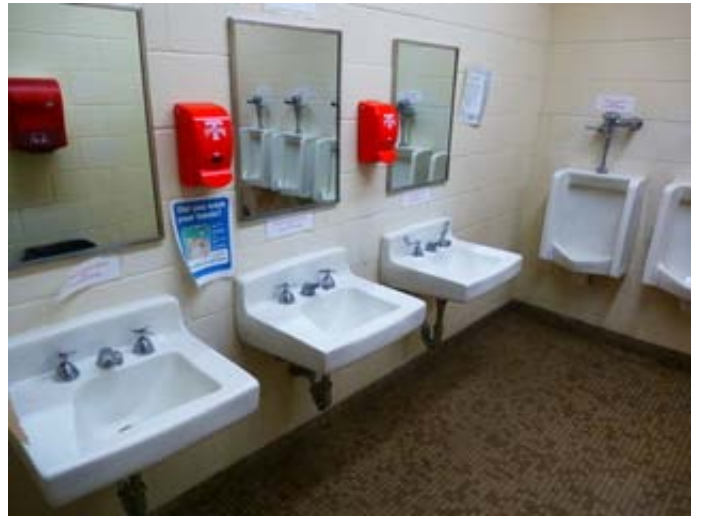
**Description:** The service entrance is not equipped with a reduced pressure back flow preventer. A water treatment system is not provided. The domestic water supply piping in the overall facility is copper, was installed in 1974, and is in fair condition. The waste piping in the overall facility is cast iron, was installed in 1974, and is in fair condition. The facility is equipped with 1 gas water heater in good condition, with 1 separate 115 gallon storage tank in good condition. The school contains 3 Large Group Restrooms for boys, 3 Large Group Restrooms for girls, 1 Locker Room Restroom for boys (currently used as the Special Education Classroom), 1 Locker Room Restroom for girls, 2 Restrooms associated with specialty Classrooms, and 4 Restrooms for staff. Boys' Large Group Restrooms contain 0 ADA and 5 non-ADA wall mounted flush valve toilets, 0 ADA and 12 non-ADA wall mounted flush valve urinals, as well as 0 ADA and 8 non-ADA wall mounted lavatories. Girls' Large Group Restrooms contain 0 ADA and 13 non-ADA wall mounted flush valve toilets, as well as 0 ADA and 8 non-ADA wall mounted lavatories. The Special Education Classroom Restroom contains 0 ADA and 1 non-ADA wall mounted flush valve toilet, 0 ADA and 1 non-ADA wall mounted lavatory, as well as 4 non-ADA showers. The Girls' Locker Room Restroom contains 0 ADA and 2 non-ADA wall mounted flush valve toilets, as well as 0 ADA and 1 non-ADA wall mounted lavatory, as well as 0 ADA and 4 non-ADA showers. Staff Restrooms contain 0 ADA and 6 non-ADA wall mounted flush valve toilets, 0 ADA and 2 non-ADA wall mounted urinals, 0 ADA and 3 non-ADA wall mounted lavatories, as well as 0 ADA and 3 non-ADA countertop lavatories. Condition of fixtures is good. The facility is equipped with 0 ADA and 8 non-ADA electric water coolers, in good condition. The Elementary Classrooms are not equipped with ADA sink mounted type drinking fountains. The Special Education Classroom is equipped with the required Restroom facilities and fixtures are in good condition. Kitchen is equipped with the required Restroom, and fixtures are in good condition. Health Clinic is equipped with the required Restroom, and fixtures are in good condition. Due to existing grade configuration, Kindergarten / Pre-K Classroom Restroom considerations are not relevant. Kitchen fixtures consist of 1 single compartment sink, 1 dishwasher and 1 disposal, which are in good condition. The Kitchen is equipped with an unsatisfactory grease interceptor. The Kitchen is provided the required 140 degree hot water supply via a 91 gallon gas fired type water heater, with a 115 gallon storage tank, which is in good condition. The school does not meet the OBC requirements for fixtures. Relative to LEED requirements, the school is not equipped with low flow type fixtures. Per OBC and OSDM requirements this facility should be equipped with 22 toilets, 5 urinals, 16 lavatories, and 7 electric water coolers. Observations revealed that the school is currently equipped with 30 toilets, 15 urinals, 27 lavatories, and 6 electric water coolers. ADA requirements are not met for fixtures and drinking fountains (see Item O). Custodial Closets are properly located and are adequately provided with required service sinks, which are in good condition. Science Classroom / Lab utility sinks, gas connections, compressed air connections, and safety shower / eyewash are not provided, but are not required due to existing grade configuration. Due to existing grade configuration, no Biology or Chemistry Classroom acid waste systems are required. Adequate exterior wall hydrants are not provided.

**Rating:** 3 Needs Replacement

Existing Grease Interceptor

Typical Lavatory and Urinal

**Recommendations:** Based on age, condition, LEED, and OSFC requirements, the facility should be provided with a total of 30 toilets, 15 urinals, 27 lavatories, and 6 electric water coolers. Due to the lack of ADA-compliant Restroom stalls, toilet and urinal fixtures have been removed throughout the facility to create additional space for properly sized stalls. With the removal of fixtures, the new total fixture counts are 22 toilets, 13 urinals, 27 lavatories, and 6 electric water coolers. These fixture totals are coordinated between Item E - Plumbing and Fixtures and Item O - Handicapped Access. Within Item E - Plumbing and Fixtures, provide 7 new toilets, 10 new urinals, 9 new lavatories, 3 new electric water coolers, and 19 new lavatory mounted type drinking fountains. See Item O - Handicapped Access for the remainder of fixture replacements and additions related to ADA requirements. Replace water supply piping in the overall facility with copper piping due to age and condition. Replace sanitary waste piping in the overall facility due to age and condition. Provide reduced pressure back flow preventer. Provide a new grease interceptor due to age and condition. Provide adequate wall hydrants.

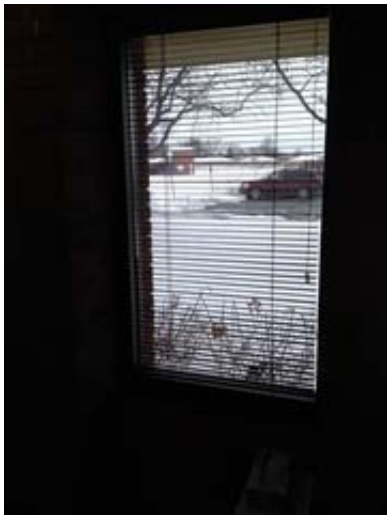
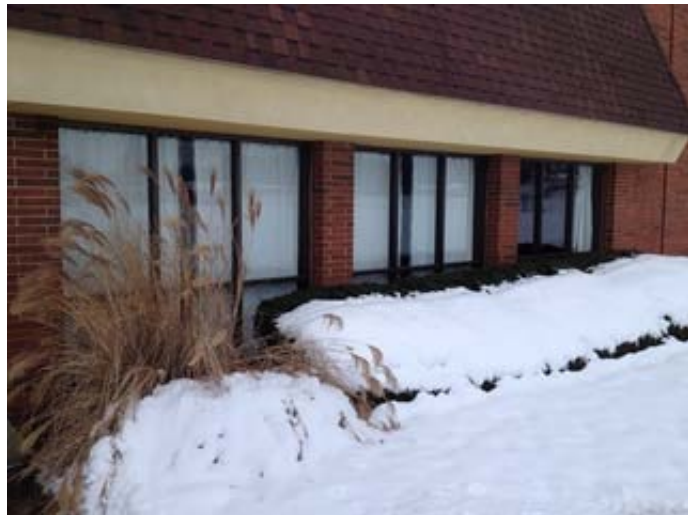
**Description:** The overall facility is equipped with aluminum frame windows with single glazed type window systems, which were installed in 1974, and are in fair condition. The window system features inoperable windows throughout the building. Window system seals are in fair condition, with moderate air and water infiltration being experienced. The window system features surface-mounted blinds and surface-mounted curtains, which are in fair condition. An aluminum storefront type wall system is found in the west half of the facility and is in fair condition. This facility does not feature any glass block windows. The exterior doors in the overall facility are equipped with aluminum frame sidelights and transoms with tempered, single-pane glazing, in fair condition. Exterior door vision panels are tempered, single pane glazing, in fair condition. The school does not contain skylights. The school does not contain clerestories. Interior glass is OSDM-compliant. Window security grilles are not provided for ground floor windows. There is not a Greenhouse associated with this school.

**Rating:** 3 Needs Replacement

Office Casement Window with Surface-Mounted Blinds

Art Room Casement Windows with Surface-Mounted Curtains

**Recommendations:** Provide new insulated window systems with integral blinds to meet with Ohio School Design Manual requirements. Provide additional exterior windows and roof monitors to comply with the OSDM vision and daylighting requirements for Classroom spaces. Replace window transoms and sidelights at exterior doors of the overall facility to meet Ohio School Design Manual requirements. Exterior door vision panel replacement is addressed in the replacement of exterior doors in Item S - Exterior Doors.

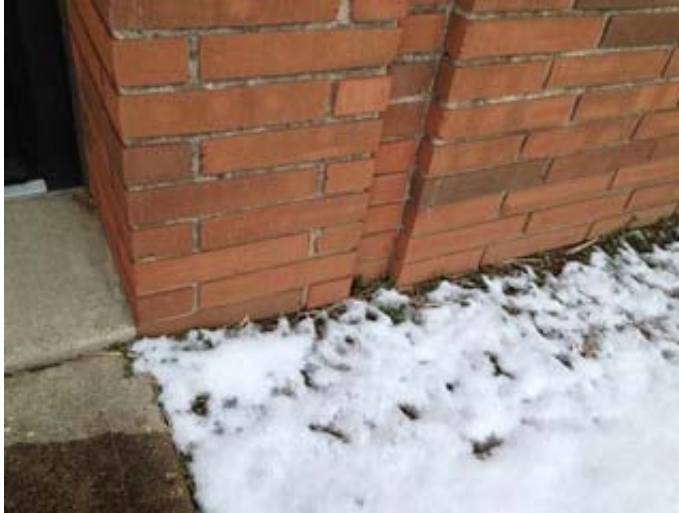
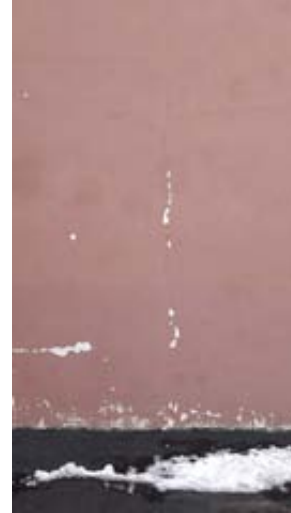
**Description:** The overall facility is equipped with concrete masonry unit foundation walls on concrete footings, which displayed no locations of significant differential settlement, cracking, or leaking, and are in fair condition. No significant issues related to foundation cracking or spalling were encountered. The District reports that there has been no past leaking. No grading or site drainage deficiencies were noted around the perimeter of the structure that are contributing or could contribute to foundation/wall structural deterioration.

Typical Foundation View

West Gym Wall Cement Plaster

**Recommendations:** Existing conditions require no renovation or replacement at the present time.

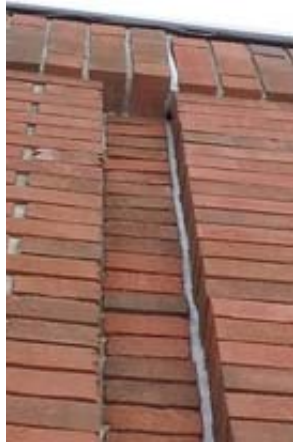
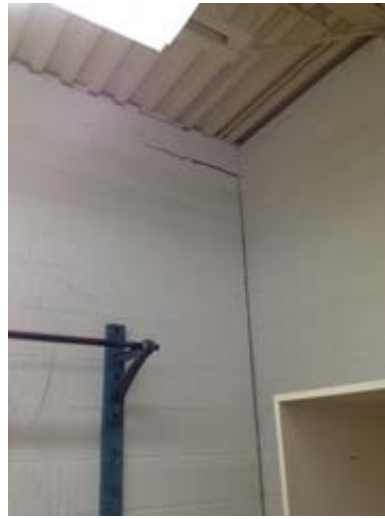
**Description:** The overall facility has a brick veneer on a load bearing masonry wall system, which displayed locations of deterioration, and is in fair condition. The west wall of the Gymnasium is a painted cement plaster finish on a load bearing masonry wall system, and is in poor condition. The exterior masonry appears to have appropriately spaced and inadequately caulked control joints in poor condition. Control joints are provided at lintel locations, at doors and windows, building corners, and wall offsets, and are in poor condition. The facility features expansion joints on the roof level. Interior control joints with cracks due to shrinkage, minor building movement, etc. should be repaired with caulk/sealant. Exterior walls in the overall facility are inadequately insulated. Brick veneer masonry walls are not cavity walls. Weep holes and vents are not provided or required. The exterior masonry has not been cleaned and sealed in recent years, and shows evidence of mortar deterioration and lichen growth in selective locations. Architectural exterior accent materials consist of stone in good condition and painted cement plaster in poor condition. Interior walls in the west half of the building are concrete masonry units in fair condition, and interior walls in the east half are primarily an open concept steel column structure with partition panel walls in fair condition and steel stud and gypsum board assemblies in fair condition. Interior masonry appears to have adequately spaced and caulked control joints in fair condition. Interior soffits are of plaster type construction, and in fair condition. The window sills are stone, and are in good condition. The exterior lintels are precast steel, and are rusting, or are both rusting and sagging, in poor condition. There are no chimneys. Canopies over entrances are wood framing type construction with asphalt shingle finish, and are in fair condition. Exterior soffits are of plaster type construction, and in fair condition. The school is provided with a partially covered conventional Loading Dock to facilitate the receipt of product, supplies, and foodstuffs, 93 SF in size and featuring two standard hollow metal doors, one to the Mechanical Room and one to the Kitchen. The dock itself is in poor condition, and is equipped with two bumper pads in poor condition. Large items can be accommodated through a 10' overhead door on the west face of the facility, but vehicular access is not provided. Also, this storage space has been divided to support a Classroom space and must comply with noise regulation standards, therefore limiting its time of use for maintenance and storage purposes.

**Rating:** 2 Needs Repair

Typical Exterior Control Joint

East Wall of the Multipurpose Room

**Recommendations:** Provide tuckpointing in all areas of mortar deterioration as required through the overall facility. Provide masonry cleaning, sealing, and caulking as required through the overall facility. Recaulk both exterior and interior control joints. Prep and paint exposed steel lintels through the overall facility. Replace sagging steel lintels with new lintels. Exterior wall insulation deficiencies are addressed in Item J - General Finishes. Costs associated with repairs to the Loading Dock area are provided in Item P - Site Condition. Interior and exterior soffits need to be repainted. The associated cost of repainting exterior soffits can be found below. The associated cost of repainting interior soffits is included in Item J - General Finishes, under the full replacement of finishes and casework.

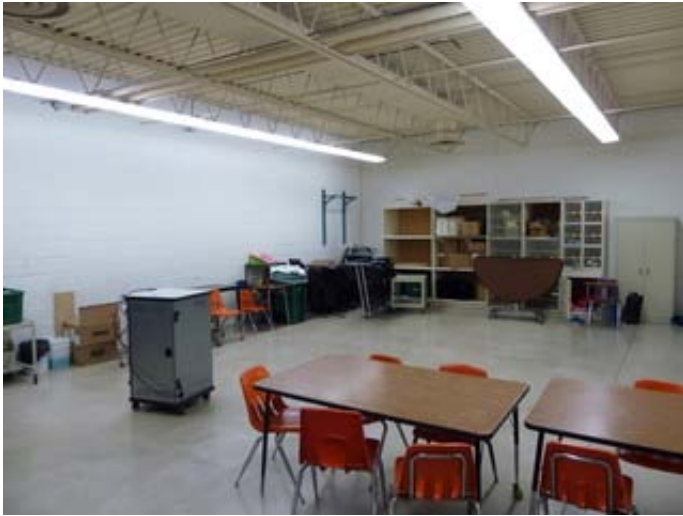
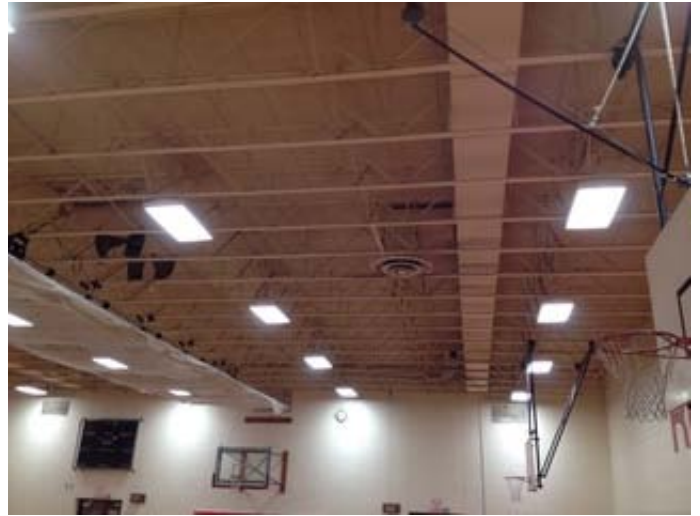
**Description:** The floor construction of the primary level of the facility is a poured-in-place concrete slab on grade, and is in fair condition. There is no crawl space. The floor construction of the Mezzanine level is precast concrete planks with concrete topping bearing on structural steel and masonry type construction, and is in good condition. Ceiling to structural deck spaces are sufficient to accommodate HVAC, electrical, and plumbing scopes of work in required renovations. The roof construction of the overall facility consists of two assemblies; metal deck on open web steel joists in good condition and Tectum deck on open web steel joists in fair condition.

**Rating:** 2 Needs Repair

Metal Roof Deck on Open Web Steel Joists

Tectum Deck on Open Web Steel Joists

**Recommendations:** Repair exposed cracked concrete floor slab. Funding for refinishing this water stained tectum panel is accounted for in Item J - General Finishes.

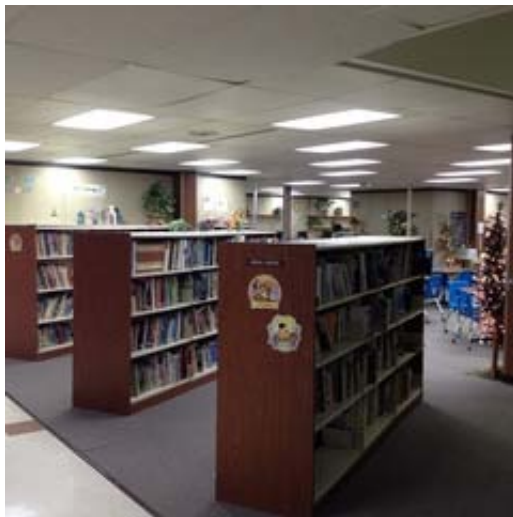
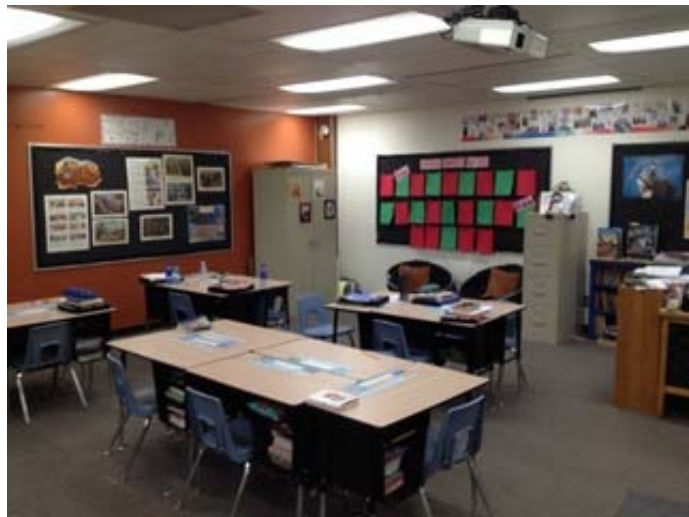
**Rating:** 3 Needs Replacement

Media Center Typical Finishes

Typical Classroom Finishes

**Recommendations:** Provide complete replacement of finishes and casework due to condition and installation of systems outlined in Items A, C, D, E, I, K, L, M, N, T, U, W. Funding for replacement of interior doors is provided in Item O - Handicapped Access. Provide for the replacement of outdated and/or damaged Kitchen equipment. Replace the Kitchen hood due to the lack of appropriate 6" overhangs on all three exposed sides of the cooking equipment. The Ohio Department of Health advises that synthetic polymer type floors be analyzed by an environmental contractor for potential mercury levels in the flooring system. If hazardous levels of mercury are detected, the floor material should be removed and replaced with an alternative material. Cost to replace this floor will occur in section T - Hazardous Materials. Paint any visible moisture marks on the Tectum deck. Refinish the exterior cement plaster wall of the Gymnasium. Cost associated with the addition of Stage railings is provided in Item U - Life Safety. Provide for the replacement of sound attenuation in the Music Room due to condition. Replacement costs have also been provided in the table below in coordination with the abatement of materials in Item T - Hazardous Material.

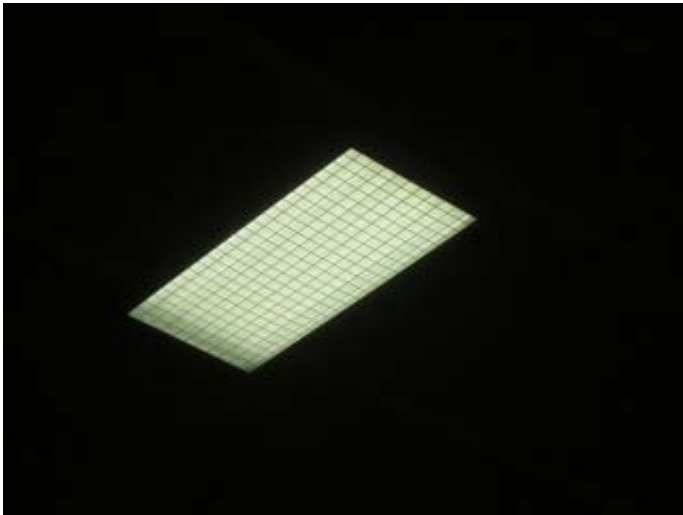
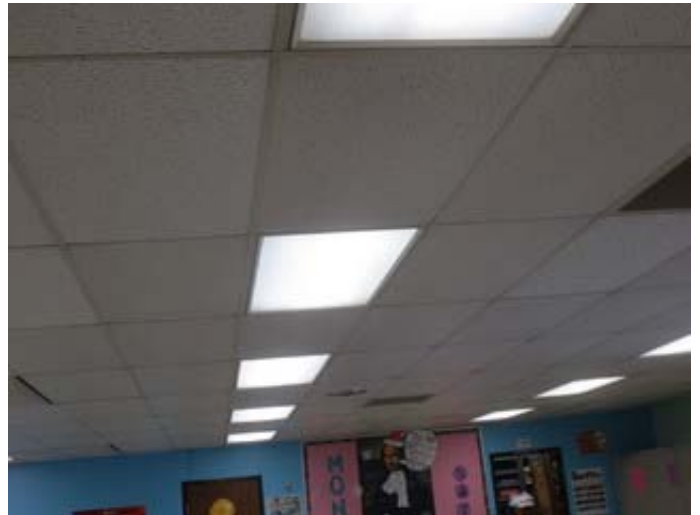
**Description:** The typical Classrooms in the overall facility are equipped with T-8 2x4 lay-in acrylic lensed fluorescent fixtures with single level switching. Classroom fixtures are in poor condition, providing an average illumination of 70 FC, thus complying with the 50 FC recommended by the OSDM. The typical Corridors in the overall facility are equipped with T-8 2x4 lay-in acrylic lensed fluorescent fixtures with single level switching. Corridor fixtures are in poor condition, providing an average illumination of 30 FC, thus complying with the 20 FC recommended by the OSDM. The Primary Gymnasium spaces are equipped with pendant T-8 fluorescent fixtures type lighting, in good condition, providing an average illumination of 40 FC, which is less than the 50 (ES / MS) FC recommended by the OSDM. The Media Center is equipped with 2x4 lay-in T-8 acrylic lensed fluorescent fixture type lighting in poor condition, providing an average illumination of 60 FC, thus complying with the 50 FC recommended by the OSDM. The Student Dining spaces are equipped with 2x4 lay-in T-8 acrylic lensed fluorescent fixture type lighting with single level switching. Student Dining fixtures are in poor condition, providing an average illumination of 37 FC, which is less than the 50 FC recommended by the OSDM. The Kitchen spaces are equipped with 1x4 lay-in T-8 acrylic lensed fluorescent fixture type lighting with single level switching. Kitchen fixtures are in poor condition, providing an average illumination of 60 FC, which is less than the 75-80 FC recommended by the OSDM. The Service Areas in the overall facility are equipped with 4' industrial T-8 fluorescent fixture type lighting in good condition. The typical Administrative spaces in the overall facility are equipped with 2x4 surface mounted T-8 acrylic lensed fluorescent fixture type lighting in poor condition, providing inadequate illumination based on OSDM requirements. The overall lighting systems of the facility are not compliant with Ohio School Design Manual requirements due to age, condition, inadequate lighting levels, and the lack of multi-level switching.

**Rating:** 3 Needs Replacement

Gymnasium Lighting Fixture

Classroom Lighting Fixture

**Recommendations:** Provide complete replacement of lighting system due to condition, lighting levels, and a lack of multilevel switching.

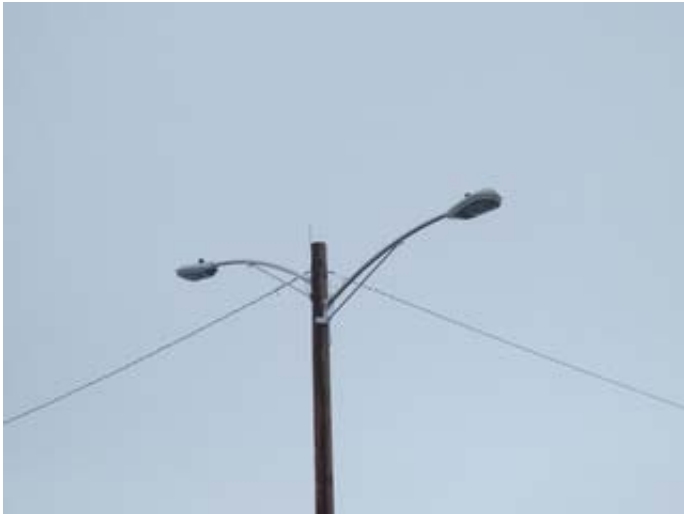
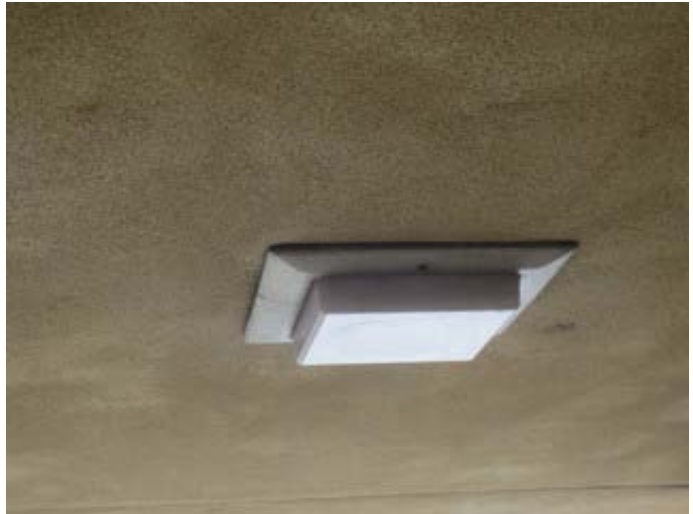
**Description:** The overall facility contains a CCTV type security system in poor condition. Motion detectors are not provided in main entries, central gathering areas, offices, main Corridors, and spaces where 6 or more computers are located. Exterior doors are equipped with door contacts. An automatic visitor control system is not provided. Compliant color CCTV cameras are provided at main entry areas but not parking lots, central gathering areas, and main Corridors. CCTV is not monitored in Administrative Area with an LCD monitor. A compliant computer controlled access control system integrating alarms and video signals, with appropriate UPS backup, is not provided. The system is not equipped with card / biometric readers. The security system is not adequately provided throughout, and the system is not compliant with Ohio School Design Manual guidelines. The overall 43 acre site is fenced against the surrounding residential properties, and athletic fields are fenced separately. The direct playground area for L.T. Ball Intermediate School is not fenced, which poses a potential security risk for staff and students. Fencing is discussed further in Item P - Site Condition. The exterior site lighting system is equipped with recessed compact fluorescent entry lights in poor condition. Pedestrian walkways are not illuminated. Parking and bus pick-up / drop off areas are illuminated by pole mounted HID fixtures in good condition. The exterior site lighting system provides inadequate illumination due to sparse placement of fixtures.

**Rating:** 3 Needs Replacement

Site Lighting Fixture

Entry Canopy Lighting Fixture

**Recommendations:** Provide complete replacement of security system to meet Ohio School Design Manual guidelines. Provide complete replacement of exterior site lighting system to meet Ohio School Design Manual guidelines. Funding for the playground area fencing is provided below, within the complete replacement scope of the security system.

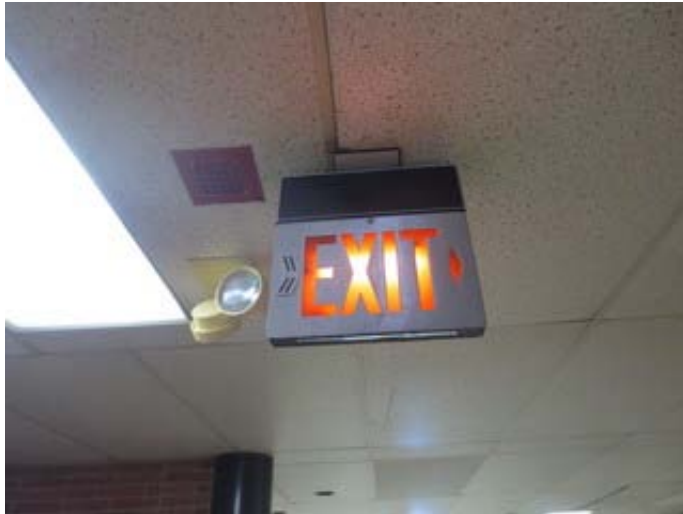
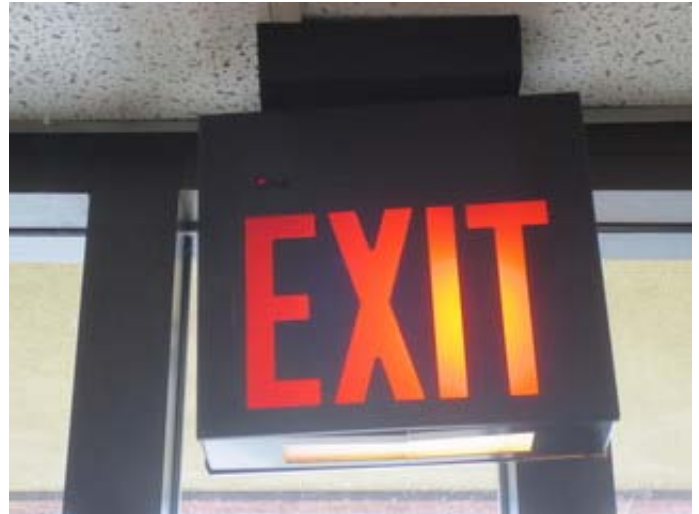
**Description:** The overall facility is equipped with an emergency egress lighting system consisting of incandescent, plastic construction, and non illuminated exit sign. The system is in poor condition. The facility is inadequately equipped with emergency egress floodlighting, and the system is in poor condition. The system is provided with appropriate battery backup. The system is not adequately provided throughout, and does not meet Ohio School Design Manual and Ohio Building Code requirements.

**Rating:** 3 Needs Replacement

Exit Sign and Emergency Lighting Fixture

Non-Compliant Exit Sign

**Recommendations:** Provide complete replacement of emergency / egress lighting system to meet Ohio School Design Manual and Ohio Building Code guidelines.

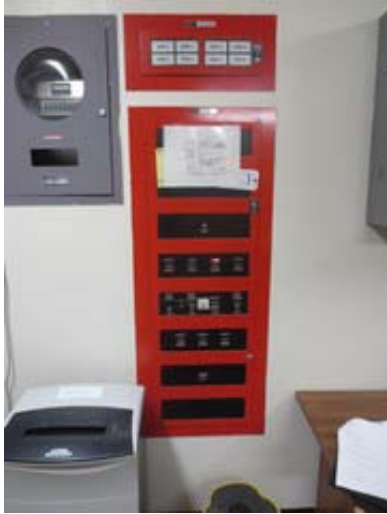
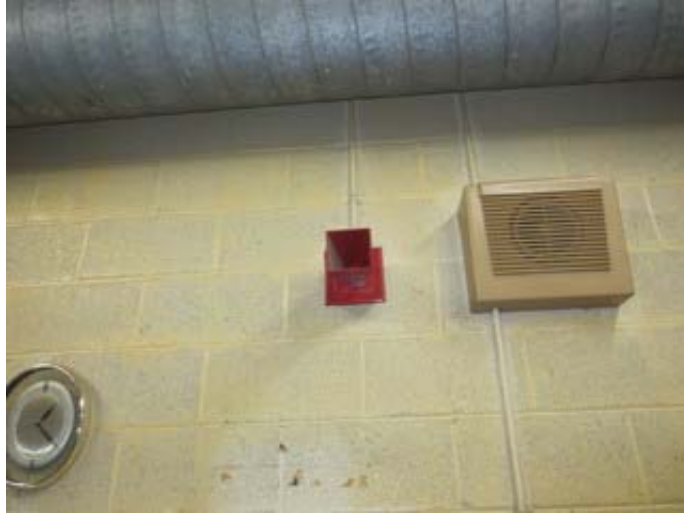
**Rating:** 3 Needs Replacement

Fire Alarm Panel

Fire Alarm Horn

**Recommendations:** Provide complete replacement of fire alarm system to meet OBC, NFPA, and Ohio School Design Manual guidelines.

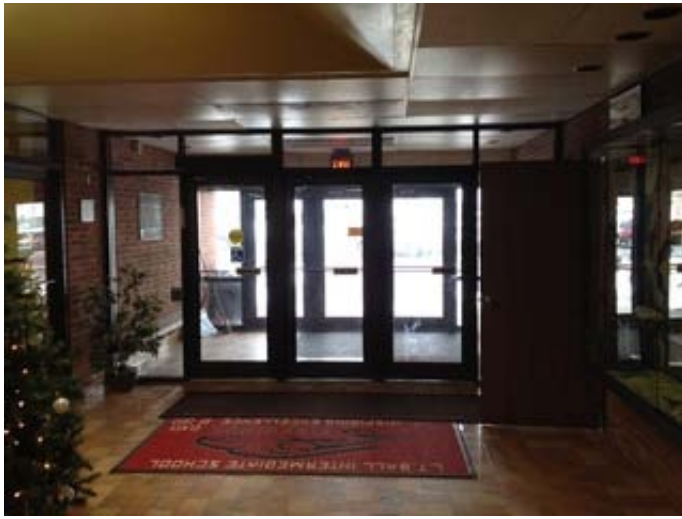
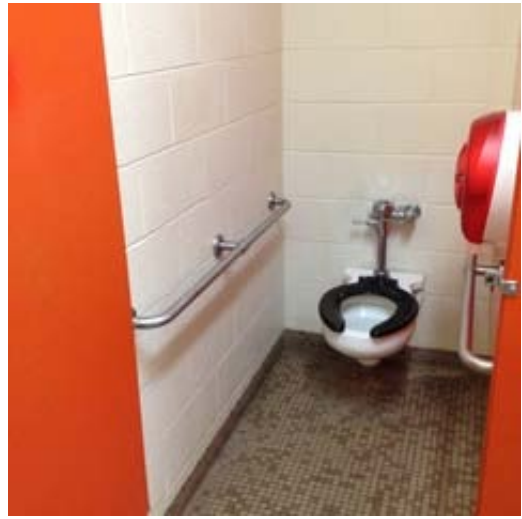
**Rating:** 3 Needs Replacement

Power Assisted Main Entrance

Typical Non-Compliant Stall Configuration

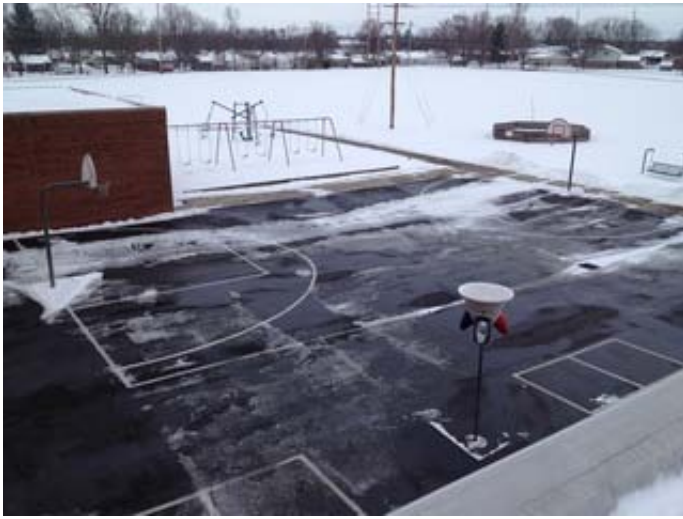
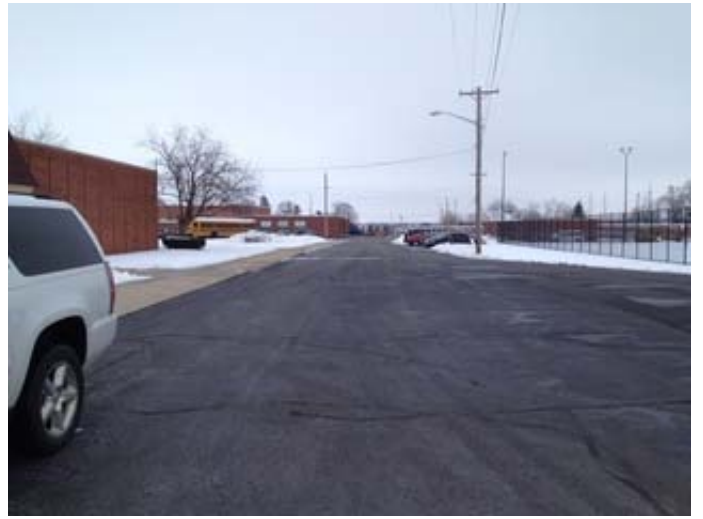
Playground View from the Roof Level

Typical Asphalt Condition

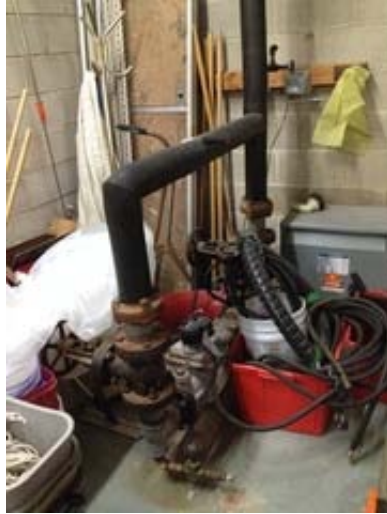
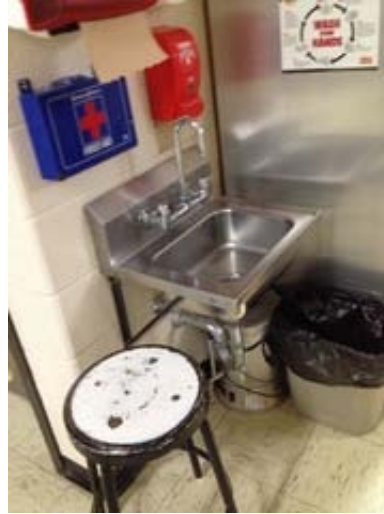
Water Service

Kitchen Hand Sink

**Recommendations:** Provide a new city water supply line of adequate capacity to support the existing needs of the facility, as well as a future automated fire suppression system. Funding provided in Item U.

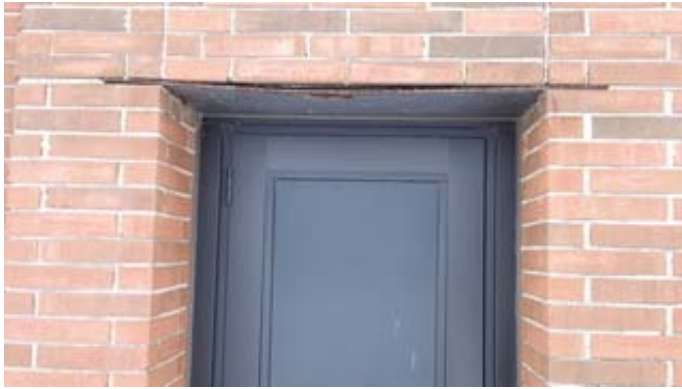
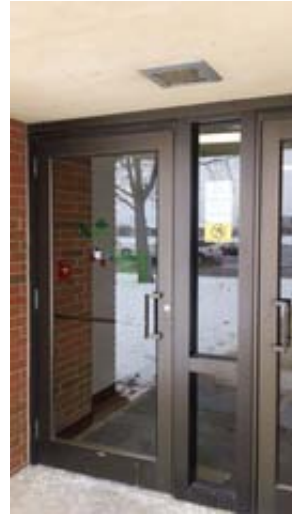
South Elevation Lintel Condition

Typical Entrance Condition

**Recommendations:** Replace existing overhead door and exterior doors to comply with Ohio Building Code, ADA, and Ohio School Design Manual guidelines. Replace the existing roof access door. Replacement of single glazed door transoms and sidelights is addressed in Item F - Windows.

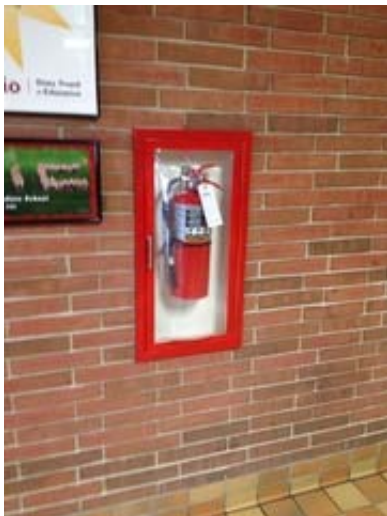
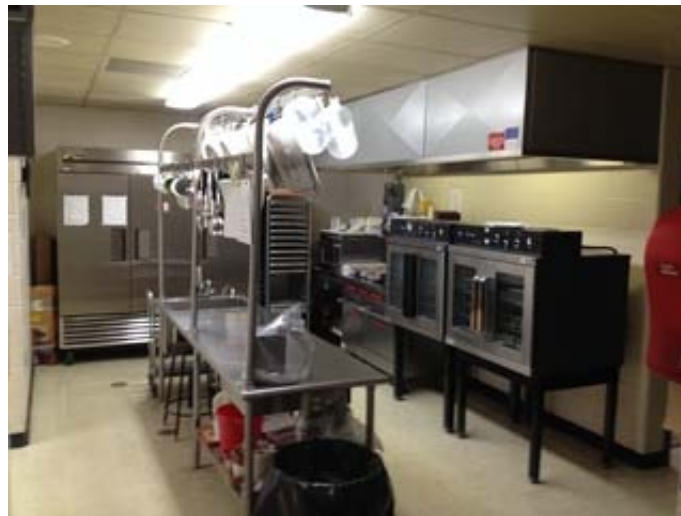
Typical Fire Extinguisher Cabinet

Exhaust Hood with Suppression System

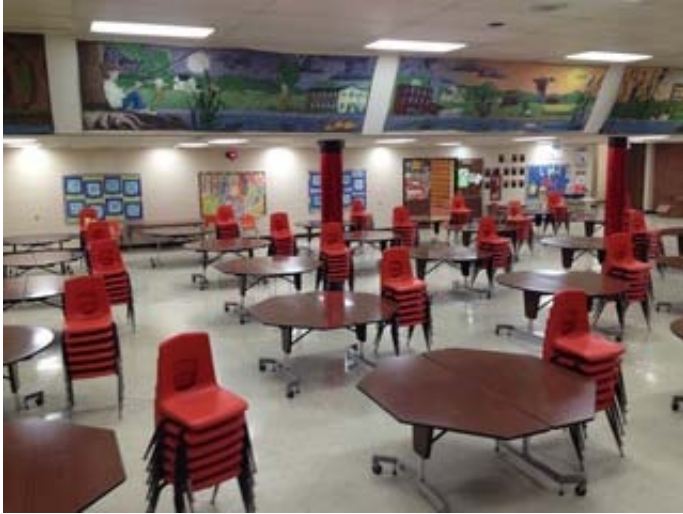
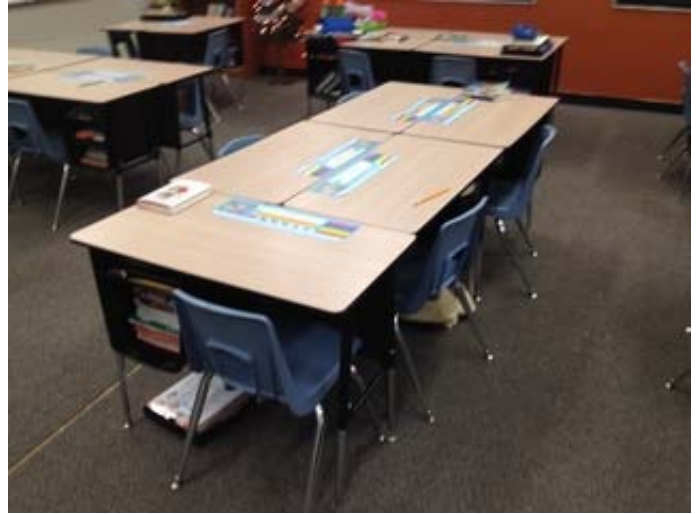
Student Dining Area Loose Furnishings

Typical Classroom Loose Furnishings

**Recommendations:** Provide for replacement of outdated or inadequate furnishings.
