Nevin Coppock Business Cost Analysis

OFCC FacilitiesAssessment - March 2015

Assessment Consultant - Legat and Kingscott Architects

Building Information - Tipp City Exempted Village (45617) - Nevin Coppock Elementary

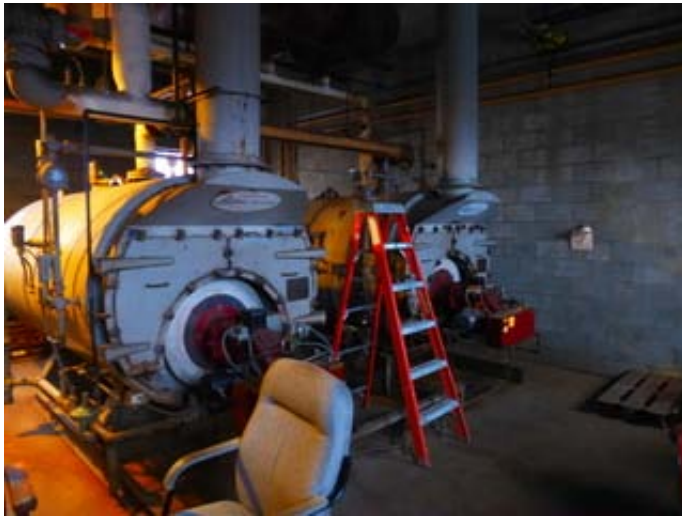
Description: The existing system for the overall facility is a gas fired boiler with heating water circulating pumps located in a separate building to the west of the school (which also serves Tippecanoe Middle School), installed in 1959, and is in fair condition. 2-pipe vs. 4-pipe designations are not applicable in this facility, as no central air conditioning is provided. The two boilers, manufactured by Atlas, were installed in 1959 and are in poor condition. Heating water is distributed to terminal units consisting of unit ventilators, cabinet heaters, unit heaters and air handlers. The terminal equipment was installed in 1959 and is in fair condition. The system does not comply with the 15 CFM per person fresh air requirements of the Ohio Building Code mechanical code and Ohio School Design Manual. The pneumatic type system temperature controls were installed in 1959 and are in fair condition. The system does feature individual temperature controls in all spaces required by the OSDM. The overall system does not feature any central energy recovery systems. The facility is equipped with both louvered and non-louvered interior doors. A moderate quantity of louvered interior doors are used to facilitate Corridor utilization as return air plenums. Interior door replacement is discussed in Item O - Handicapped Access. The existing system is not ducted, and floor to structural deck heights will not accommodate the installation of properly sized ductwork for a future Ohio School Design Manual approved system. The overall heating system is evaluated as being in safe but inefficient working order, and long term life expectancy of the existing system is not anticipated. The structure is not equipped with central air conditioning. The site does not contain underground fuel tanks.

Existing Boiler Plant

Recommendations: Provide new overall heating, ventilating, and air conditioning system to achieve compliance with Ohio Building Code and Ohio School Design Manual standards. Convert to a ducted system to facilitate efficient exchange of conditioned air. Provide architectural soffits to accommodate the installation of ductwork.

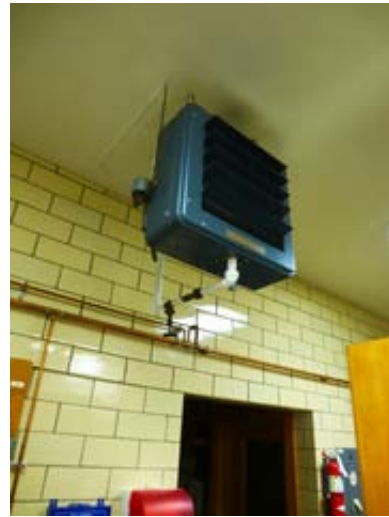
Existing Unit Heater

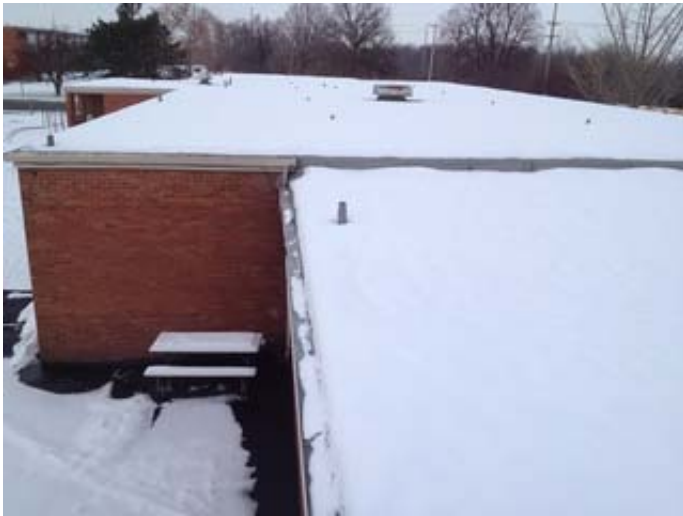
Description: The roof over the overall facility is a built-up asphalt system that was installed in 2000 and is in poor condition. There are no District reports of current leaking. Moisture stains were documented on Corridor drop panel ceiling tiles, but these stains could also be attributed to past issues with plumbing or mechanical systems within the drop ceiling. Access to the low roof was gained by an access hatch in the Mechanical Room, and access to the Multipurpose Room roof was gained by an access ladder from the low roof. Both the access hatch and access ladder are in poor conditions. Fall safety protection cages are not provided and are not required. There were no observations of standing water on the roof. Metal cap flashings are in fair condition. Roof storm drainage is addressed through a system of gutters and downspouts, which are properly located, and in poor condition. The roof is not equipped with overflow roof drains, and they are not needed on this building. No problems requiring attention were encountered with any roof penetrations. There are not any covered walkways attached to this structure.

Typical Roof Condition

Recommendations: The roof over the overall facility requires replacement to meet Ohio School Design Manual guidelines for age of system and due to condition. Remove all existing roof insulation. Provide a minimum of 4" new polyiso rigid roof insulation over the overall facility. The flashing and coping on the overall facility require replacement due to condition. Due to existing conditions gutters and downspouts require replacement. Replace the upper roof access ladder.

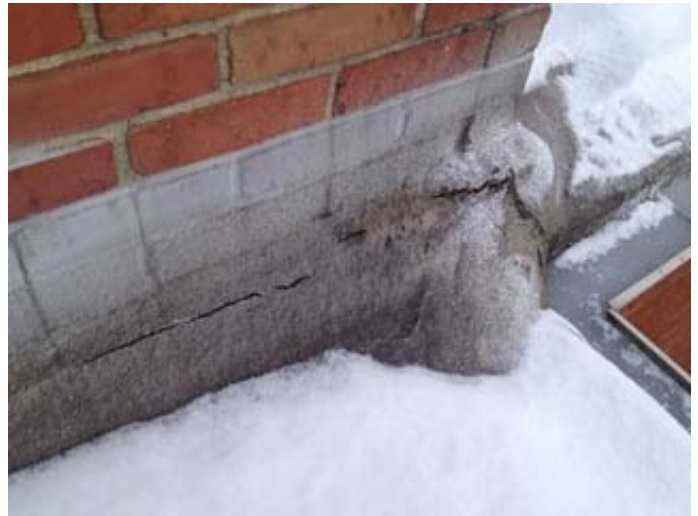
Roof Damage at a Corner Transition

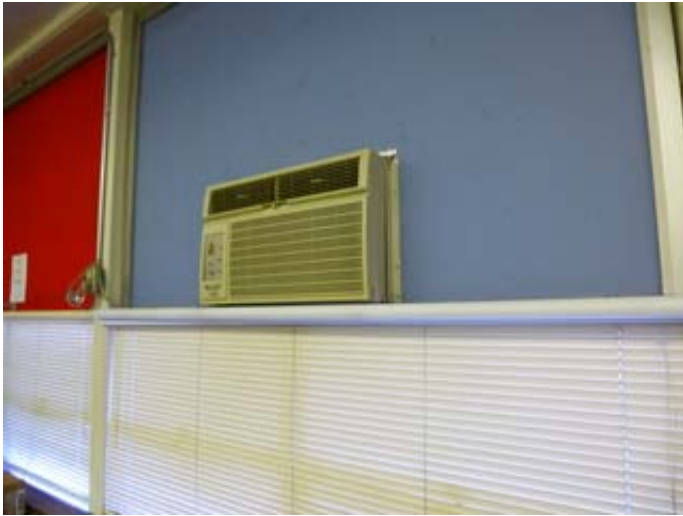
Description: The overall facility is not equipped with a central air conditioning system. Window units are provided in Office and Media Center. The ventilation system in the overall facility consists of unit ventilators, installed in 1959 and in fair condition, providing fresh air to Classrooms, and air handlers, installed in 1959 and in fair condition, providing fresh air to other miscellaneous spaces such as Gymnasiums. Relief air venting is provided by louvered interior doors. The ventilation system does not meet the Ohio Building Code 15 CFM per occupant fresh air requirement. The overall system is not compliant with Ohio Building Code and Ohio School Design Manual requirements. Dust collection systems are not required in this facility. The Art program is equipped with a kiln, and existing kiln ventilation is adequate, and in fair condition. General building exhaust systems for Restrooms, Storage Rooms, Art Rooms and Custodial Closets are adequately placed, and in fair condition.

Typical Window A/C Unit

Recommendations: (The above rating of "1 Satisfactory" has been provided because the following item costs are included Item A - Heating System, in the cost to completely replace the HVAC system. This section would receive a "3 Needs Replacement" if associated costs appeared in the table below.) Provide an air conditioning system to meet with Ohio Building Code and Ohio School Design Manual requirements. Pricing included in Item A. Replace general building exhaust systems located in Restrooms, Storage Rooms and Custodial Closets.

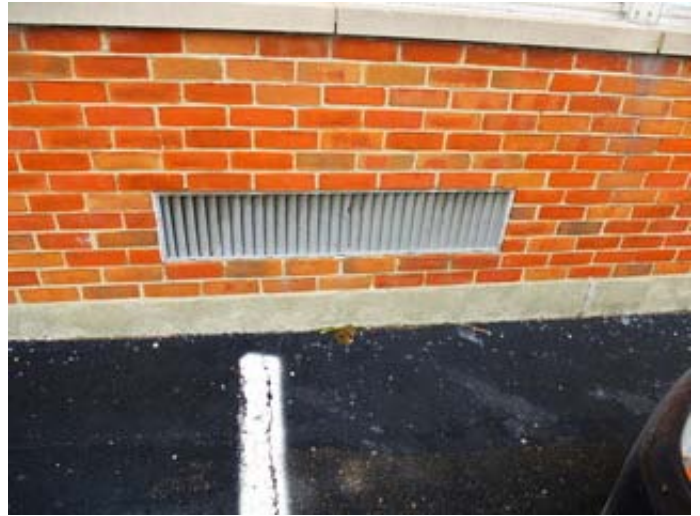
Unit Ventilator Outdoor Louver

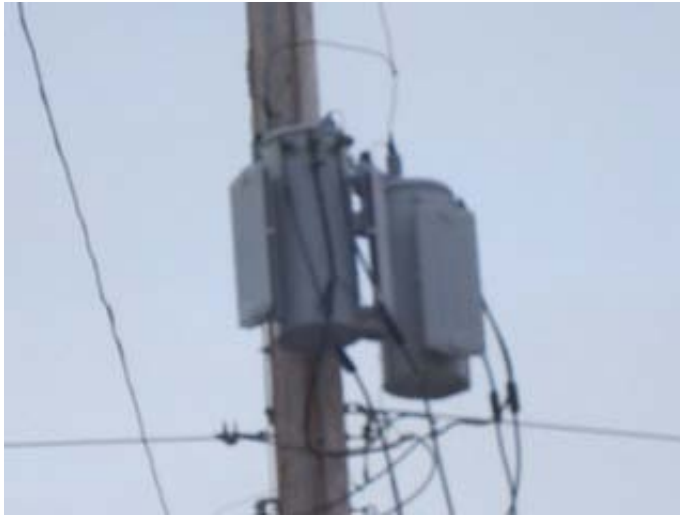
Description: The electrical system provided to the overall facility is a 120/240 volts, 800 amp, 1 phase and 3 wire system installed in 1998 and is in good condition. Power is provided to the school by a single utility owned pole-mounted transformer located outside on the property line and in good condition. The panel system, installed in 1959 is in poor condition, and cannot be expanded to add additional capacity. The Classrooms are not equipped with adequate electrical outlets. The typical Classroom contains 4 general purpose outlets, 2 dedicated outlets for each Classroom computer, and 0 dedicated outlets for each Classroom television. Some Classrooms are equipped with as many as 5 general purpose outlets, while others are equipped with as few as 2 general purpose outlets. There are not any spaces that have no electrical outlets. The Corridors are equipped with adequate electrical outlets for servicing. Adequate GFI protected exterior outlets are provided around the perimeter of the building. The facility is not equipped with an emergency generator. Adequate lightning protection safeguards are not provided. Stage lighting power system including control panel, breakers, and dimmers is inadequately provided, in poor condition and does not meet OSDM requirements. The overall electrical system meets does not meet Ohio School Design Manual requirements in supporting the current needs of the school, and will be inadequate to meet the facility's future needs.

Utility Owned Transformer

Recommendations: The entire electrical system requires replacement to meet Ohio School Design Manual guidelines for overall capacity, Classroom capacity, due to condition and age, lack of OSDM-required features, and to accommodate the addition of an air conditioning system.

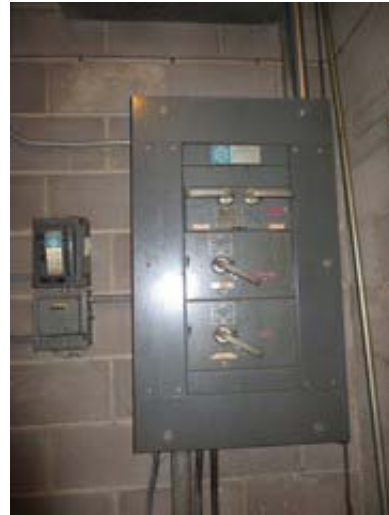
Original Electrical Distribution Equipment

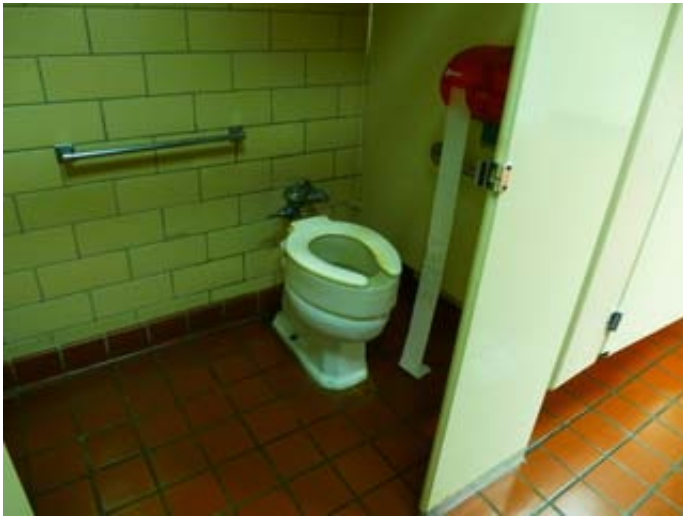
Description: The service entrance is not equipped with a reduced pressure back flow preventer. A water treatment system is provided and is in good condition. The domestic water supply piping in the overall facility is galvanized piping, was installed in 1959 and is in fair condition. The waste piping in the overall facility is cast iron, was installed in 1959, and is in fair condition. The school contains 2 Large Group Restrooms for boys, 2 Large Group Restrooms for girls, and 2 Restrooms for staff. Boys' Large Group Restrooms contain 0 ADA and 7 non-ADA floor mounted flush valve toilets, 0 ADA and 13 non-ADA floor mounted central flush urinals, as well as 0 ADA and 6 non-ADA wall mounted lavatories. Girls' Large Group Restrooms contain 0 ADA and 14 non-ADA floor mounted flush valve toilets, as well as 0 ADA and 7 non-ADA wall mounted lavatories. Staff Restrooms contain 0 ADA and 2 non-ADA floor mounted flush valve toilets, as well as 0 ADA and 2 non-ADA wall mounted lavatories. Condition of fixtures is fair. The facility is equipped with 0 ADA and 4 non-ADA electric water coolers, in fair condition. The 25 Elementary Classrooms are equipped with 0 ADA and 25 non-ADA sinks (no drinking fountains), in fair condition. Special Education Classroom is equipped with the required Restroom facilities, and fixtures are in fair condition. Kitchen is equipped with the required Restroom, and fixtures are in fair condition. Health Clinic is equipped with the required Restroom, and fixtures are in fair condition. Kindergarten / Pre-K Classrooms are not equipped with Restroom facilities. Kitchen fixtures consist of 1 double compartment sink, 1 triple compartment sink and 1 dishwasher, which are in good condition. The Kitchen is equipped with a satisfactory grease interceptor, and is in fair condition. The Kitchen is provided the required 140 degree hot water supply via a 91 gallon type water heater, which is in good condition. The school does not meet the OBC requirements for fixtures. Relative to LEED requirements, the school is not equipped with low flow type fixtures. Per OBC and OSDM requirements this facility should be equipped with 15 toilets, 4 urinals, 12 lavatories, 25 Classroom sink mounted drinking fountains, and 6 electric water coolers. Observations revealed that the school is currently equipped with 26 toilets, 13 urinals, 18 lavatories, 25 Classroom sinks without mounted drinking fountains, and 4 electric water coolers. ADA requirements are not met for fixtures and drinking fountains (see Item O). Custodial Closets are properly located and are adequately provided with required service sinks or floor drain sinks, which are in fair condition. Science Classroom, Lab utility sinks, gas connections, compressed air connections, and safety shower and eyewash are not provided, but are not required due to existing grade configuration. Due to existing grade configuration, no Biology or Chemistry Classroom acid waste systems are required. Adequate exterior wall hydrants are provided.

Typical Floor Mounted Water Closet

Recommendations: Due to age, condition, LEED, and OSFC requirements, provide a total of 26 toilets, 13 urinals, 18 lavatories, 25 Classroom sink mounted drinking fountains, and 6 electric water coolers. Fixture totals are coordinated between Item E - Plumbing and Fixtures and Item O - Handicapped Access. Within Item E - Plumbing and Fixtures, provide 20 new toilets, 11 new urinals, 12 new lavatories, 3 new electric water coolers, and 25 new lavatory mounted type drinking fountains. See Item O - Handicapped Access, for the remainder of fixture replacements and additions related to ADA requirements. Replace galvanized water supply piping in the overall facility with copper piping. Replace sanitary waste piping in the overall facility due to age and condition. Replace grease interceptor due to age and condition. Provide new mop sink. Provide reduced pressure back flow preventer. See Item O - Handicapped Access, for replacement of fixtures related to ADA requirements. Provide required sink mounted type drinking fountains in Elementary Classroom spaces.

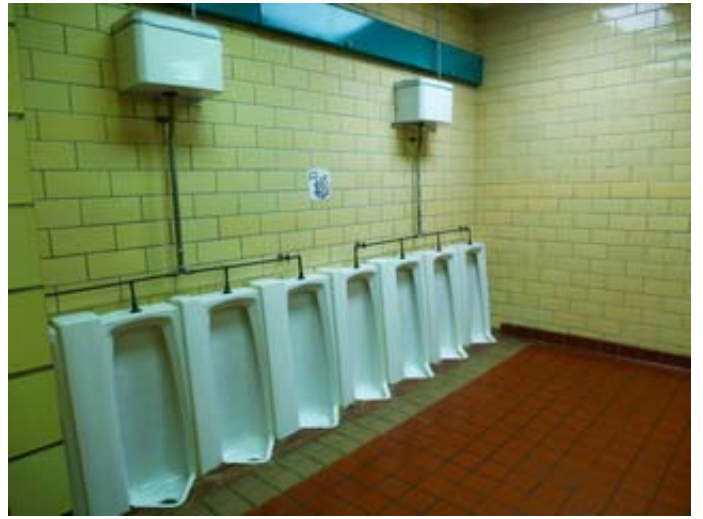
Typical Urinals

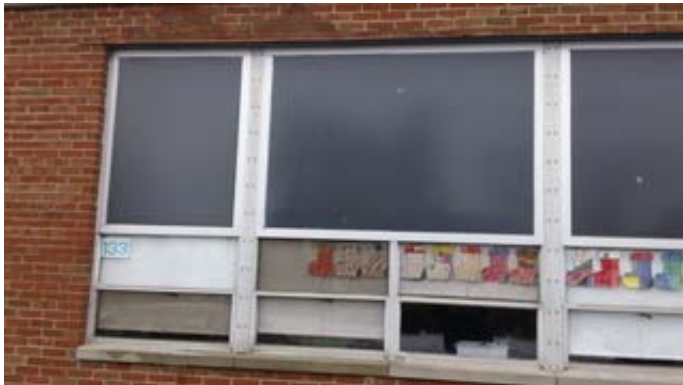
Description: The 1958 Original Construction is equipped with aluminum frame windows with single glazed type window system and is in poor condition. The window system features operable windows throughout the building, and operable windows are equipped with opening limiters in poor condition, but no insect screens were present. Window system seals are in poor condition, with moderate air and water infiltration being experienced. Window system hardware is in poor condition. The window system features no blinds. This facility is not equipped with any curtain wall systems. This facility does not feature any glass block windows. The exterior doors in the overall facility are equipped with aluminum and steel sidelights and transoms with single pane glazing in fair condition at the main entry. Exterior door vision panels are single pane at the main entry. Exterior transoms and door vision panels are double-pane at some locations that have been replaced. The school does not contain skylights. The school does not contain clerestories. Interior glass is not OSDM-compliant due to not being tempered. Window security grilles are not provided for ground floor windows. There is not a Greenhouse associated with this school.

Typical Window Condition

Recommendations: Provide a new insulated window system with integral blinds to meet with Ohio School Design Manual requirements. Exterior door vision panel replacement is addressed in the replacement of exterior doors in Item S - Exterior Doors. Replace the two Main Entry storefronts and inner storefront on the south elevation of the facility due to poor condition. Costs associated with the replacement of window transoms and sidelights at exterior doors of the overall facility are included within the replacement of the exterior storefront systems. Refer to Item S - Exterior Doors and Item O - Handicapped Access, for exterior and interior door replacement. Existing window panel square footages are included within the insulated glass/panels square footage values provided in the table below. Gymnasium upper window panels have been replaced within the Door and Window Panel Replacement item in the table below.

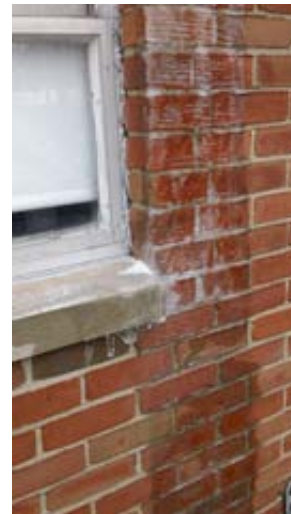
Ice Formation on the Facade Adjacent to a Window Unit

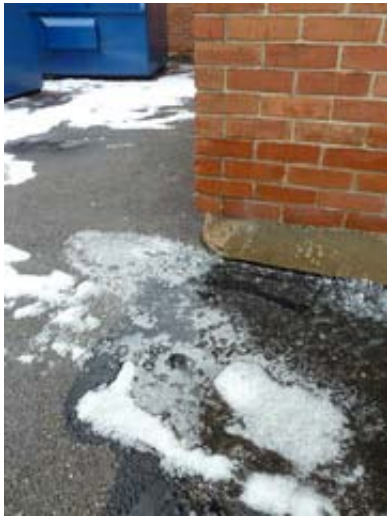
Description: The overall facility is equipped with concrete foundation walls on concrete spread footings. Moderate longitudinal cracking and moisture were documented along a portion of the west-face of the north Classroom wing, and additional moderate cracking was observed along this upper portion of the north Classroom wing. Significant corner damage and its repair were documented in this area, while a severed corner without repair was documented near the exterior trash area on the south face of the facility. The District reports that there has been no past leaking. The southwest corner of the building is the only documented location of standing water around the perimeter of the structure, which, due most likely to issues of ground settlement, could be a potential contributor to future foundation deterioration. The overall facility is equipped with concrete foundation walls on concrete spread footings, which displayed areas of minor cracking and spalling, were observed through the overall facility. The District reports that there has been no past leaking. No grading or site drainage deficiencies were noted around the perimeter of the structure that are contributing or could contribute to foundation / wall structural deterioration.

Deteriorated Concrete Foundation

Recommendations: Repair areas of cracking and spalling through the overall facility. Repair areas of depressed asphalt at the southwest corner of the facility in order to eliminate the potential for standing water around the foundation and to promote appropriate drainage. Costs associated with this work will be in Item P - Site Condition.

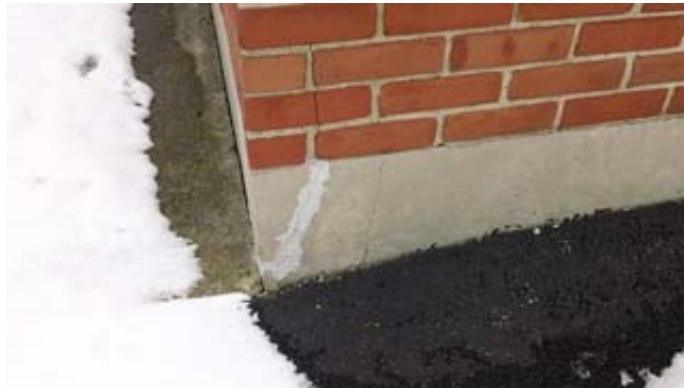
Damaged Concrete Foundation

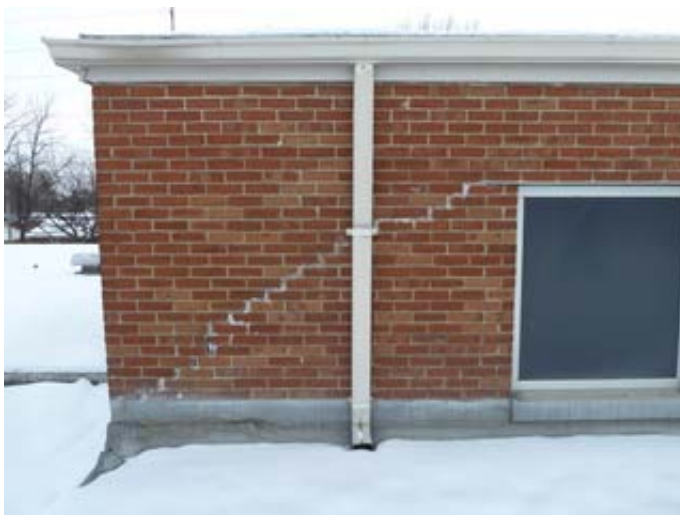
Description: The overall facility has a brick veneer on load bearing masonry wall system, which displayed locations of deterioration, and is in fair condition. The exterior masonry appears to have no caulked control joints. Control joints are not provided at lintel locations, at doors and windows, building corners, and wall offsets. The school does not contain expansion joints. Effects of settlement can be seen from the low roof on the north-facing Multipurpose Room brickwork, which appears to have previously been addressed with sealant. Moderate longitudinal cracking and moisture were documented along a portion of the west-face of the north Classroom wing, and additional moderate cracking was observed along this upper portion of the north Classroom wing. Significant corner damage and its repair were documented in this area, while a severed corner without repair was documented near the exterior trash area on the south face of the facility. The District reports that there has been no past leaking. Exterior walls in the overall facility are inadequately insulated. Brick veneer masonry walls are not cavity walls. Weep holes and vents are not provided. The exterior masonry has not been cleaned and sealed in recent years, and shows evidence of mortar deterioration at the wall base and window heads. Architectural exterior accent materials consist of stone sills, which are in poor condition. Interior walls are concrete masonry units and glazed block and are in fair condition. Interior masonry appears to have no control joints. Interior soffits are of plaster type construction, and in fair condition. Exterior window sills are stone, and are in poor condition, as is mentioned above. Interior window sills are marble, and are in good condition. The exterior lintels are steel, and are rusting and in fair condition. Chimneys are in fair condition. Masonry cleaning and tuckpointing is required. Canopies over entrances are concrete type construction, and are in fair condition. Exterior soffits are of plaster type construction, and in fair condition. The school is not equipped with a loading dock.

Exterior Masonry Wall Damage

Recommendations: Provide tuckpointing in all areas of mortar deterioration as required through the overall facility, including exterior window sills. Provide masonry cleaning and sealing as required through the overall facility, including exterior window sills. Sawcut and caulk new appropriately spaced control joints in existing masonry through the overall facility. Prep and paint exposed steel lintels through the overall facility. Exterior wall insulation deficiencies are addressed in Item J - General Finishes. Provide brick, insulation and CMU back-up infill at locations where unit ventilator louvers are being removed. Interior and exterior soffits need to be repainted. The associated cost of repainting exterior soffits can be found below. The associated cost of repainting interior soffits is included in Item J - General Finishes, under the full replacement of finishes and casework. Consult a structural or geotechnical engineer to analyze potential issues of settlement documented on the north-facing Multipurpose Room brickwork.

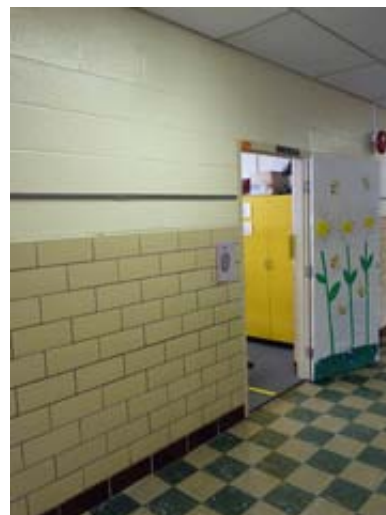
Interior Corridor Walls

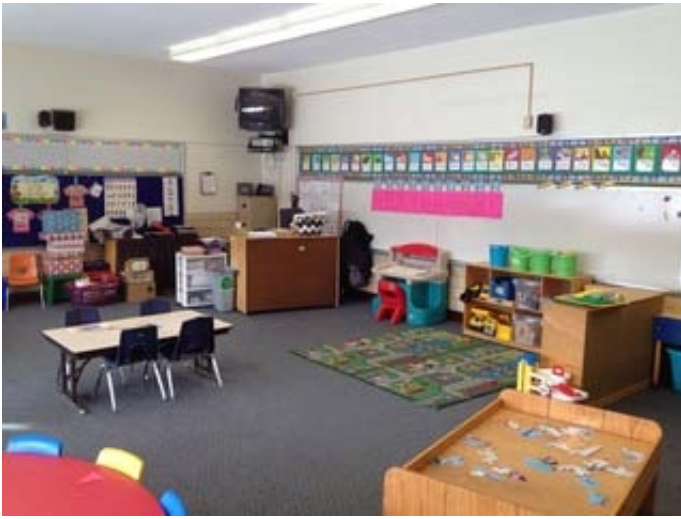
Description: The overall facility features conventionally partitioned Classrooms with carpet or VAT type flooring, painted plaster type ceilings, as well as CMU, glazed masonry unit and operable partition type wall finishes, and they are in poor condition. The overall facility has Corridors with VAT type flooring, ACT type ceilings, as well as painted CMU and glazed block type wall finishes, and they are in poor condition. The overall facility has Restrooms with quarry type flooring, plaster type ceilings, as well as glazed block type wall finishes, and they are in fair condition. Toilet partitions are metal, and are in poor condition. Classroom casework in the overall facility is wood type construction with plastic laminate tops, is inadequately provided, and in fair condition. The typical Classroom contains 10 lineal feet of casework. Classrooms are provided adequate chalkboards / markerboards / tackboards which are in fair condition. Classroom storage for student coats and backpacks is not provided. The metal lockers located in the Corridors are inadequately provided, and in fair condition. The Art program is equipped with a kiln in fair condition, and existing kiln ventilation is adequate. The facility is primarily equipped with metal non-louvered interior doors that are flush mounted without proper ADA hardware and clearances, and in fair condition. A moderate number of metal louvered doors are present. These doors are also flush mounted without proper ADA hardware and clearances, and in fair condition. The Gymnasium space has VAT type flooring, fiber plank type ceiling on open web steel joist, as well as CMU and ceramic tile type wall finishes, and they are in fair condition. Gymnasium basketball backboards are manually and electrically operated type, and are in good condition. The Media Center has carpet type flooring, painted plaster type ceilings, as well as CMU and ceramic tile type wall finishes, and they are in fair condition. Student Dining shares the Gymnasium space. OSDM-required fixed equipment for Stage is inadequately provided, and in poor condition. Existing Gymnasium / Student Dining / Media Center / and Music spaces are inadequately provided with appropriate sound attenuation acoustical surface treatments. Stage is undersized and used as Storage Room for the Gymnasium. The existing Kitchen is full service, is undersized based on current enrollment, and the existing Kitchen equipment, varies in age of installation, is in fair to poor condition. The Kitchen hood is in fair condition, and is not equipped with the required UL 300 compliant wet chemical fire suppression system. The required 6" overhang on all three exposed sides of the cooking equipment is not provided by the hood. Kitchen hood exhaust ductwork is not of proper construction, material, insulation, or installed as required by the OSDM and OBCMC. The walk-in cooler and freezer are located within the Kitchen spaces and are in poor condition.

Typical Classroom Finishes

Recommendations: Provide complete replacement of finishes and casework due to condition and installation of systems outlined in Items (A / C / D / E / I / K / L / M / N / T / U / W). Funding for replacement of interior doors is provided in Item O - Handicapped Access, including doors here noted as being in fair condition. Replace toilet partitions as required, throughout the overall facility due to condition. Replace the toilet room accessories throughout the overall facility due to condition. Provide for the replacement of kitchen equipment, including reach-in cooler and freezer, due to age and condition. Provide a heat removal hood for the Art program kilns. Costs associated with this located in Item A - Heating Systems. Provide the Stage area with a Stage Curtain replacement due to hazardous material removal in Item T - Hazardous Material. Costs associated with the replacement of the non-compliant Stage stair railing are discussed in Item U - Life Safety. Provide a projector screen for the Stage to comply with OSDM fixed Stage equipment recommendations. Provide sound attenuation for the Multipurpose Area (Gymnasium/Student Dining and Stage) and the Media Center due to inadequate acoustical surface treatments. Replace non-electric Gymnasium backboards due to age. Replacement costs have also been provided in the table below in coordination with the abatement of materials in Item T - Hazardous Material.

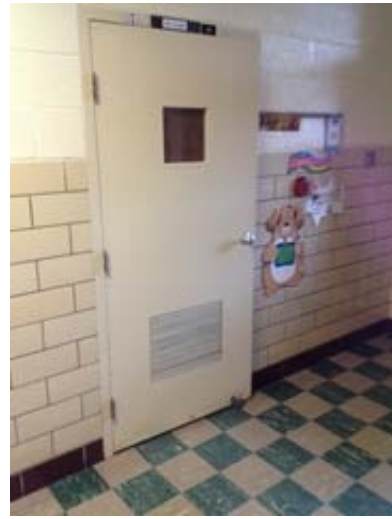
Typical Corridor Finishes

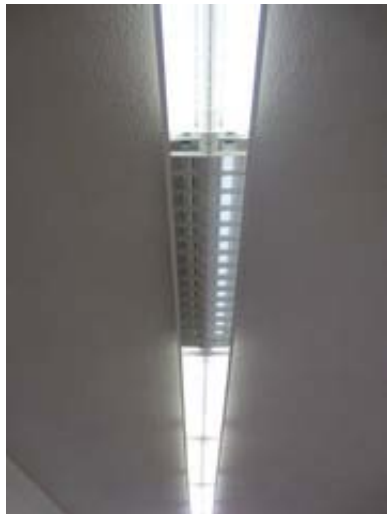
Description: The typical Classrooms in the overall facility are equipped with T-12 1x4 surface mount fluorescent fixtures with single level switching. Classroom fixtures are in poor condition, providing an average illumination of 20 FC, which is less than the 50 FC recommended by the OSDM. The typical Corridors in the overall facility are equipped with T-8 2x4 surface mount acrylic lensed fluorescent fixtures with single level switching. Corridor fixtures are in poor condition, providing an average illumination of 20 FC, thus complying with the 20 FC recommended by the OSDM. The Primary Gymnasium/Student Dining spaces are equipped with T-8 pendant mount fluorescent fixtures lighting, in good condition, providing an average illumination of 45 FC, which is less than the 50 (ES / MS) FC recommended by the OSDM. The Media Center is equipped with 2x4 surface mount T-8 acrylic lensed fluorescent fixture type lighting in poor condition, providing an average illumination of 67 FC, thus complying with the 50 FC recommended by the OSDM. The Student Dining (see Primary Gymnasium). The Kitchen spaces are equipped with 2x4 surface mount T-8 acrylic lensed fluorescent fixture type lighting with single level switching. Kitchen fixtures are in poor condition, providing an average illumination of 35 FC, which is less than the 75-80 FC recommended by the OSDM. The Service Areas in the overall facility are equipped with 2x4 suspended T-8 fluorescent fixture and incandescent type lighting in poor condition. The typical Administrative spaces in the overall facility are equipped with 2x4 surface mount T-8 acrylic lensed fluorescent fixture type lighting in poor condition, providing inadequate illumination based on OSDM requirements. The overall lighting systems of the facility are not compliant with Ohio School Design Manual requirements due to age and condition, inadequate lighting levels, lack of multi-level switching, the utilization of T-12 fluorescent and incandescent fixtures.

Classroom Lighting Fixture

Recommendations: Provide complete replacement of lighting system due to condition, lighting levels, utilization of T-12 and incandescent fixtures, lack of multilevel switching.

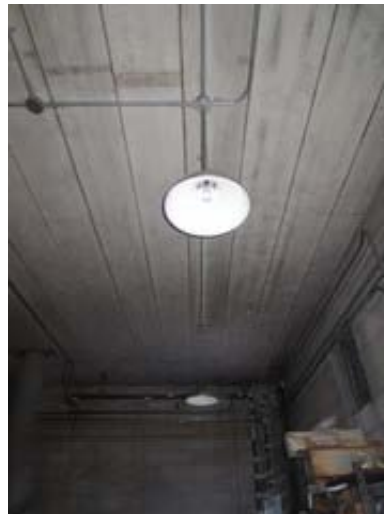
Service Area Incandescent Lighting Fixture

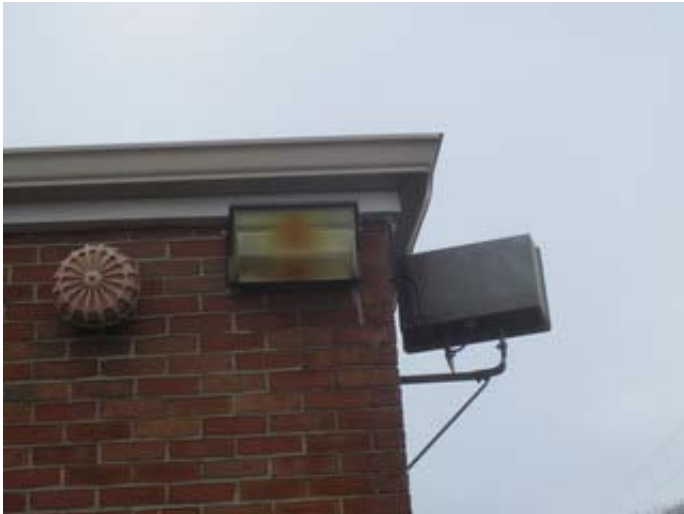
Description: The overall facility contains an CCTV type security system in poor condition. Motion detectors are not provided in main entries, central gathering areas, offices, main Corridors, and spaces where 6 or more computers are located. Exterior doors are equipped with door contacts. An automatic visitor control system is not provided. Compliant color CCTV cameras are provided at main entry areas but not parking lots, central gathering areas, and main Corridors. CCTV is not monitored in Administrative Area with an LCD monitor. A compliant computer controlled access control system integrating alarms and video signals, with appropriate UPS backup, is not provided. The system is not equipped with card / biometric readers. The security system is not adequately provided throughout, and the system is not compliant with Ohio School Design Manual guidelines. Playground fencing is located against vehicular traffic and parking spaces on the north elevation of the facility. Currently, the fencing does not feature any gates that limit pedestrian access into the Playground. The exterior site lighting system is equipped with recessed compact fluorescent entry lights in poor condition. Pedestrian walkways are not illuminated. Parking and bus pick-up / drop off areas are illuminated by pole mounted HID fixtures in good condition. The exterior site lighting system provides inadequate illumination due to sparse placement of fixtures.

Exterior Site Lighting Fixtures

Recommendations: Provide complete replacement of security system to meet Ohio School Design Manual guidelines, including the Playground fencing due to condition and the need for improvements such as gated entrances. Provide complete replacement of exterior site lighting system to meet Ohio School Design Manual guidelines.

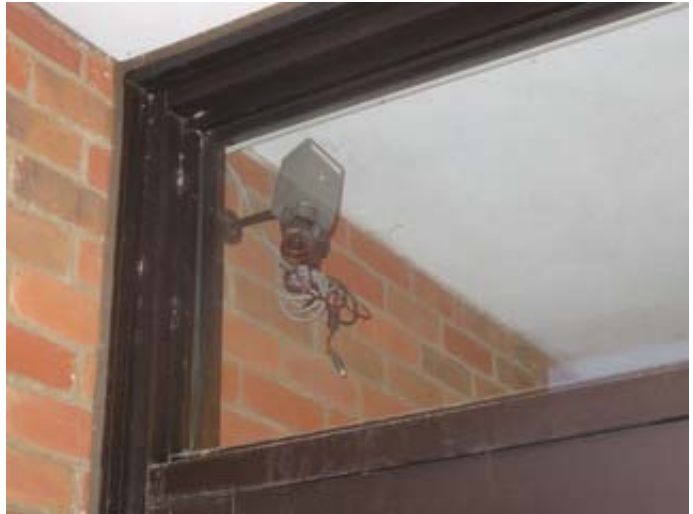
Entrance Camera

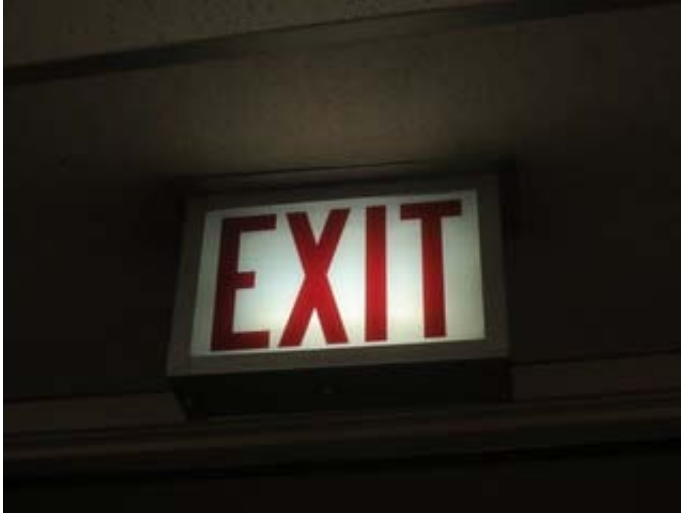
Description: The overall facility is equipped with an emergency egress lighting system consisting of incandescent, plastic construction, and non illuminated exit sign. The system is in poor condition. The facility is inadequately equipped with emergency egress floodlighting, and the system is in poor condition. The system is provided with appropriate battery backup. The system is not adequately provided throughout, and does not meet Ohio School Design Manual and Ohio Building Code requirements.

Non-Compliant Exit Sign

Recommendations: Provide complete replacement of emergency / egress lighting system to meet Ohio School Design Manual and Ohio Building Code guidelines.

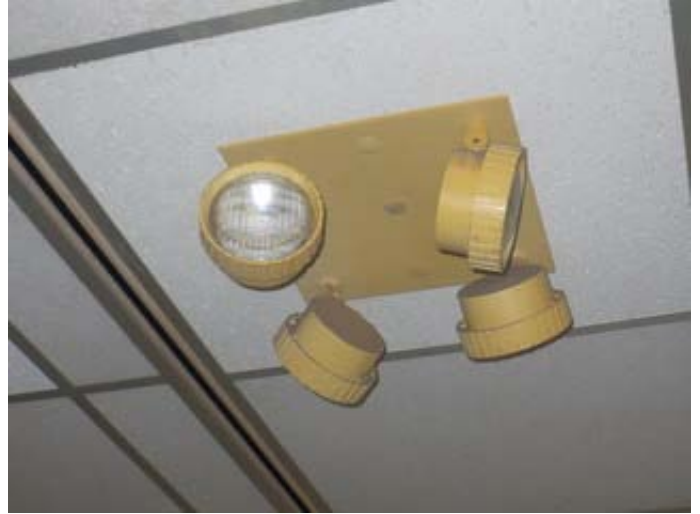
Emergency Egress Lighting Fixture

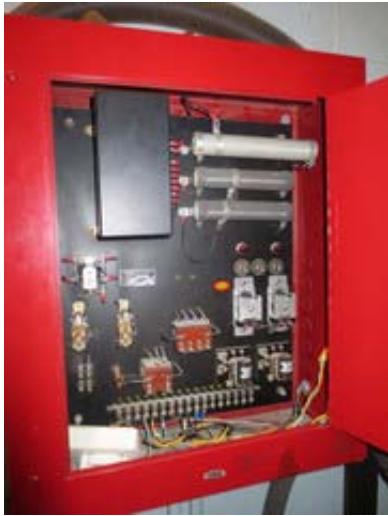
Description: The overall facility is equipped with a Standard type fire alarm system, installed in 1959 and in poor condition, consisting of manual pull stations, and bells indicating devices. The system is not automatic and is not monitored by a third party. The system is not equipped with sufficient audible horns. The system is not equipped with any strobe indicating devices, flow switches, tamper switches, smoke detectors, and heat sensors. The system thus will not support future fire suppression systems. The system is not compliant with Ohio Building Code, NFPA, and Ohio School Design Manual requirements.

Fire Alarm Panel

Recommendations: Provide complete replacement of fire alarm system to meet OBC, NFPA, and Ohio School Design Manual guidelines.

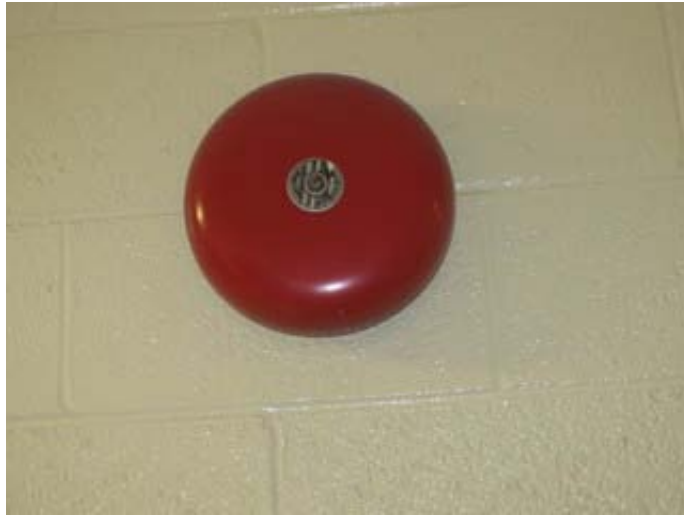
Fire Alarm Bell

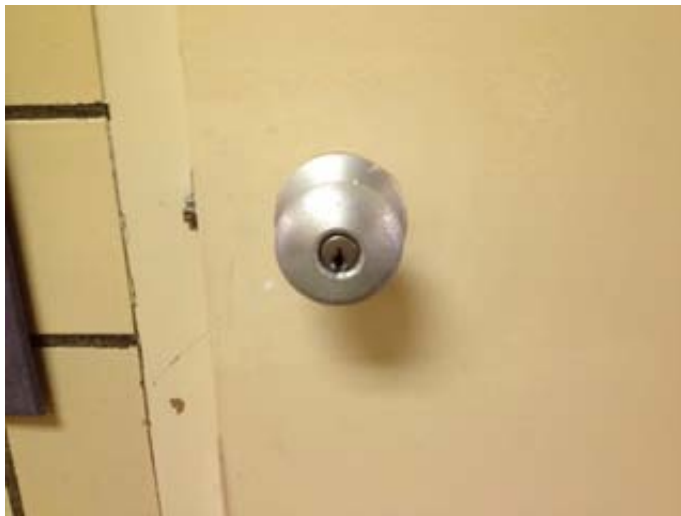
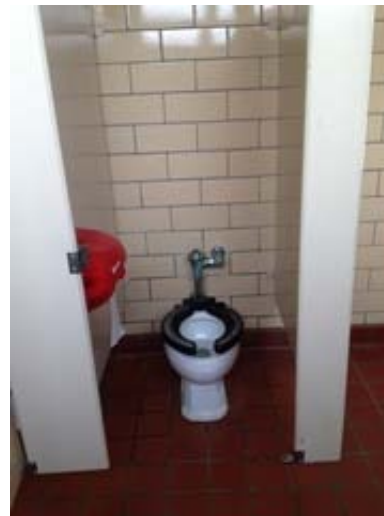
Typical Classroom Door Handle

Typical Toilet Stall

Recommendations: Provide ADA-compliant signage, power assist door opener, electric water coolers, toilets, sinks, urinals, toilet partitions, toilet accessories, door and frames and door hardware in the overall facility to facilitate the school's meeting of ADA requirements. Provide one lift for handicapped access to the Stage level due to space restrictions. Replace the ADA non-compliant interior ramp and provide a new, compliant ramp in its place. Provide a ramp for the north elevation entry due to the north elevation parking and potential need to accessible entrance. Funding for ramp railings is provided in Item U - Life Safety.

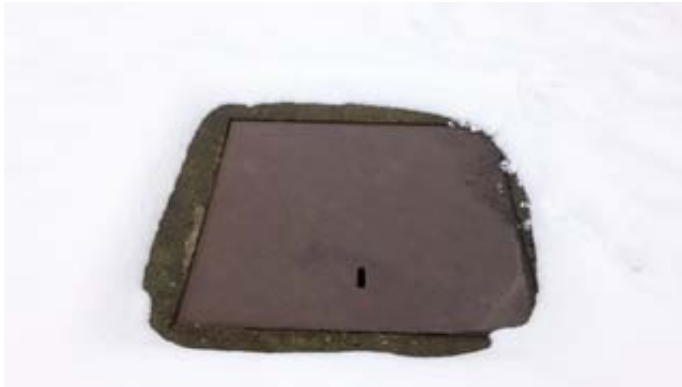
Exterior Sanitary Access

Recommendations: Provide new sanitary line and grease interceptor due to age.

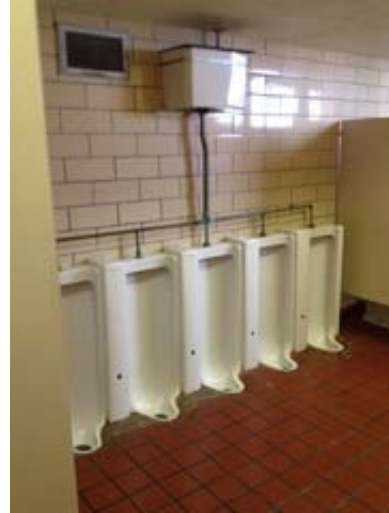
Urinals Double as Floor Drains

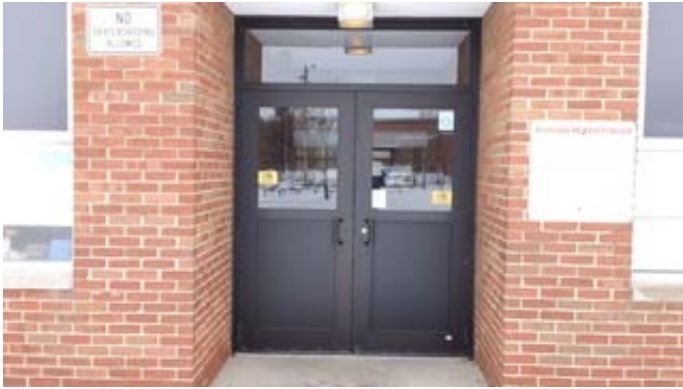
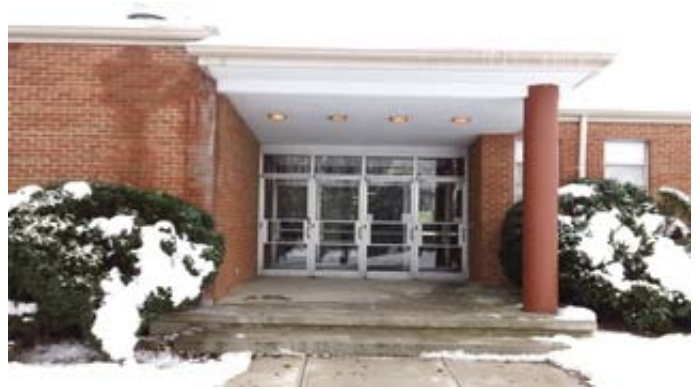
Exterior Doors

Main Entry Doors

Recommendations: Replace all exterior doors to comply with Ohio Building Code, ADA, and Ohio School Design Manual guidelines. Replace all hollow metal and single-glazed exterior doors, due to poor condition. Refer to Item B - Roofing for costs associated with replacing roof hatches.

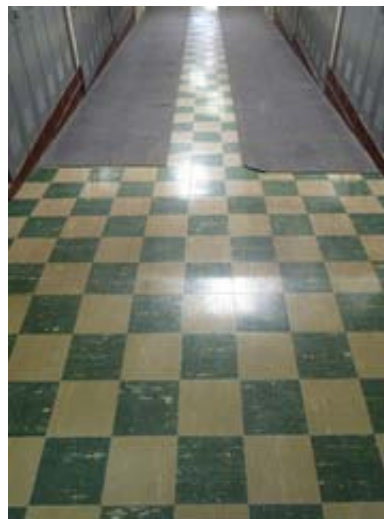
Existing Corridor Ramp without Handrails

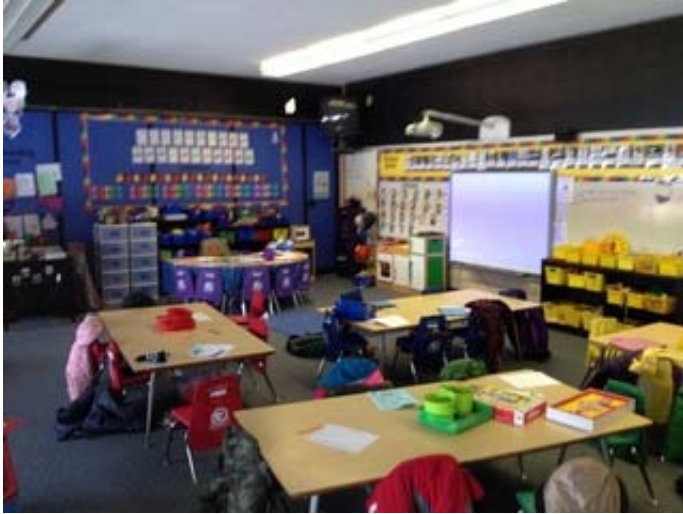
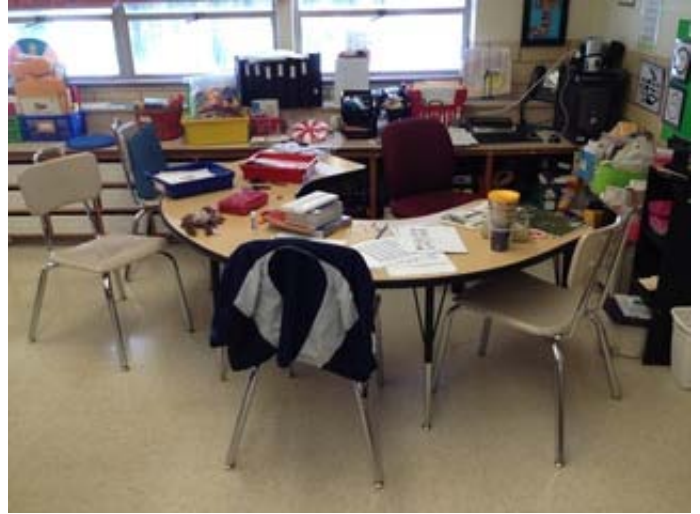
Typical Classroom

Typical Reading Table

Recommendations: Provide for replacement of outdated or inadequate furnishings.
