**Building Information - Tipp City Exempted Village (45617) - Tipp City Enrichment Program**

Program Type	Classroom Facilities Assistance Program (CFAP) - Regular
Setting	Small City
Assessment Name	Tipp City Enrichment Program with EEA & 2018 Costs
Assessment Date (on-site; non-EEA)	2015-03-31
Kitchen Type	No Kitchen
Cost Set:	2018
Building Name	Tipp City Enrichment Program
Building IRN	
Building Address	223 West Broadway
Building City	Tipp City
Building Zipcode	45371
Building Phone	937-667-8800
Acreage	5.50
Current Grades:	PK
Teaching Stations	26
Number of Floors	3
Student Capacity	346
Current Enrollment	184
Enrollment Date	2014-01-13
Enrollment Date is the date in which the current enrollment was taken.	
Number of Classrooms	18
Historical Register	<b>NO</b>
Building's Principal	Melissa Price
Building Type	Elementary

The Tipp City (TC) Enrichment Program Building, formerly known as Tippecanoe Central, is not on the National Register of Historic Buildings and was originally constructed in 1912. The three-story, brick and stone building measures approximately 29,288 square feet and is located in a small town residential setting. The existing facility features a conventionally part

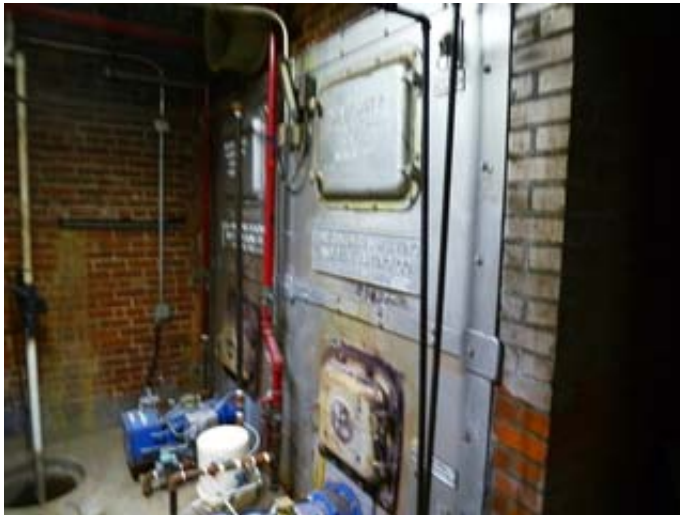
**Description:** The existing system for the overall facility is a gas fired forced air furnace, installed in 1916, and is in poor condition. 2-pipe vs. 4-pipe designations are not applicable in this facility because the heating source is a gas fired furnace. There are no boilers in this facility. The two gas fired furnaces, manufactured by Columbus Heating and Ventilation, were installed in 1916 and are in fair condition. The system does not comply with the 15 CFM per person fresh air requirements of the Ohio Building Code mechanical code and Ohio School Design Manual. The pneumatic type system temperature controls were installed in 1954 and are in poor condition. The system does not feature individual temperature controls in all spaces required by the OSDM. The overall system does not feature any central energy recovery systems. The facility is not equipped with louvered interior doors to facilitate Corridor utilization as return air plenums. The existing system is concrete/brick ducted, but the ductwork cannot be integrated into a possible future system due to arrangement, air volume, and routing of existing ductwork. The overall heating system is evaluated as being in safe but inefficient working order, and long term life expectancy of the existing system is not anticipated. The structure is not equipped with central air conditioning. The site does not contain underground fuel tanks.

**Rating:** 3 Needs Replacement

Existing Gas Fired Forced Air Furnace

**Recommendations:** Provide a new overall heating, ventilating, and air conditioning system to achieve compliance with Ohio Building Code and Ohio School Design Manual standards. Provide new DDC type temperature controls only meet Ohio Building Code and Ohio School Design Manual standards. Provide architectural soffits to accommodate the installation of ductwork.

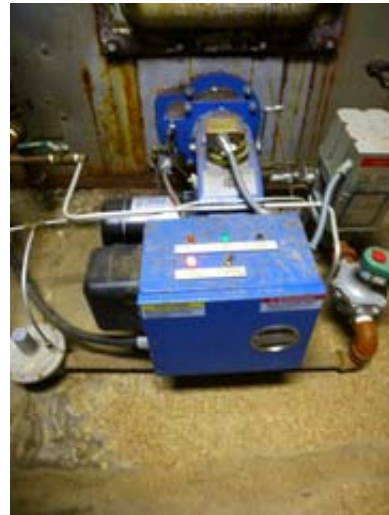
Existing Gas Burner

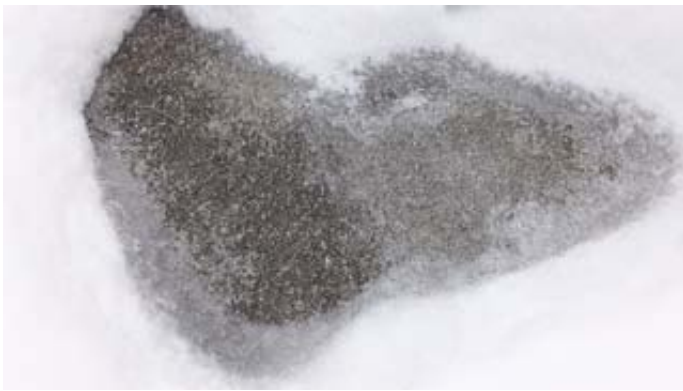
**Description:** The roof over the overall facility is a built-up asphalt roof membrane system that was installed in 1994 and is in poor condition. There are no District reports of current leaking. Signs of past leaking were observed during the physical assessment. Access to the roof was gained by a portable ladder along the outside of the building. There were no observations of standing water on the roof. Stone copings are in poor condition due to age. Roof storm drainage is addressed through a system of roof drains, which are improperly located, and in poor condition. The roof is not equipped with overflow roof drains though they will be required in areas of roof replacement. No problems requiring attention were encountered with any roof penetrations. There are not any covered walkways attached to this structure.

**Rating:** 3 Needs Replacement

Roof Membrane

**Recommendations:** The roof over the overall facility requires replacement to meet Ohio School Design Manual guidelines for age of system and due to condition. The flashing and copings on the overall facility require replacement due to condition. Provide tapered insulation to promote proper roof drainage. Due to existing conditions, roof drains require replacement. Install new overflow roof drains as per OBC requirements. Provide a roof hatch for roof access.

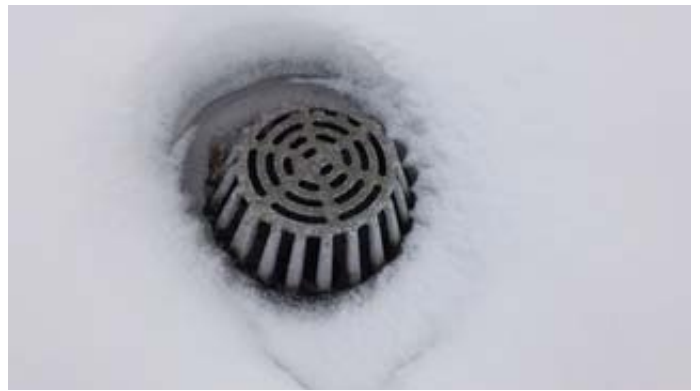
Roof Drain

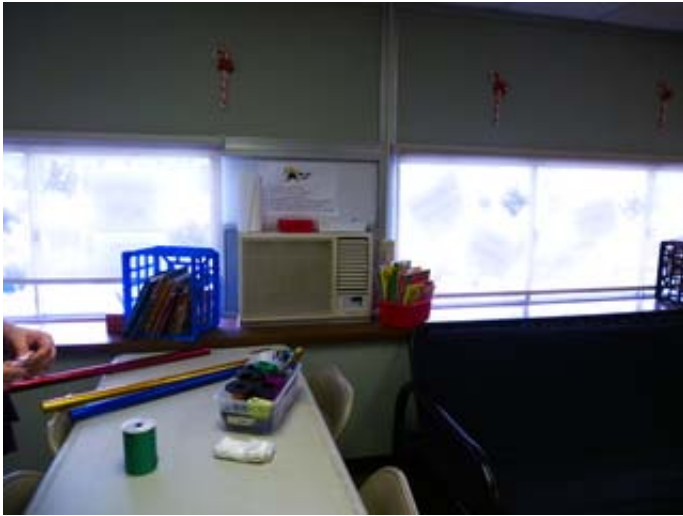
**Description:** The overall facility is not equipped with a central air conditioning system. Window units are provided in two locations. The ventilation system in the overall facility consists of gas fired forced air system, installed in 1916 and in poor condition, providing fresh air to Classrooms. Relief air venting is provided by being ducted back through the forced air system. The ventilation system does not meet the Ohio Building Code 15 CFM per occupant fresh air requirement. The overall system is not compliant with Ohio Building Code and Ohio School Design Manual requirements. Dust collection systems are not required in this facility. The facility does not feature an Art Room. General building exhaust systems for Restrooms, Storage Rooms, and Custodial Closets are inadequately placed, and in poor condition.

Typical Window A/C Unit

**Recommendations:** (The above rating of "1 Satisfactory" has been provided because the following items are discussed in other sections. This section would receive a "3 Needs Replacement" if associated costs appeared in the table below.) Provide an air conditioning system to meet with Ohio Building Code and Ohio School Design Manual requirements. Pricing is included in Item A - Heating System. Replace general building exhaust systems located in Restrooms, Storage Rooms, and Custodial Closets. Pricing is included in Item A - Heating System.

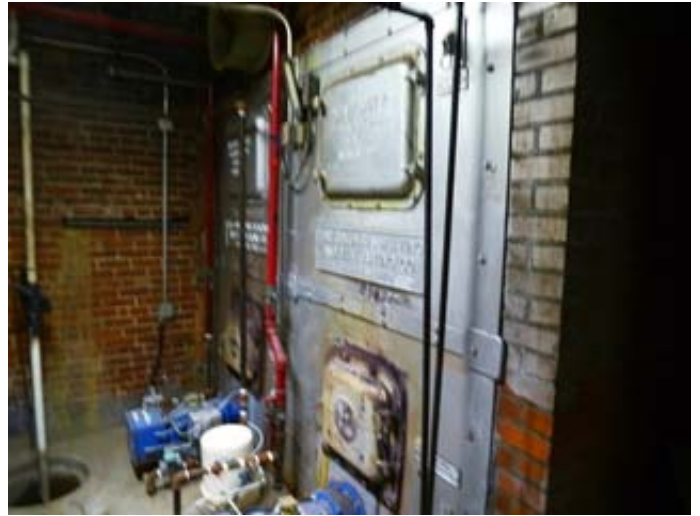
Gas Fired Forced Air Unit

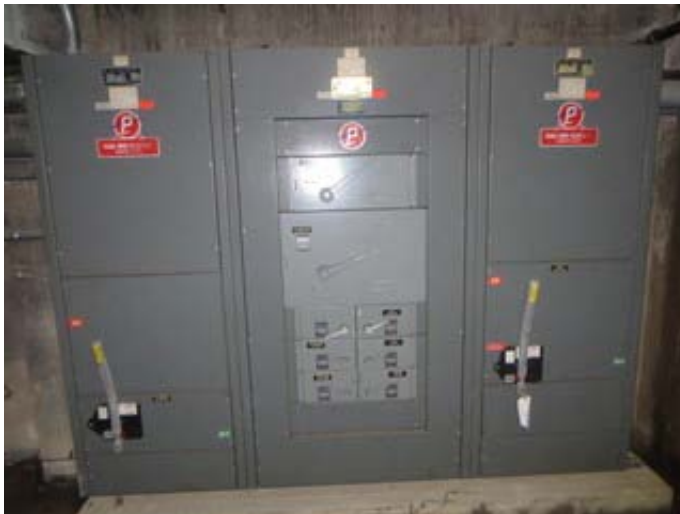
**Description:** The electrical system provided to the overall facility is a 240V, 200 AMP, 1 phase and 3 wire system installed in 1986, and is in poor condition. The electrical system in the building is an extension of that found in Broadway Elementary School. The panel system, modified in 1986, is in poor condition, and cannot be expanded to add additional capacity. The Classrooms are not equipped with adequate electrical outlets. The typical Classroom contains 4 general purpose outlets, 0 dedicated outlets for each Classroom computer, and 0 dedicated outlets for each Classroom television. Some Classrooms are equipped with as many as 5 general purpose outlets, while others are equipped with as few as 2 general purpose outlets. There are not any spaces that have no electrical outlets. The Corridors are not equipped with adequate electrical outlets for servicing. Adequate GFI protected exterior outlets are not provided around the perimeter of the building. The facility is not equipped with an emergency generator. Adequate lightning protection safeguards are not provided. The existing facility is not equipped with a Stage. The overall electrical system does not meet Ohio School Design Manual requirements in supporting the current needs of the school, and will be inadequate to meet the facility's future needs.

**Rating:** 3 Needs Replacement

Broadway Elementary Gear that Provides Distribution

**Recommendations:** The entire electrical system requires replacement to meet Ohio School Design Manual guidelines for overall capacity, Classroom capacity, due to condition and age, and the lack of OSDM-required features.

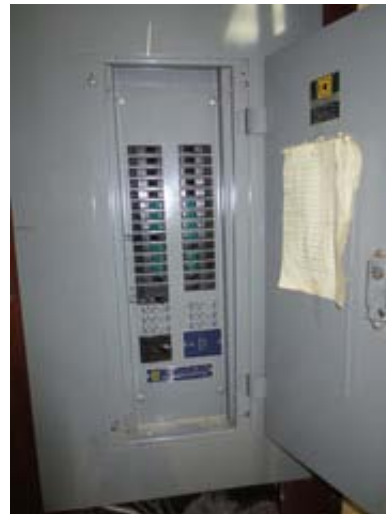
Electrical Panel

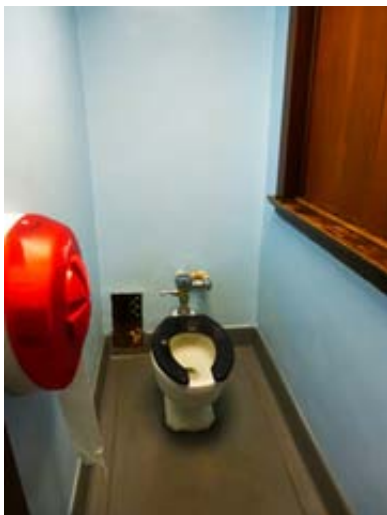
**Description:** The service entrance is not equipped with a reduced pressure back flow preventer. A water treatment system is not provided. The domestic water supply piping in the overall facility is galvanized, was installed in 1916, and is in poor condition. The waste piping in the overall facility is cast iron, was installed in 1916, and is in poor condition. The facility is equipped with a 40 gallon gas water heater in good condition. The school contains 1 Large Group Restroom for boys (no longer in service), 1 Large Group Restroom for girls (no longer in service), 1 Locker Room Restroom (no longer in service) and 4 Shared Restrooms. The Boys' Large Group Restroom contains 0 ADA and 4 non-ADA floor mounted flush valve toilets, 0 ADA and 4 non-ADA floor mounted flush valve urinals, as well as 0 ADA and 2 non-ADA wall mounted lavatories. The Girls' Large Group Restroom contains 0 ADA and 4 non-ADA floor mounted flush valve toilets, as well as 0 ADA and 1 non-ADA wall mounted lavatories. The Locker Room Restroom contains 0 ADA and 2 non-ADA floor mounted flush valve toilets, 0 ADA and 2 non-ADA wall mounted lavatories, as well as 0 ADA and 2 non-ADA showers. Shared Restrooms contain 0 ADA and 4 non-ADA floor mounted flush valve toilets, as well as 0 ADA and 4 non-ADA wall mounted lavatories. Condition of fixtures is poor. The facility is equipped with 0 ADA and 4 non-ADA drinking fountains. The Elementary Classrooms are not equipped with ADA sink mounted type drinking fountains. Due to existing grade configuration, the facility is not equipped with Special Education, Kitchen, and Health Clinic spaces. The school does not meet the OBC requirements for fixtures. Relative to LEED requirements, the school is not equipped with low flow type fixtures. Per OBC and OSDM requirements this facility should be equipped with 4 toilets, 1 urinal, 4 lavatories, 4 Classroom sink mounted drinking fountains, and 2 electric water coolers. Observations revealed that the school is currently equipped with 4 toilets, 4 urinals, 4 lavatories, and 4 electric water coolers. ADA requirements are not met for fixtures and drinking fountains (see Item O - Handicapped Access). Custodial Closets are properly located and are adequately provided with required service sinks or floor drain sinks, which are in fair condition. Science Classroom / Lab utility sinks, gas connections, compressed air connections, and safety shower / eyewash are not provided, but are not required due to existing grade configuration. Due to existing grade configuration, no Biology or Chemistry Classroom acid waste systems are required. Adequate exterior wall hydrants are not provided.

**Rating:** 3 Needs Replacement

Existing Non-ADA Floor Mounted Toilet

**Recommendations:** Due to age, condition, LEED, and OSFC requirements, provide a total of 4 toilets, 4 urinals, 4 lavatories, 8 Classroom sink mounted drinking fountains, and 4 electric water coolers. Fixture totals are coordinated between Item E - Plumbing and Fixtures and Item O - Handicapped Access. Within Item E - Plumbing and Fixtures, provide 1 new electric water cooler and 8 new lavatory mounted type drinking fountains (one sink for each active Classroom space). See Item O - Handicapped Access, for the remainder of fixture replacements and additions related to ADA requirements. Replace galvanized water supply piping in the overall facility with copper piping. Replace sanitary waste piping in the overall facility due to age and condition. Replace mop sinks due to age and condition. Provide exterior wall hydrants.

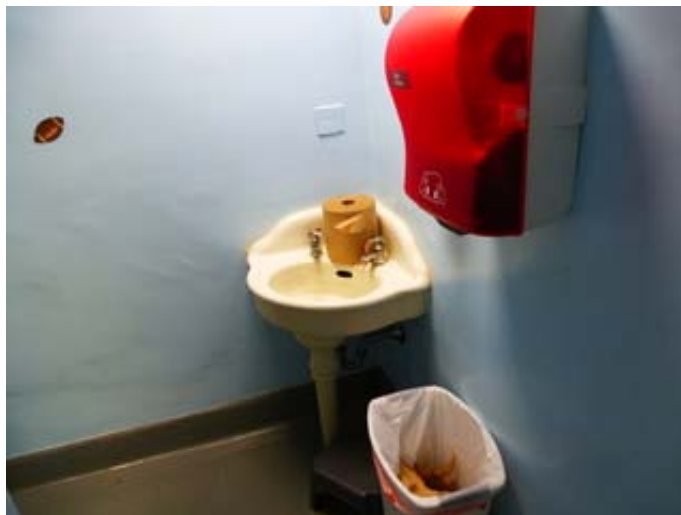
Existing Non-ADA Wall Mounted Lavatory

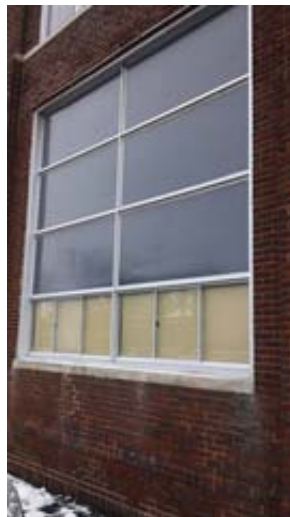
**Description:** The overall facility is equipped with metal windows with single glazed type window systems, which were installed in 1960's and are in poor condition. The window systems feature operable windows throughout the building and are equipped with opening limiters in poor condition. No insect screens are present. Window system seals are in poor condition, with moderate air and water infiltration being experienced. Window system hardware is in poor condition. The window system features surface mounted roller shades, which are in poor condition. This facility is not equipped with any curtain wall systems. This facility does not feature any glass block windows. The exterior doors in the overall facility are equipped with steel sidelights and transoms with single pane glazing, in poor condition. Exterior door vision panel glazing is also single pane. The school does not contain skylights. The school does not contain clerestories. Interior glass is not OSDM-compliant due to not being safety glass. Window security grilles are not provided for ground floor windows. There is not a Greenhouse associated with this school.

**Rating:** 3 Needs Replacement

Rear Exterior Window

**Recommendations:** Provide a new insulated window system with integral blinds to meet with Ohio School Design Manual requirements. Exterior door vision panel replacement is addressed in the replacement of exterior doors in Item S - Exterior Doors. Replace the window transoms at the east and north elevation entrances. Existing window panel square footages are included within the insulated glass/panels and exterior transom glazing square footage values provided in the table below. Replace all non-compliant interior glazing with 1/4" tempered glass.

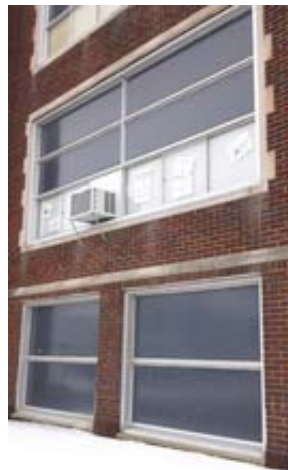
Front Exterior Window

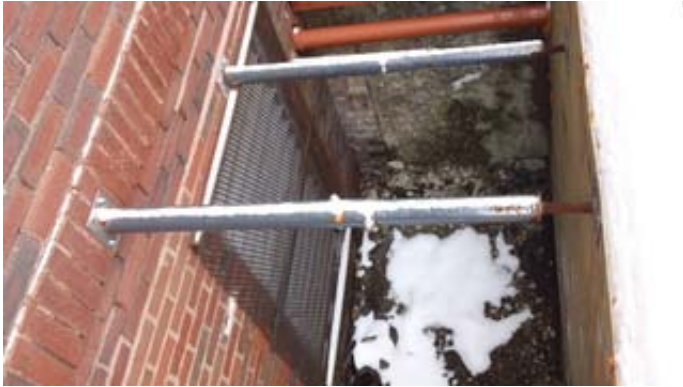
**Description:** The overall facility is equipped with concrete foundation walls on concrete spread footings, which displayed no locations of significant differential settlement, cracking, or leaking, and are in good condition. No significant issues related to foundation cracking or spalling were encountered. The District reports that there has been no past leaking. No grading or site drainage deficiencies were noted around the perimeter of the structure that are contributing or could contribute to foundation or wall structural deterioration. The exterior stair accessing the lower level Mechanical Room at the rear of the building has a retaining wall that is failing and is currently being braced in place.

**Rating:** 3 Needs Replacement

Failing Retaining Wall to Lower Level

**Recommendations:** Remove and rebuild the exterior retaining wall and access stairs down to the lower level Mechanical Room at the rear of the building.

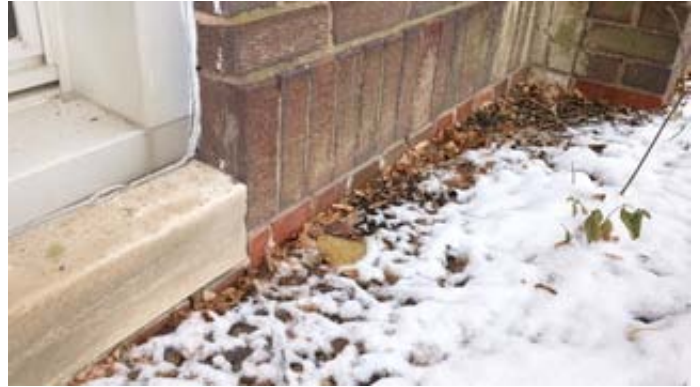
Typical Foundation at Grade

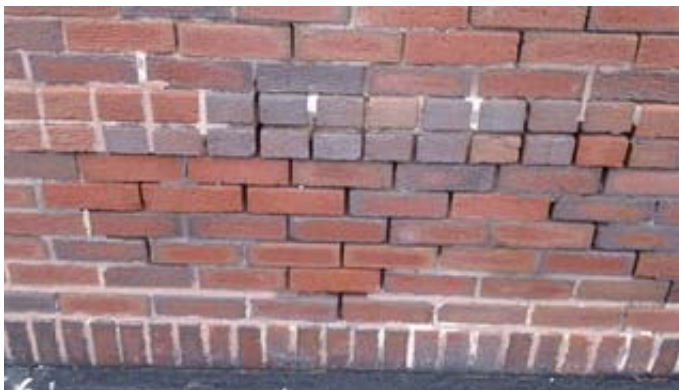
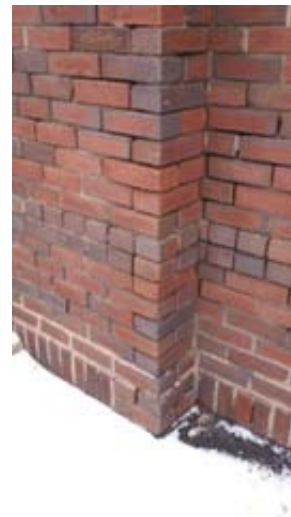
**Description:** The overall facility has a brick veneer on load bearing masonry wall, which displayed locations of deterioration, and is in poor condition. The exterior masonry appears to have inappropriately spaced and inadequately caulked control joints in poor condition. Control joints are not provided at lintel locations, at doors and windows, building corners, and wall offsets. The school does not contain expansion joints and none are needed, as there is no indication of exterior masonry cracking or separation. Exterior walls in the overall facility are inadequately insulated. Brick veneer masonry walls are not cavity walls. Mortar joints have deteriorated at numerous locations around the entire building. Weep holes and vents are not provided or required. The exterior masonry has not been cleaned and sealed in recent years, and shows evidence of mortar deterioration throughout the facade. Architectural exterior accent materials consist of stone, which is in fair condition. Interior walls are plaster covered concrete masonry units, and are in fair condition. Interior masonry appears to have inadequately spaced and caulked control joints in poor condition. Interior soffits are of plaster type construction, and in fair condition. The window sills are stone, and are in fair condition. The exterior lintels are precast steel members that are rusting and in fair condition. Chimneys are in fair condition. Canopies over entrances are plaster type construction, and are in fair condition. The school is not equipped with a loading dock.

**Rating:** 2 Needs Repair

Exterior Brick Wall

**Recommendations:** Provide tuckpointing in all areas of mortar deterioration as required through the overall facility. Repoint exterior stone window sills. Provide masonry cleaning, sealing, and caulking as required through the overall facility. Sawcut and caulk new appropriately spaced control joints in existing masonry through the overall facility. Prep and paint exposed steel lintels through the overall facility. Exterior wall insulation deficiencies are addressed in Item J - General Finishes. Interior and exterior soffits need to be repainted. The associated cost of repainting exterior soffits can be found below. The associated cost of repainting interior soffits is included in Item J - General Finishes, under the full replacement of finishes and casework.

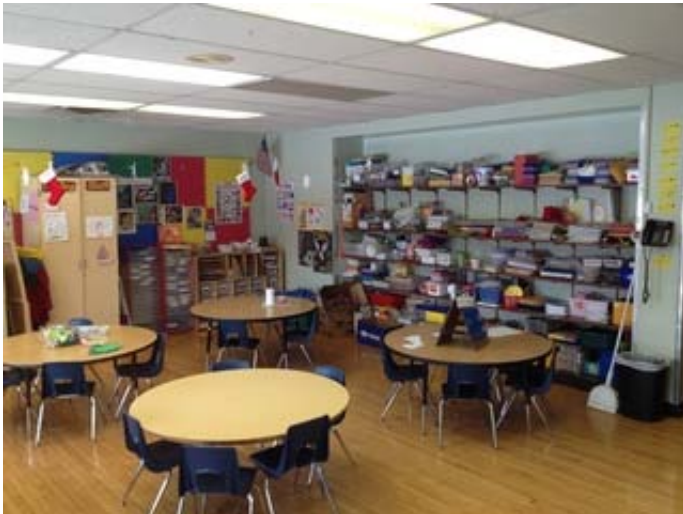
**Description:** The overall facility features conventionally partitioned Classrooms with wood, carpet, or asbestos tile type flooring, acoustical lay-in type ceilings, as well as hard plaster type wall finishes, and they are in poor condition. The overall facility has Corridors with VAT, VCT, or painted concrete type flooring, acoustical lay-in type ceilings, as well as hard plaster type wall finishes, and they are in poor condition. The overall facility has Restrooms with painted concrete type flooring, concrete type ceilings, as well as hard plaster type wall finishes, and they are in poor condition. Toilet partitions are wood, and are in poor condition. Classroom casework is not provided in the overall facility. Classrooms are not provided adequate chalkboards, markerboards, tackboards which are in poor condition. The lockers, located in the Corridors, are adequately provided, and are in poor condition. The building does not feature an Art program. The facility is equipped with wood non-louvered interior doors that are recessed without proper ADA hardware and clearances, and in poor condition. There is not a Gymnasium space in the building. Students use the Gymnasium in Broadway Elementary School, which is attached to the building. The Media Center has wood type flooring, acoustical lay-in type ceilings, as well as hard plaster type wall finishes, and they are in poor condition. There is not a Student Dining space in the building. Students dine at Broadway Elementary School, which is attached to the building. The building does not feature a Kitchen space. Food for students is prepared by the Kitchen in Broadway Elementary School, which is attached to the building.

**Rating:** 3 Needs Replacement

Typical Classroom Finishes

**Recommendations:** Provide complete replacement of finishes and casework due to condition and installation of systems outlined in Items (A / C / D / E / I / K / L / M / N / T / U / W). Funding for replacement of interior doors is provided in Item O - Handicapped Access, including doors that are in poor condition. The replacement of toilet partitions and toilet accessories has been coordinated with Item O - Handicapped Access. Provide wall insulation, furring, and gypsum wall board along exterior walls. Provide sound attenuation for the Media Center due to inadequate acoustical surface treatments. Replacement costs have also been provided in the table below in coordination with the abatement of materials in Item T - Hazardous Material.

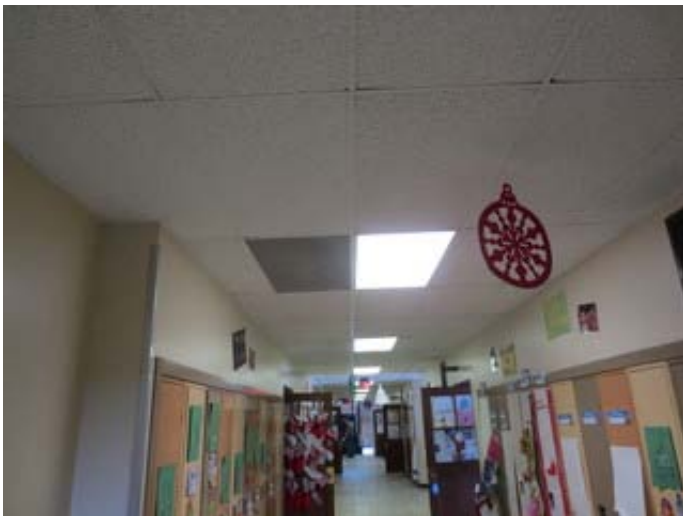
**Description:** The typical Classrooms in the overall facility are equipped with T-8 2x4 lay-in acrylic lensed fluorescent fixtures with single level switching. Classroom fixtures are in poor condition, providing an average illumination of 65 FC, thus complying with the 50 FC recommended by the OSDM. The typical Corridors in the overall facility are equipped with T-8 2x4 lay-in acrylic lensed fluorescent fixtures with single level switching. Corridor fixtures are in poor condition, providing an average illumination of 25 FC, thus complying with the 20 FC recommended by the OSDM. The Media Center is equipped with 2x4 lay-in T-8 fluorescent fixture type lighting in poor condition, providing an average illumination of 54 FC, thus complying with the 50 FC recommended by the OSDM. The Student Dining spaces are located in the attached Broadway Elementary School. The Kitchen spaces are located in the attached Broadway Elementary School. The Service Areas in the overall facility are equipped with industrial fluorescent T-8 fixture type lighting in poor condition. The typical Administrative spaces in the overall facility are equipped with 2x4 lay-in T-8 fluorescent fixture type lighting in poor condition, providing adequate illumination based on OSDM requirements. The overall lighting systems of the facility are not fully compliant with Ohio School Design Manual requirements due to age and condition and lack of multi-level switching.

**Rating:** 3 Needs Replacement

Corridor Lighting

**Recommendations:** Provide complete replacement of lighting system due to condition and lack of multilevel switching.

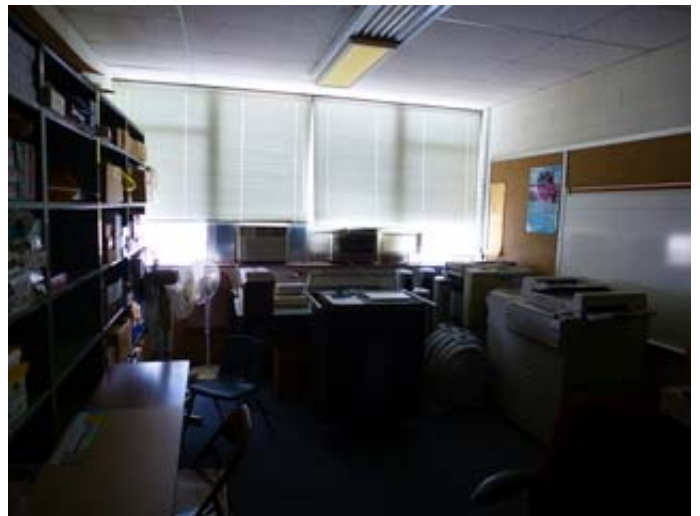
Storage Lighting Fixture

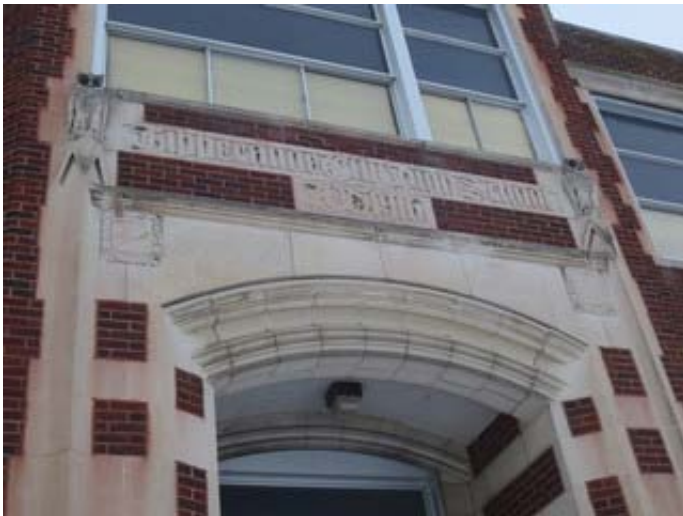
**Rating:** 3 Needs Replacement

Exterior Entry Lighting

**Recommendations:** Provide a new security system to meet Ohio School Design Manual guidelines. Provide complete replacement of exterior site lighting system to meet Ohio School Design Manual guidelines. Due to the age group of the students, it is important for proper fencing and security measures to be in place. The proximity to Broadway Elementary School provides access to a fenced playground environment for the TC Enrichment Program students. If students travel through Broadway Elementary School to access the playground area, then a safe route is in place that protects students from the parking lot and Maintenance Building located between the TC Enrichment Program Building and the playground area. Refer to the Broadway Elementary School Assessment for further recommendations regarding the existing playground fencing. If students utilize the open areas to the east of the TC Enrichment Program Building, fencing would be recommended to protect students from surrounding vehicular and pedestrian traffic, but the need for fencing is dependent on whether or not this area of the site is used for school instruction/play. Funding for any potential fencing in this area would be provided under the complete replacement of the security system.

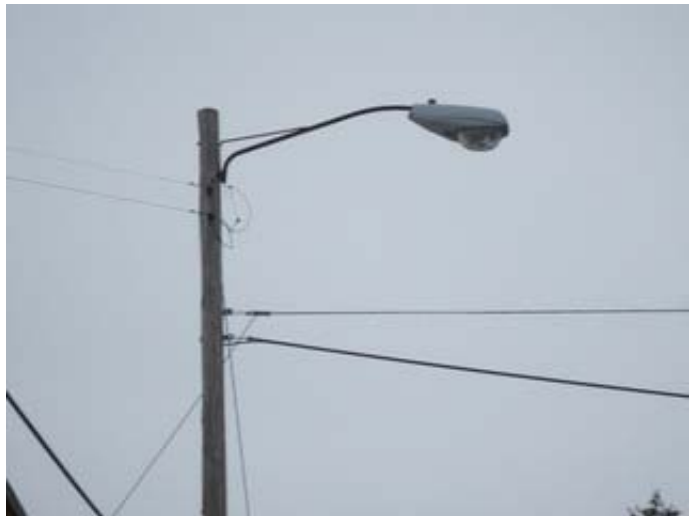
Exterior Site Lighting

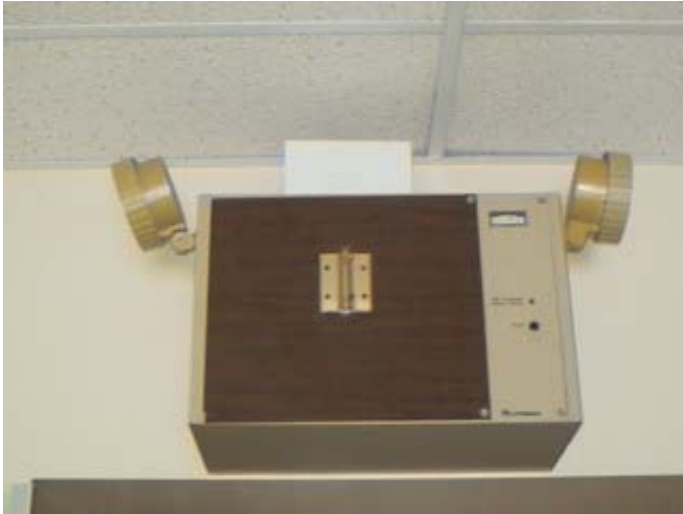
**Description:** The overall facility is equipped with an emergency egress lighting system consisting of non compliant red lettered, incandescent, cast aluminum construction and non illuminated exit signs, and the system is in poor condition. The facility is inadequately equipped with emergency egress floodlighting, and the system is in poor condition. The system is provided with appropriate battery backup. The system is not adequately provided throughout, and does not meet Ohio School Design Manual and Ohio Building Code requirements.

**Rating:** 3 Needs Replacement

Emergency Egress Lighting Fixture

**Recommendations:** Provide complete replacement of new emergency / egress lighting system to meet Ohio School Design Manual and Ohio Building Code guidelines.

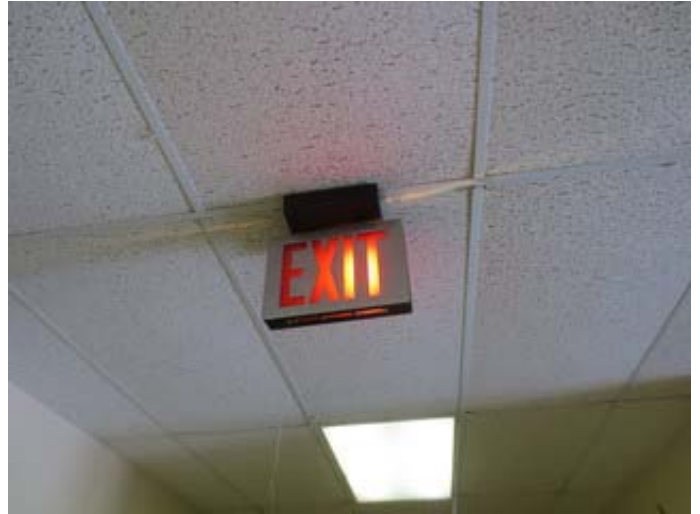
Incandescent Exit Sign

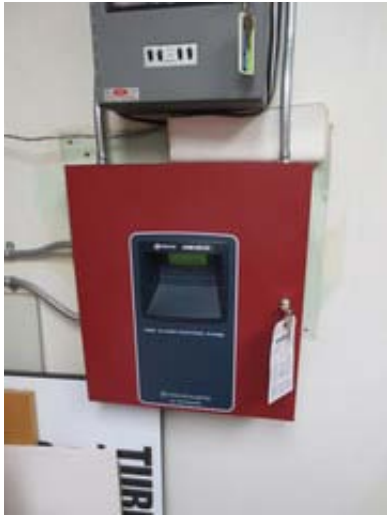
**Description:** The Fire Alarm Control Panel is located in Broadway Elementary School. The overall facility is equipped with a Honeywell Fire-Lite MS-5UD type fire alarm system, installed in 2000, and in good condition, consisting of manual pull stations, and horn and strobe indicating devices. The system is not automatic and is monitored by a third party. The system is not equipped with sufficient audible horns / strobe indicating devices, and smoke detectors. The system is not equipped with any flow switches, tamper switches and heat sensors. The system thus will not support future fire suppression systems. The system is not fully compliant with Ohio Building Code, NFPA, and Ohio School Design Manual requirements.

**Rating:** 3 Needs Replacement

Broadway Elementary School Fire Alarm Panel

**Recommendations:** Provide complete replacement of fire alarm system to meet OBC, NFPA, and Ohio School Design Manual guidelines.

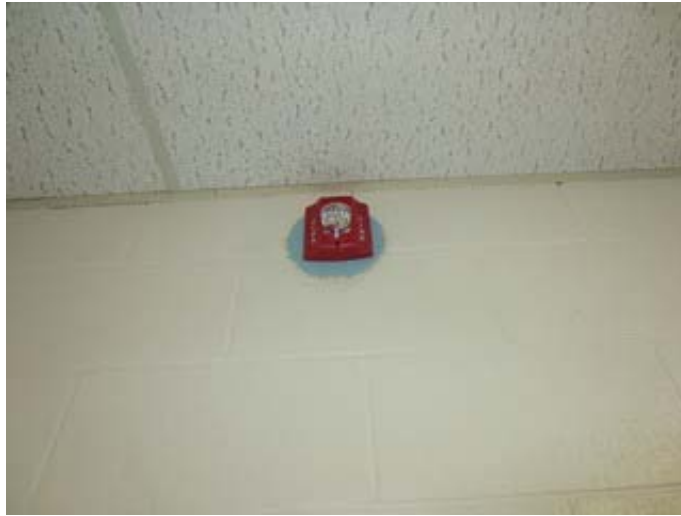
Fire Alarm Device

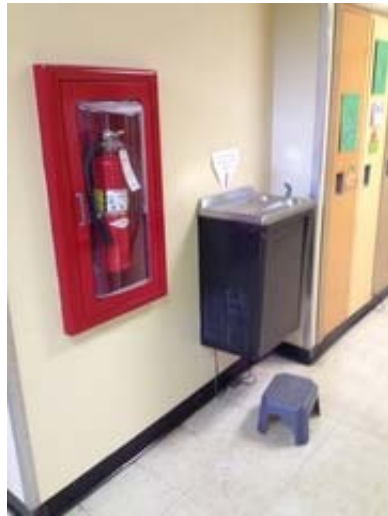
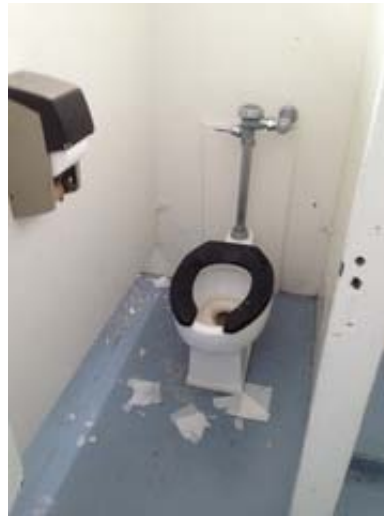
**Rating:** 3 Needs Replacement

Water Fountain

Toilet

**Recommendations:** Provide ADA-compliant signage, power assist door opener, elevator, electric water coolers, toilets, sinks, urinals, toilet partitions, toilet accessories, doors and frames, door hardware in the overall facility to facilitate the school's meeting of ADA requirements. Parking issues are discussed in Item P - Site Condition. Provide an ADA compliant ramp at the north elevation entry to access the building. Refer to Item U - Life Safety for costs associated with the replacement of non-compliant stair railings and the addition of interior stairwell enclosures. Refer to Item P - Site Condition, for costs associated with exterior stair and guardrail replacement.

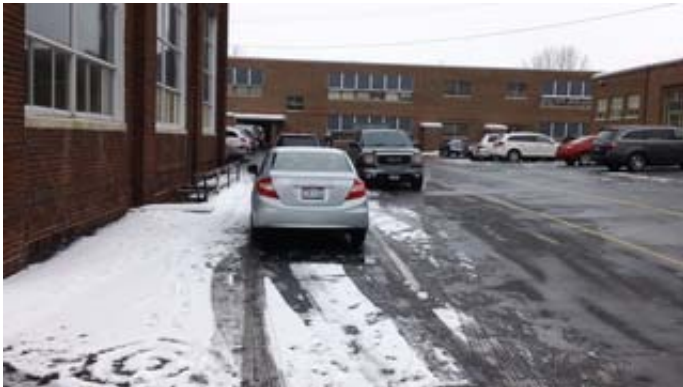
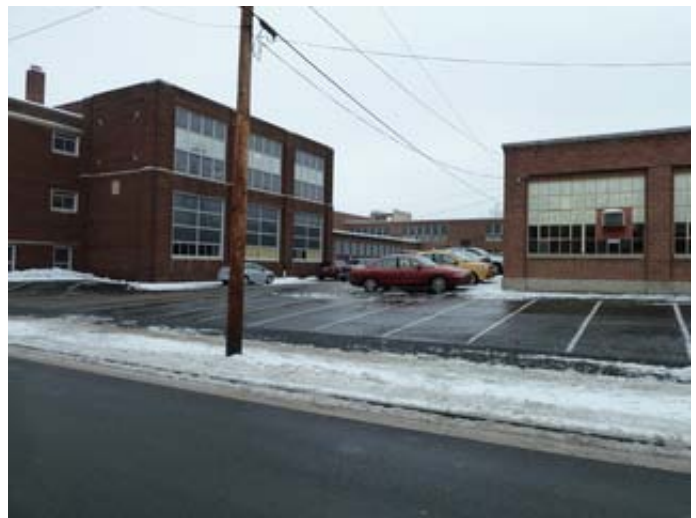
2 Needs Repair

Current Parking Area

Provide additional parking spaces to meet OSDM guidelines, including adequate provisions for the disabled. Replace all non-compliant exterior guardrails and railings. Provide additional guardrails for the proposed north elevation ramp referenced in Item O - Handicapped Access. Refer to the Broadway Elementary School Assessment for further information regarding site improvement costs.

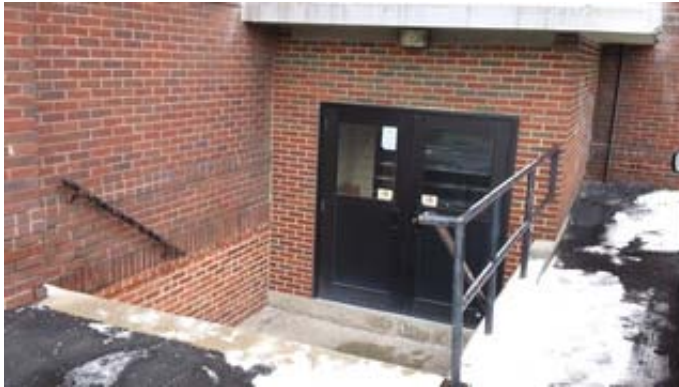
**Description:** Typical exterior doors in the overall facility are aluminum type construction, installed on aluminum frames, and in fair condition. Typical exterior doors feature single glazed tempered glass vision panels, and inappropriate hardware. Entrance doors in the overall facility are aluminum type construction, installed on aluminum frames, and in fair condition. Entrance doors feature single glazed tempered glass vision panels, transoms, and inappropriate hardware. The facility is not equipped with any roof access doors.

**Rating:** 3 Needs Replacement

Rear Exterior Door

**Recommendations:** Replace all exterior doors to comply with Ohio Building Code, ADA, and Ohio School Design Manual guidelines. Refer to Item F - Windows, for further information regarding costs associated with transom glazing replacement. Due to the replacement of exterior doors, costs associated with vision panel replacement will be included in the funding for new door systems.

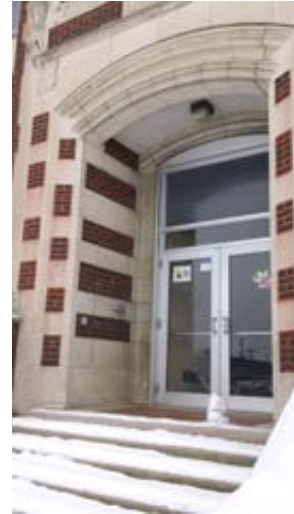
Front Exterior Door

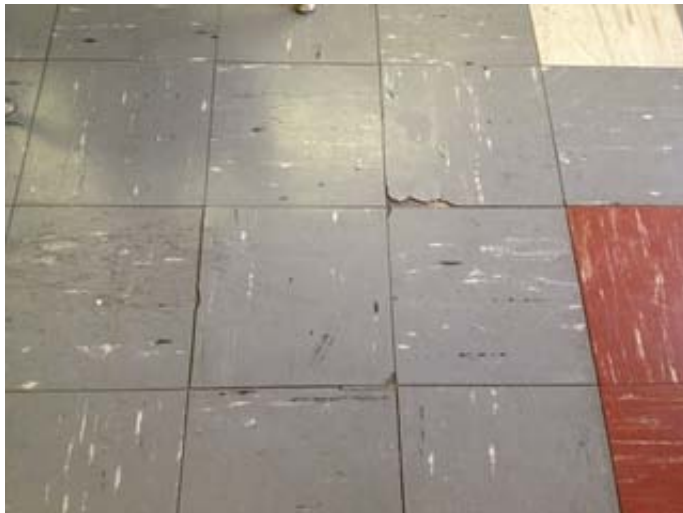
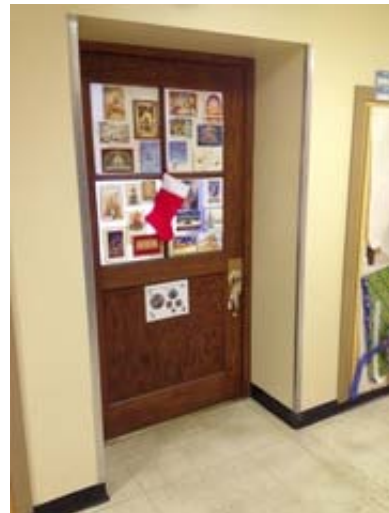
**Description:** The School District provided the AHERA three year reinspection reports, prepared by Westech Environmental Solutions and dated July 29, 2013, documenting known and assumed locations of asbestos and other hazardous materials. Floor tile and floor tile mastic, carpet mastic, ceiling tile, cove base mastic, acoustical ceiling tile and acoustical ceiling tile mastic, drywall/joint compound, texture compound on drywall, wall panels, fume hood, laboratory counters/sinks, sink undercoating, cement boards, window and door caulking, fire doors and solid core doors, hard plaster, and window panels containing hazardous materials are located in the overall facility in poor condition. These materials were described in the report to be in friable and non-friable condition moderate damage. There are no underground storage tanks on the site. Due to the construction date, there is a potential for lead based paint. Fluorescent lighting will require special disposal.

**Rating:** 3 Needs Replacement

VAT Floor Tile

VAT Floor Tile and Door

**Recommendations:** Remove all hazardous materials, inclusive of asbestos-containing materials in the overall facility, as noted in the attached Environmental Hazards Assessment. Remove universal waste lamps replaced under Item K, per the attached Environmental Hazards Assessment. Provide for the testing of paint that has the potential of being lead-based. Provide for disposal of fluorescent lighting.

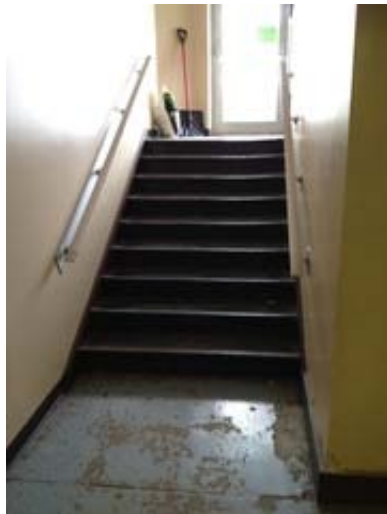
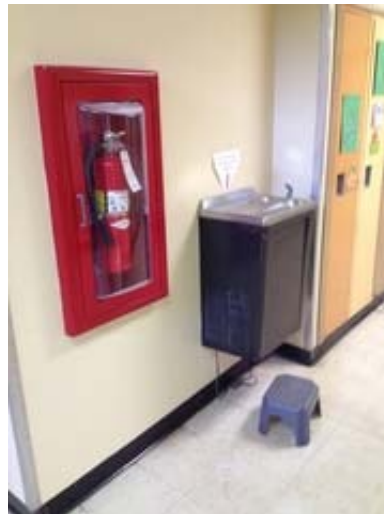
Stairway

Fire Extinguisher Cabinet

**Recommendations:** Provide a new automated fire suppression system to meet Ohio School Design Manual guidelines. Provide increased water service of a capacity sufficient to support the fire suppression system. Refer to Item R - Water Supply, for costs associated with this scope of work. Provide additional fire extinguishers to comply with Ohio Building Code. Provide new emergency generator, with funding provided via complete replacement of electrical system in Item D - Electrical Systems. Provide new handrails to meet the requirements of the Ohio Building Code. Provide fire-rated enclosures around existing stair towers.
