Broadway Business Cost Analysis

OFCC FacilitiesAssessment - March 2015

Assessment Consultant - Legat and Kingscott Architects

Building Information - Tipp City Exempted Village (45617) - Broadway Elementary

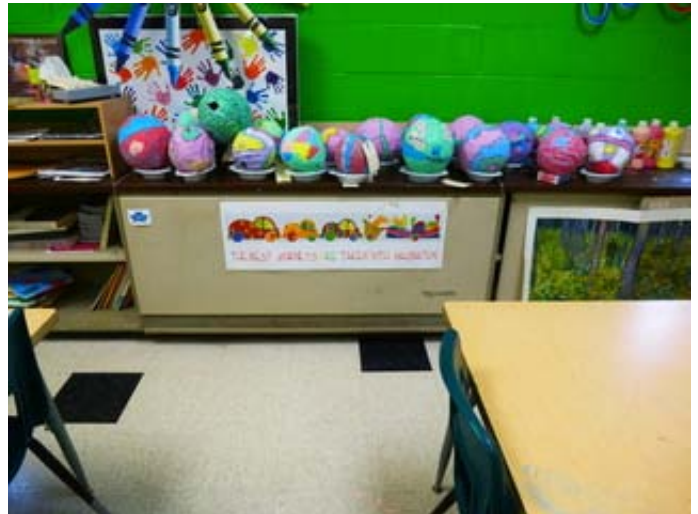
Typical Unit Ventilator

The existing system for the overall facility is a gas fired steam boiler, installed in 1951 and 1995, and is in fair condition. The boiler plant, which services Broadway Elementary School, is located in a separate Maintenance Building behind the school, and tunnels related to this system are located beneath the shared parking lot between Broadway Elementary School and the Tipp City (TC) Enrichment Program Building. The Maintenance Building structure was not assessed during the Physical Assessment. 2-pipe vs. 4-pipe designations are not applicable in this facility, as no central air conditioning is provided. The two gas-fired steam boilers, manufactured by Weil McLain, were installed in 1995 and are in fair condition, and one gas fired boiler (used only as backup), manufactured by Kewanee, was installed in 1951 and is in poor condition. Steam is distributed to terminal units consisting of unit ventilators, cabinet heaters, unit heaters and fin tubes. The terminal equipment was installed in 1951 and 1967 and is in fair condition. The system does comply with the 15 CFM per person fresh air requirements of the Ohio Building Code mechanical code and Ohio School Design Manual. The pneumatic type system temperature controls were installed in 1951 and 1967 and are in fair condition. The system does feature individual temperature controls in all spaces required by the OSDM. The overall system does not feature any central energy recovery systems. The facility is equipped with a moderate quantity of louvered interior doors to facilitate Corridor utilization as return air plenums. (Louvered doors are replaced in Item J - General Finishes and Item O - Handicapped Access, if applicable.) The existing system is not ducted, and floor to structural deck heights will not accommodate the installation of properly sized ductwork for a future Ohio School Design Manual approved system. The overall heating system is evaluated as being in safe but inefficient working order, and long term life expectancy of the existing system is not anticipated. The structure is not equipped with central air conditioning. The site does not contain underground fuel tanks.

3 Needs Replacement

Provide new overall heating, ventilating, and air conditioning system to achieve compliance with Ohio Building Code and Ohio School Design Manual standards. Convert to a ducted system to facilitate efficient exchange of conditioned air. Provide new DDC type temperature controls to meet Ohio Building Code and Ohio School Design Manual standards. Provide architectural soffits to accommodate the installation of ductwork. Refer to Item T - Hazardous Material, for information regarding the abatement of boiler system hazardous materials in the Maintenance Building.

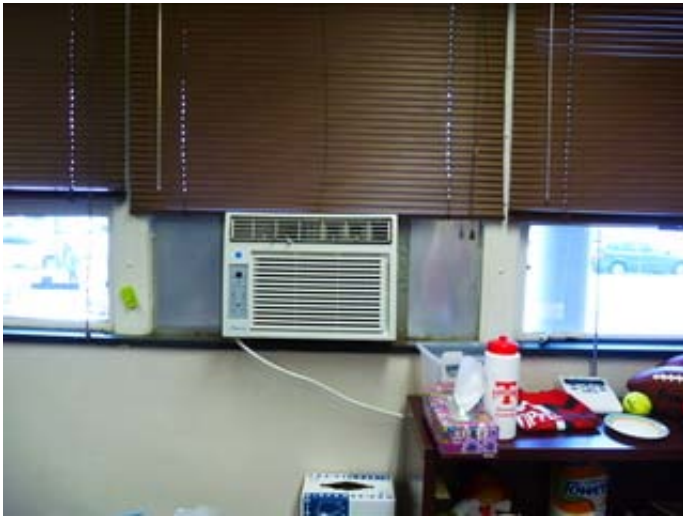
Typical Window A/C Unit

Description: The overall facility is not equipped with a central air conditioning system. Window units are provided in the Office, Library, and Clinic locations. A mobile air conditioning unit is provided in the Technology Room. The ventilation system in the overall facility consists of unit ventilators, installed in 1951 and 1967 and in fair condition, providing fresh air to Classrooms, and air handlers, installed in 1951 and 1967 and in fair condition, providing fresh air to other miscellaneous spaces such as Gymnasiums, the Student Dining area, and Media Center spaces. Relief air venting is provided by ceiling plenums exhausted by roof ventilation fans. The ventilation system does not meet the Ohio Building Code 15 CFM per occupant fresh air requirement. The overall system is not compliant with Ohio Building Code and Ohio School Design Manual requirements. Dust collection systems are not required in this facility. The Art program is equipped with a kiln, and existing kiln ventilation is adequate, and in good condition. General building exhaust systems for Restrooms Storage Rooms, Art Rooms, and Custodial Closets are adequately placed, and in fair condition.

Recommendations: (The above rating of "1 Satisfactory" has been provided because the following items are discussed in other sections. This section would receive a "3 Needs Replacement" if associated costs appeared in the table below.) Provide an air conditioning system to meet with Ohio Building Code and Ohio School Design Manual requirements. Pricing is included in Item A - Heating System.

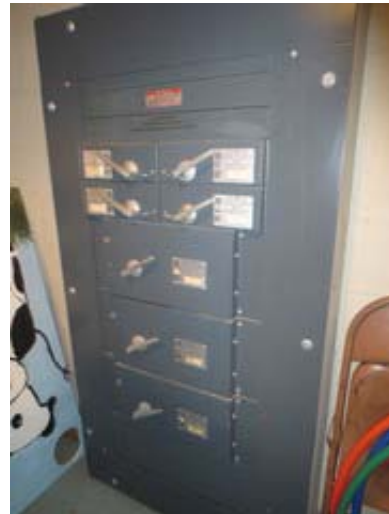
Addition Electrical Distribution

Description: The electrical system provided to the 1951 Original Construction is a 120/208V, 800A, 3 phase and 4 wire system replaced in 1986, and is in good condition, located in the Mechanical Systems Building adjacent to the school. This electric service also serves the electrical distribution in the Tippecanoe Central (TC) Enrichment Program Building. The electrical system provided to the 1967 Addition is a 120/208V, 400A, 3 phase and 4 wire system replaced in 2001, and is in good condition. The system in the 1967 Addition is a separate metered electrical service. Power is provided to the school by two district owned, pad-mounted transformers located outside the building and in good condition. The panel system, installed in the 1951 Original Construction, is in poor condition, and cannot be expanded to add additional capacity. The panel system, installed in the 1967 Addition, is in poor condition, and cannot be expanded to add additional capacity. The Classrooms are not equipped with adequate electrical outlets. The typical Classroom contains 5 general purpose outlets, 3 dedicated outlets for each Classroom computer, and 0 dedicated outlets for each Classroom television. Some Classrooms are equipped with as many as 5 general purpose outlets, while others are equipped with as few as 3 general purpose outlets. There are not any spaces that have no electrical outlets. The Corridors are equipped with adequate electrical outlets for servicing. Adequate GFI protected exterior outlets are not provided around the perimeter of the building. The facility is not equipped with an emergency generator. Adequate lightning protection safeguards are not provided. Stage lighting power system including control panel, breakers, and dimmers is not provided and does not meet OSDM requirements. The overall electrical system does not meet Ohio School Design Manual requirements in supporting the current needs of the school, and will be inadequate to meet the facility's future needs.

Rating: 3 Needs Replacement

Recommendations: The entire electrical system requires replacement to meet Ohio School Design Manual guidelines for overall capacity, due to condition and age, and lack of OSDM-required features.

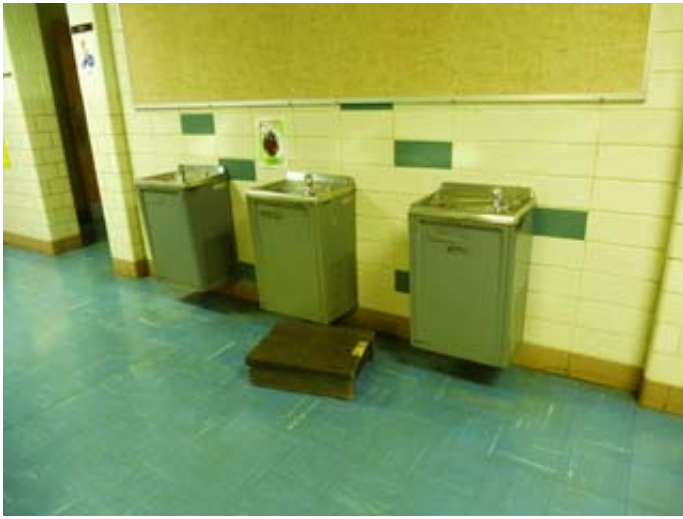
Typical Drinking Fountain

Rating: 3 Needs Replacement
