## LT Ball Business Cost Analysis

OFCC Facilities Assessment - March 2015

Assessment Consultant - Legat and Kingscott Architects

**Building Information - Tipp City Exempted Village (45617) - L.T. Ball Intermediate**

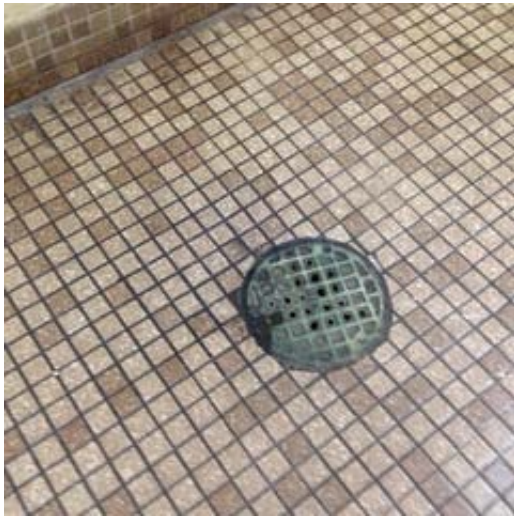
Bathroom Floor Drain

Recommendations: Existing conditions require no renovation or replacement at the present time.
